**Sinking of the Amphibious Passenger
Vehicle *Miss Majestic*, Lake Hamilton,
Near Hot Springs, Arkansas, May 1, 1999**

Marine Accident Report

**NTSB/MAR-02/01
PB2002-916401
Notation 7222B
Adopted April 2, 2002**

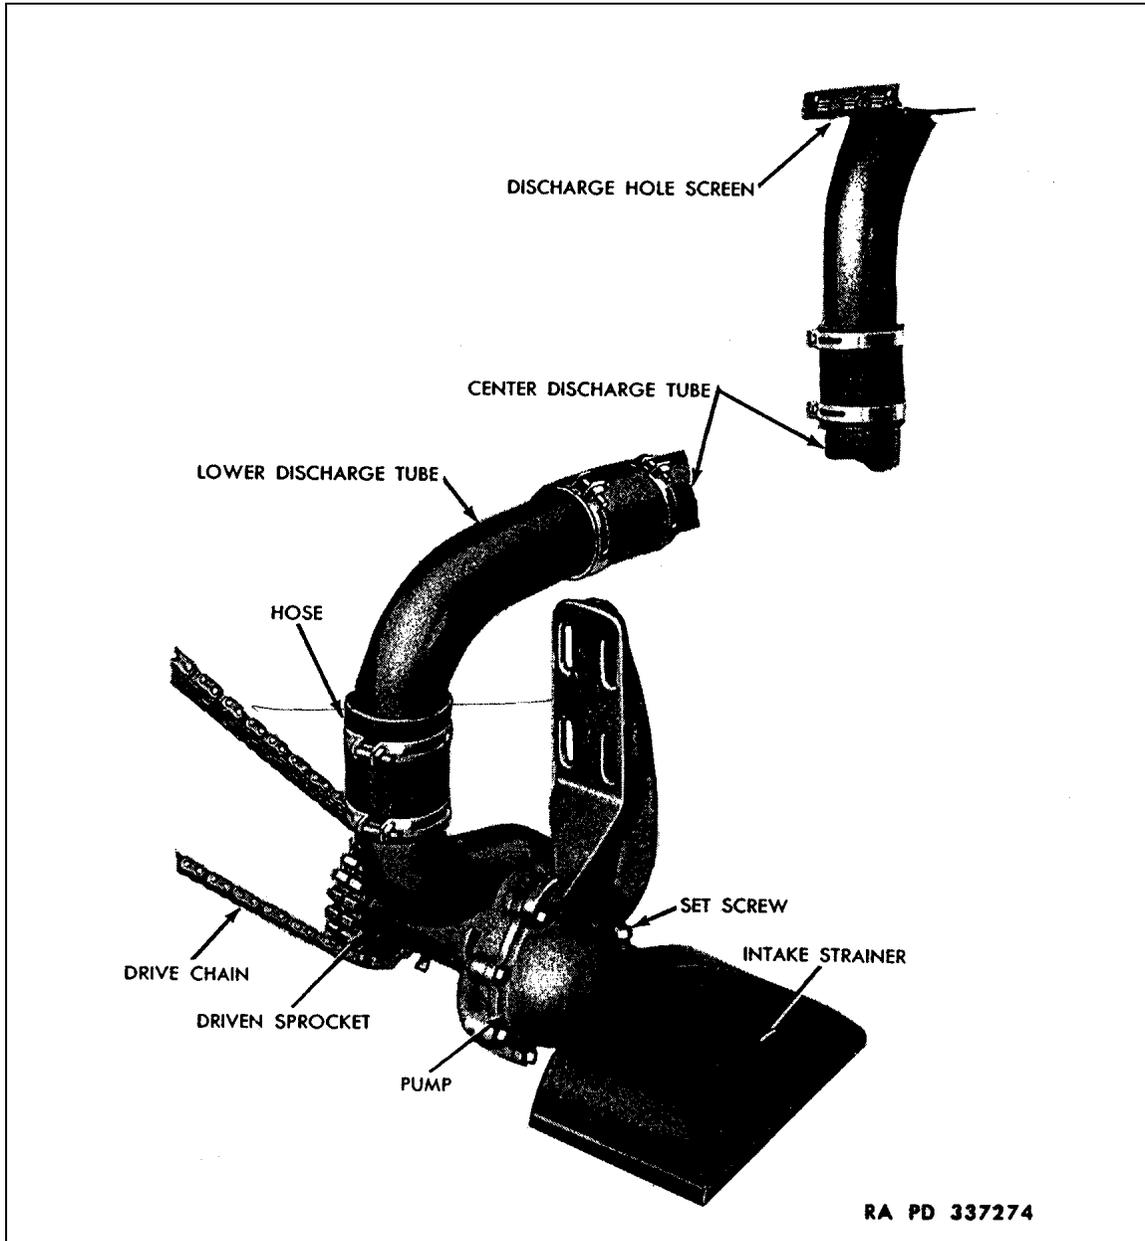
propeller driveshaft through a keyed sprocket on the pump shaft and operated whenever the propeller's driveshaft was engaged. (See figure 5.) The Higgins pump discharged straight upward and overboard through an opening on the port side gunwale, near the second row of seats.

Figure 5. The Higgins pump arrangement. The centrifugal-type, bronze pump had a 4-bolt mounting bracket, which, in the case of the Miss Majestic, attached the pump onto the port longitudinal girder (channel) under the passenger compartment. The face of the pump's intake (suction) strainer was about 1 1/2 inches above the bottom of the vehicle. The 2 1/2-inch-diameter discharge pipe extending upward from the pump had three sections: a lower discharge tube, a center discharge tube, and an upper discharge tube. A short section of hose with clamps connected the lower discharge tube to the pump discharge.

Higgins Pump. Safety Board investigators found that the key attaching the pump shaft to its drive chain sprocket was missing. The sprocket appeared old and had excess play on the pump shaft. Investigators noted that the play in the sprocket allowed the drive chain to rub against the hull frame; they also observed several abrasion marks on the frame. The pump impeller turned freely at the time of the examination. Investigators found that a 1 ½-inch portion of an impeller blade's leading edge was sheared off.
