**HUMAN PERFORMANCE GROUP CHAIRMAN'S  
FACTUAL REPORT**

**WILMER, TX**

**NATIONAL TRANSPORTATION SAFETY BOARD  
OFFICE OF HIGHWAY SAFETY  
WASHINGTON, D.C. 20594**

**NTSB #: HWY-05-MH-035**

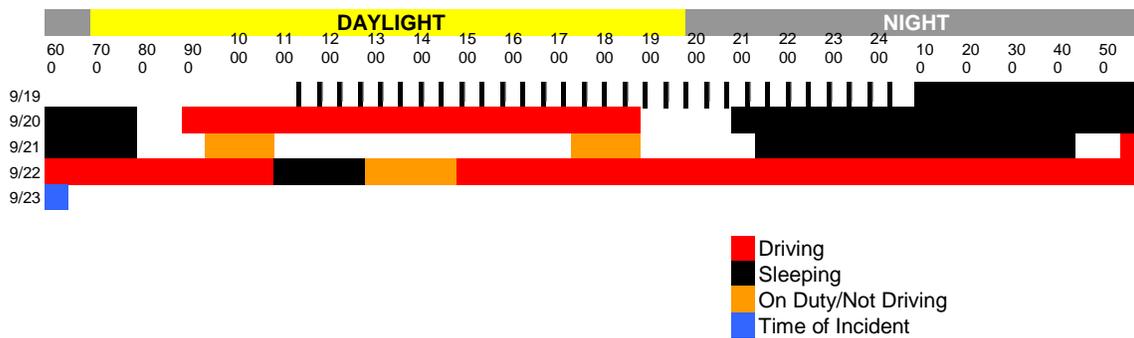
The driver's 72-hour sleep/wake/work history, constructed from preliminary interviews in the days following the fire, is depicted in Figure 1. The 72-hour history indicates a normal day-awake/night-asleep pattern, until the day (and driving period) immediately prior to the incident. During preliminary interviews, the driver told NTSB investigators he had 7 hours and 11 hours sleep, respectively, on the two nights preceding the incident. The driver slept 6.5 to 7 hours on the night before departure, and had a two-hour nap aboard the bus between the time he arrived in Bellaire, Texas and when firefighters began boarding passengers on the bus. At the time of the incident, the driver had been on duty for 24.5 hours, of which 20.5 had been driving. When he pulled the motorcoach over in Wilmer, Texas at the time of the fire, he had been on the road continuously for a 14.5-15 hour period, except for a period between about 3:30 and 4:30 a.m., while the motorcoach's tire was changed in Rice, Texas. The driver told NTSB investigators that he did not obtain any sleep during the time the motorcoach was awaiting the arrival of the tire service, nor did he attempt to sleep at that time.

Figure 1. Graphical depiction of the driver’s 72-hour sleep/wake/work history.
