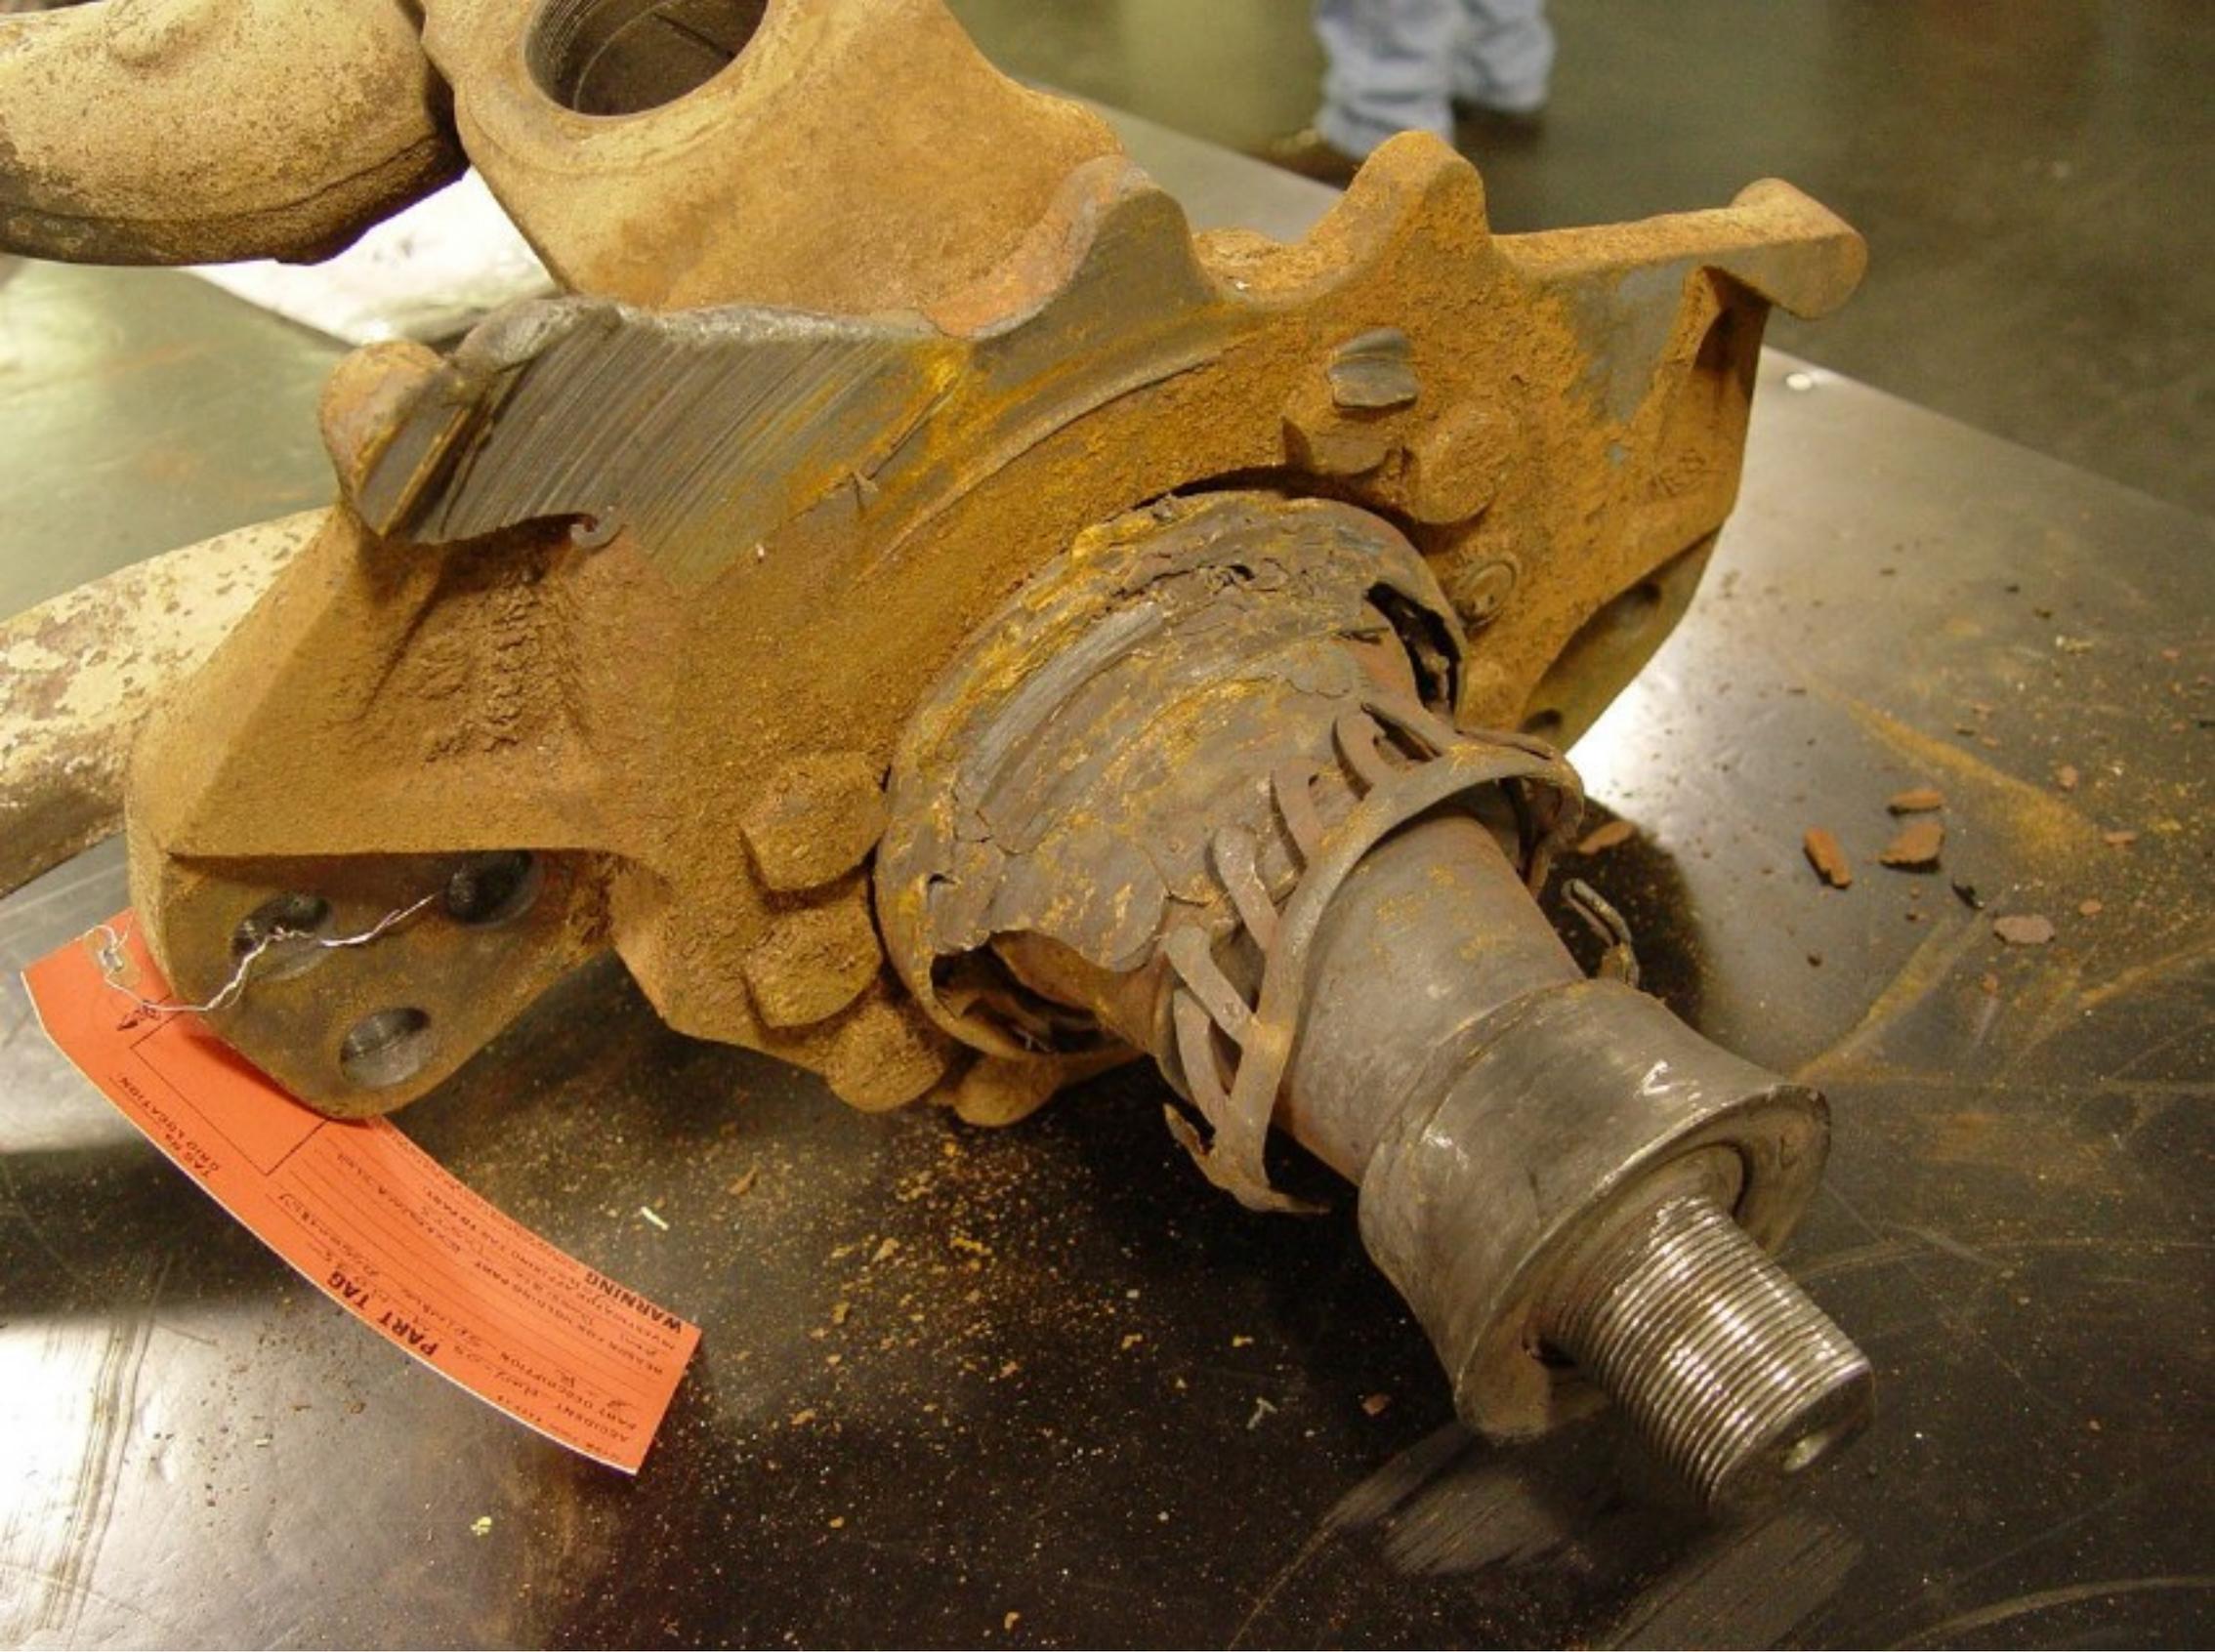
VEH Photo #44 - Damaged Bearing Cage, Melted Bearings, and Grinding Marks on Bottom of Torque Plate on Right Side Tag-Axle Spindle
