**SURVIVAL FACTORS GROUP FACTUAL REPORT**  
**(20 Pages)**

**Survival Factors Group Factual Report**

**NTSB File # HWY-05-MH-035**

Accident Type: Motorcoach Fire  
Date and Time: September 23, 2005 at 6:07 a.m. Central Daylight Time  
Accident Location: Northbound Interstate 45, .2 miles south of Mars Road,  
Near Wilmer, Dallas County, Texas  
Vehicle#1: 1998 MCI 54-passenger Motorcoach  
Motor Carrier: Global Limo  
Fatalities: 23  
Injuries: 14

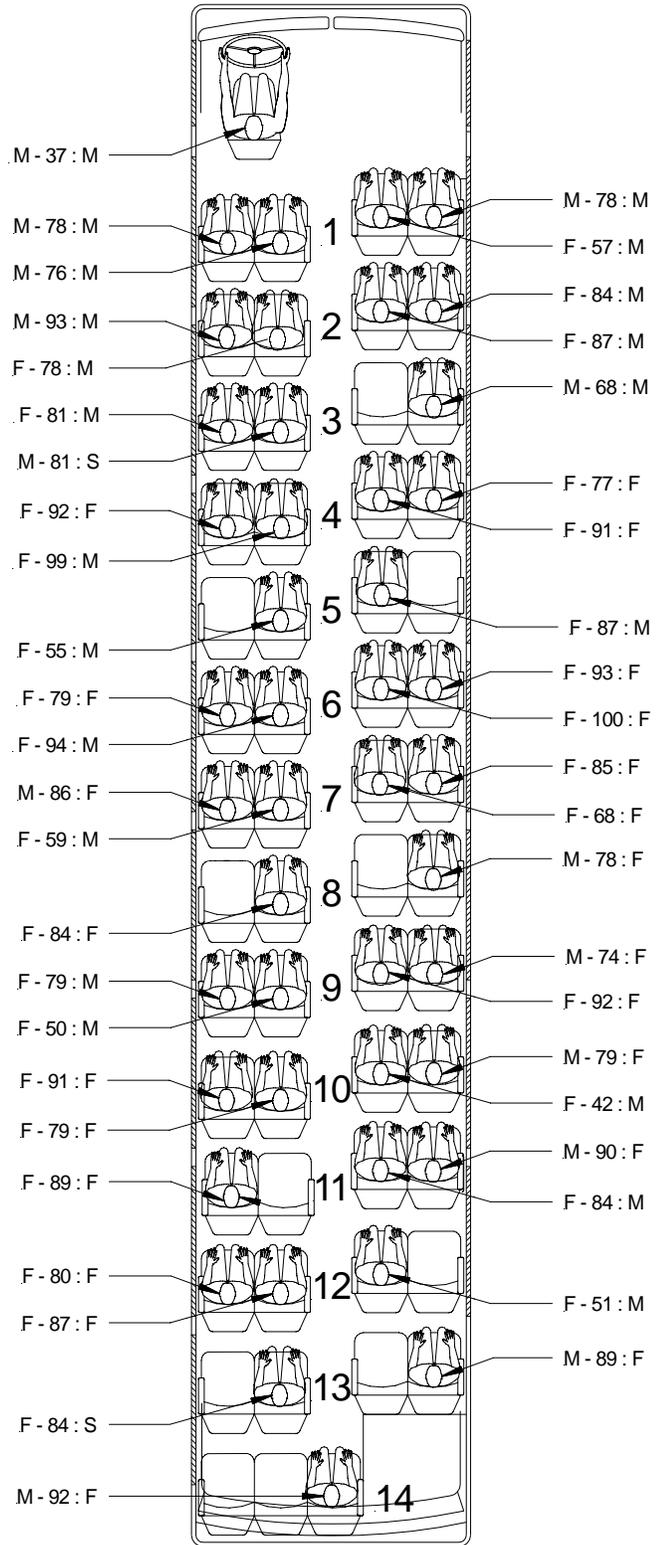
PASSENGER SEATING CHART

The post-fire inspection conducted by the Dallas County Medical Investigator and the NTSB revealed that 16 deceased passengers remained in their seats. An additional five of the deceased passengers were found in the center aisle several rows from their original seating positions. One of the five deceased passengers, who had been seated in row 10, was found near the front of the motorcoach in the aisle adjacent to row 1. Two other deceased passengers were found in aisle seat positions different than their original pre-fire seat positions.
