NTSB National Transportation Safety Board

**Circuit City Cessna 560
Pueblo, CO
February 16, 2005**

Dr. Daniel Bower
Aircraft Performance

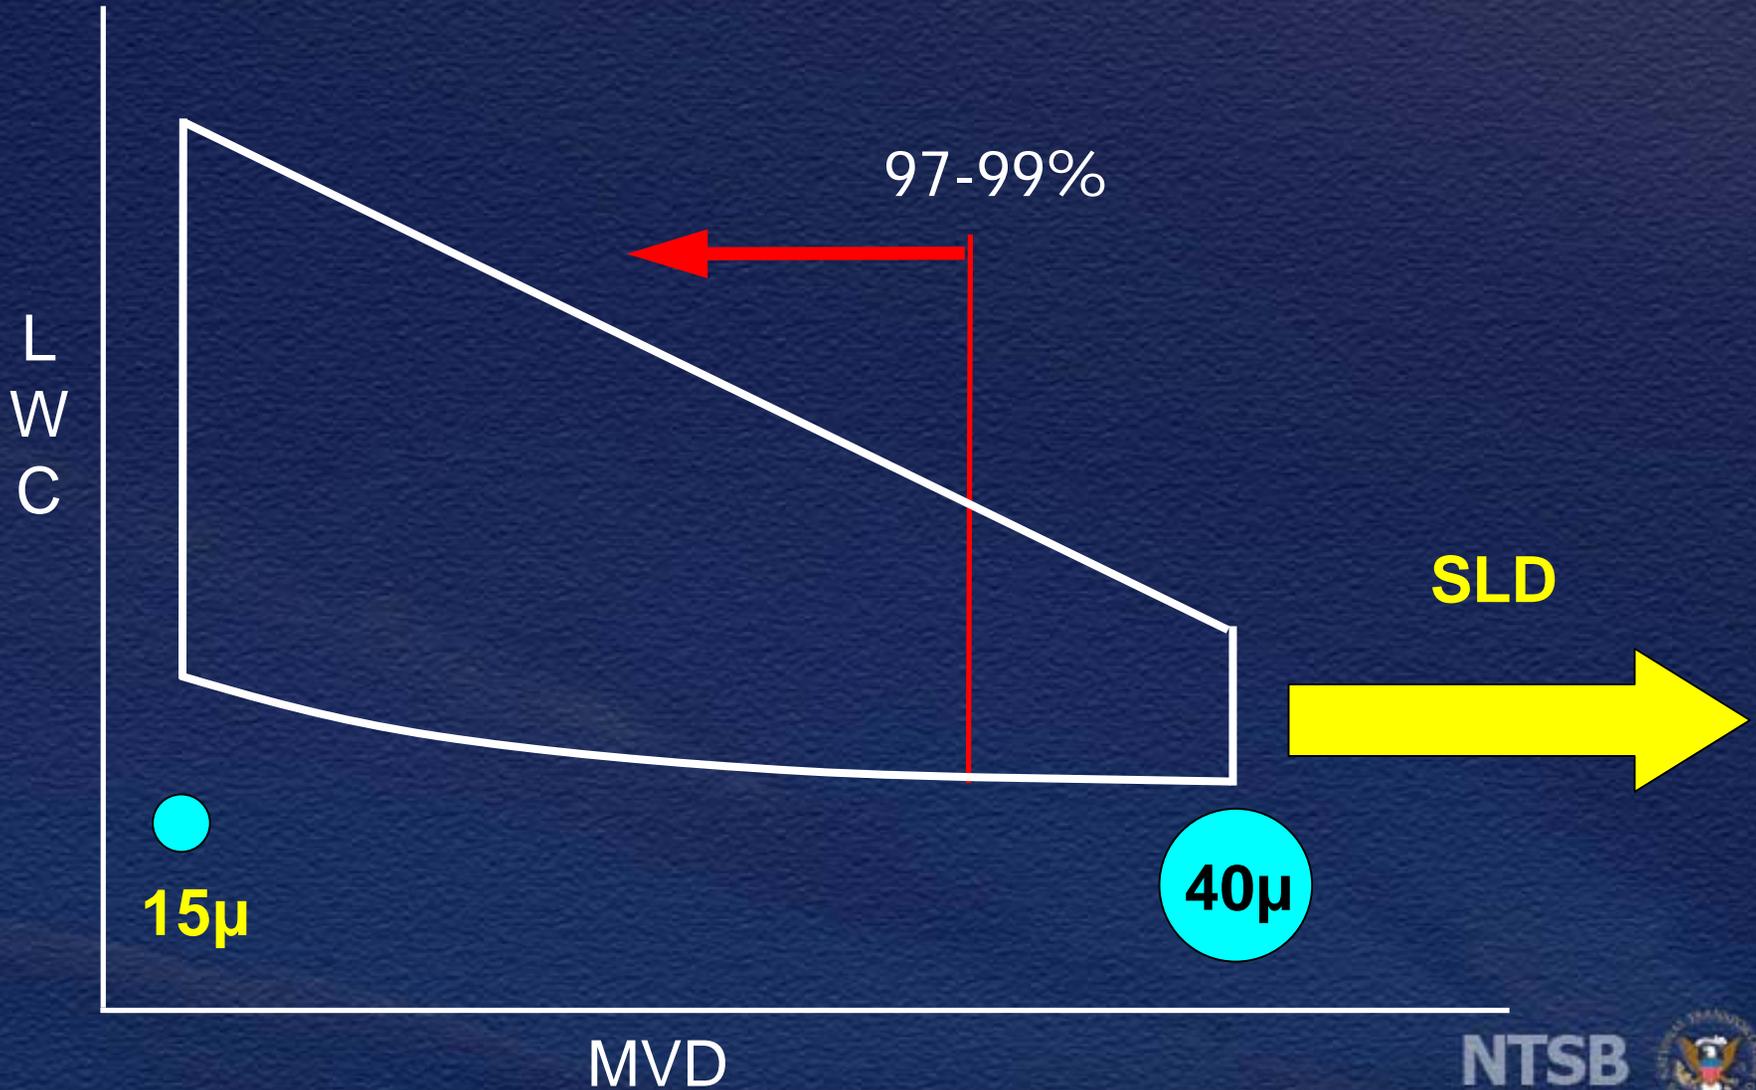
Part 25 Appendix C

Continuous Maximum

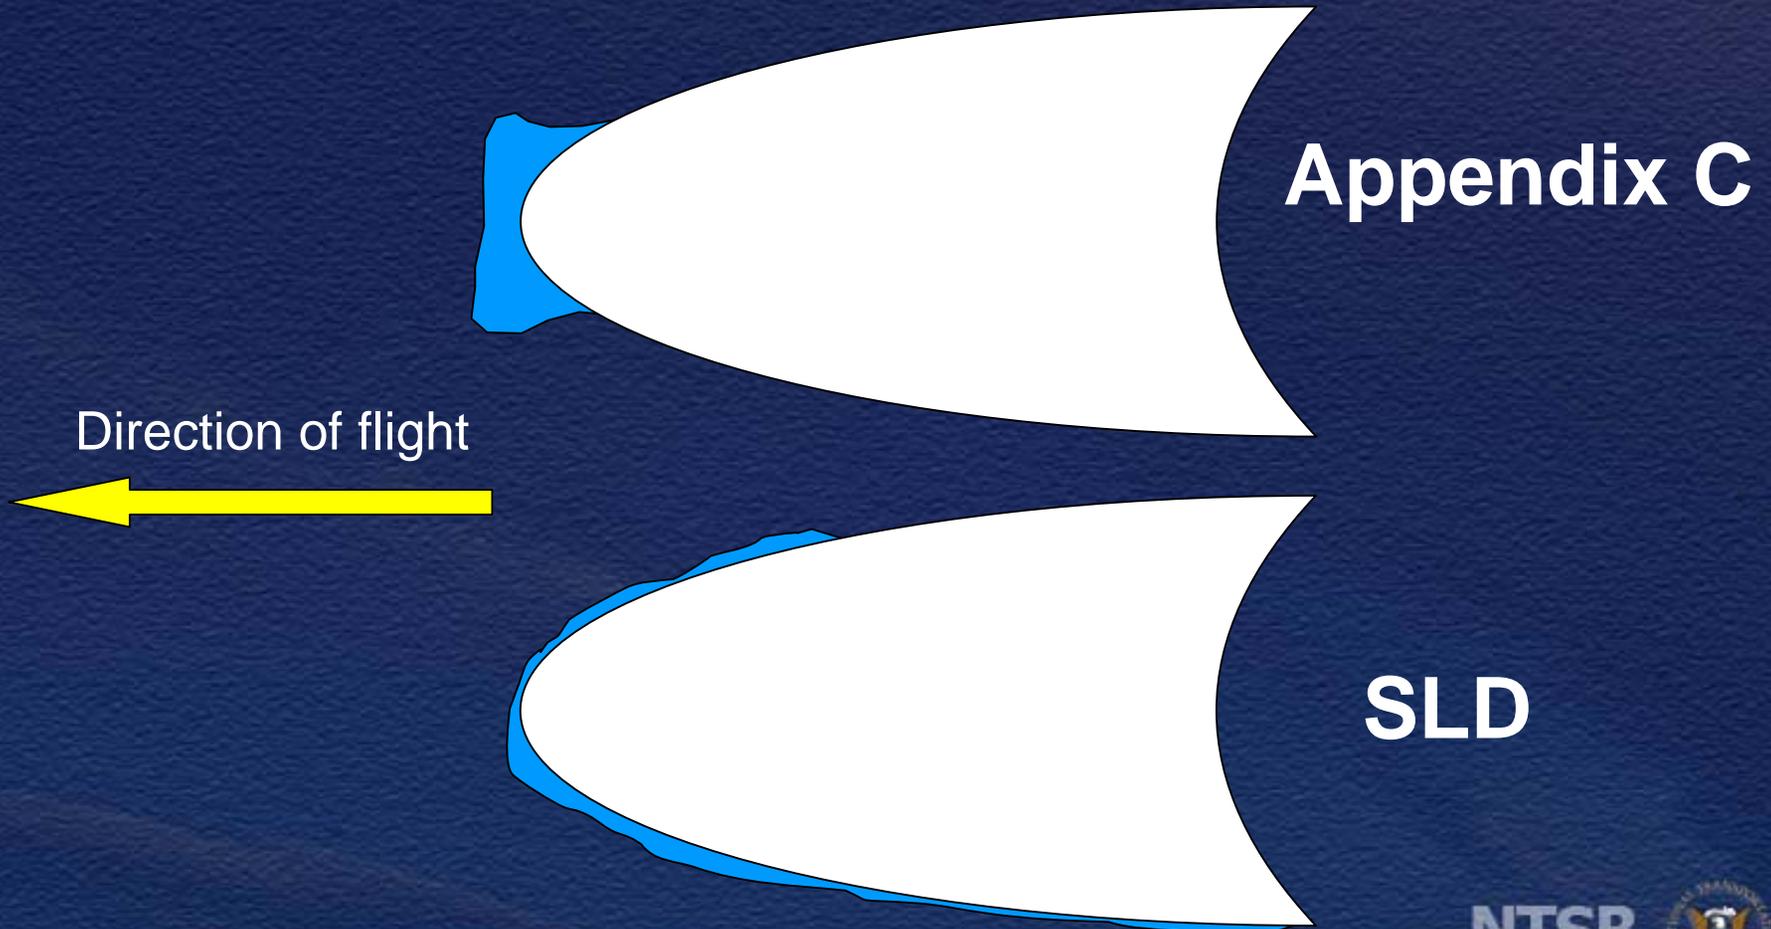
Wing leading edge cross section

Effect of SLD on ice accretion

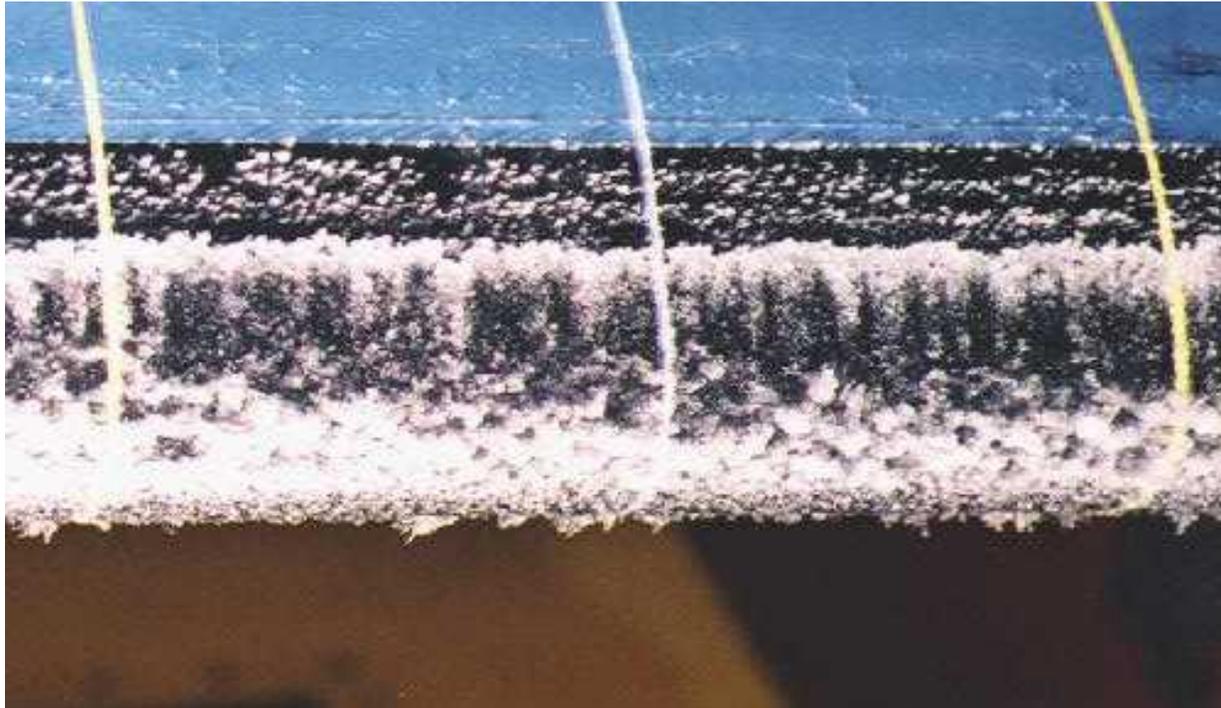
Resultant Ice Shapes

Front Edge of Wing

Rough Ice

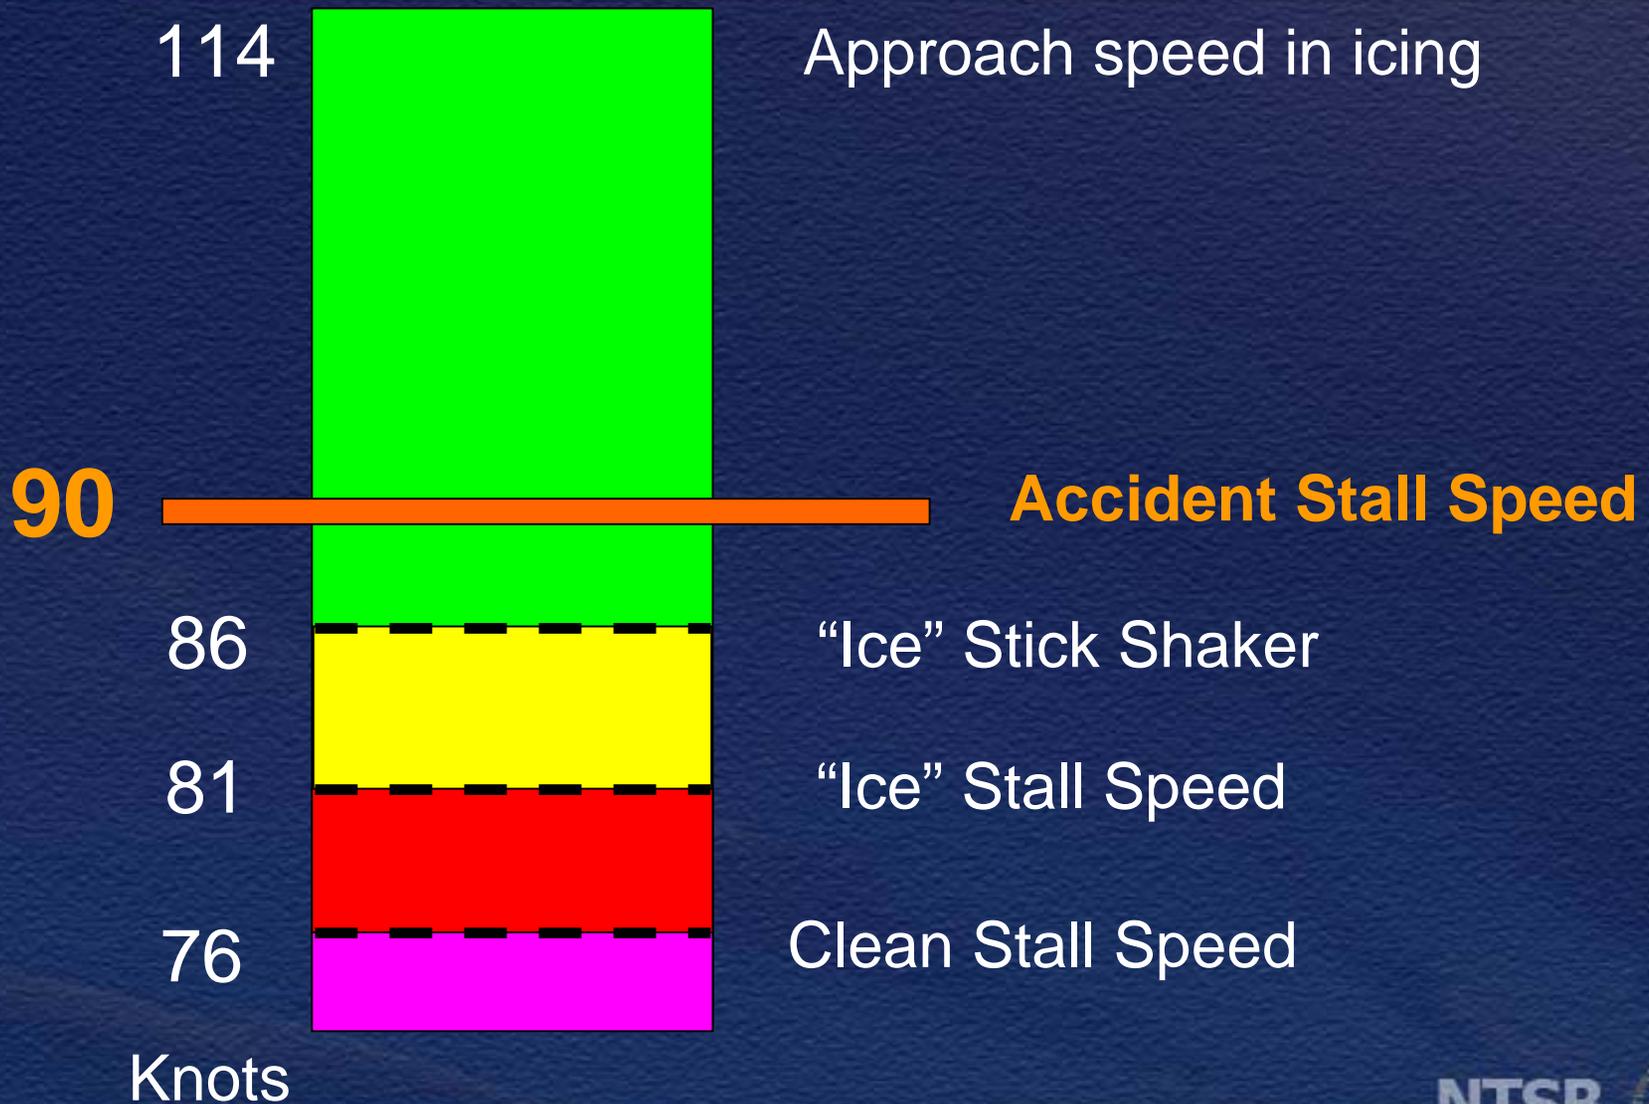
Accident Airplane Relevant Speeds

- Airplane slowed below V_{approach}
- De-ice boots not operated in second icing layer
- Presence of an estimated $1/6$ of an inch or less of ice accreted in SLD conditions caused the airplane to stall prior to stick shaker
- Airplane entered a rapid left roll
- Airplane did not recover in the 1,500 feet agl available
