MIR-24-07

# Flooding and Partial Sinking of Towing Vessel *Joanne Marie*

On June 25, 2023, about 0600 local time, the inspected towing vessel *Joanne Marie* was found partially submerged while moored at a shipyard on the Harvey Canal near New Orleans, Louisiana.<sup>1</sup> There were no crewmembers or shipyard workers on board the vessel. An estimated 10 gallons of diesel fuel were released into the water. Damage to the vessel was \$176,751.

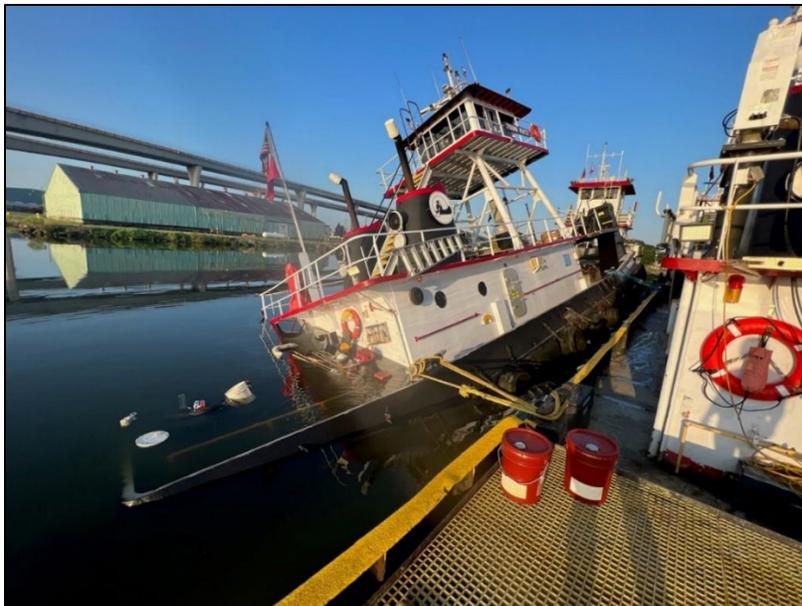
On June 25, about 0530, the on-duty port captain (a different port captain than had secured the vessel) received a phone call from company personnel notifying him that a vessel was listing at the shipyard (see figure 4). The on-duty port captain then notified the off-duty port captain (who had secured the vessel and was responsible for managing it), who headed to the shipyard, arriving about 0600. The off-duty port captain found the *Joanne Marie* partially submerged at the stern and listing to port, with the port quarter resting on the bottom of the canal at a depth of 15 feet. The mooring lines remained secured on the *Joanne Marie*’s starboard side to the towboat *Nativity*. About 0630, the port captain notified other company personnel.

**Figure 4.** *Joanne Marie* listing at the shipyard on the morning of June 25. (Source: US Coast Guard)

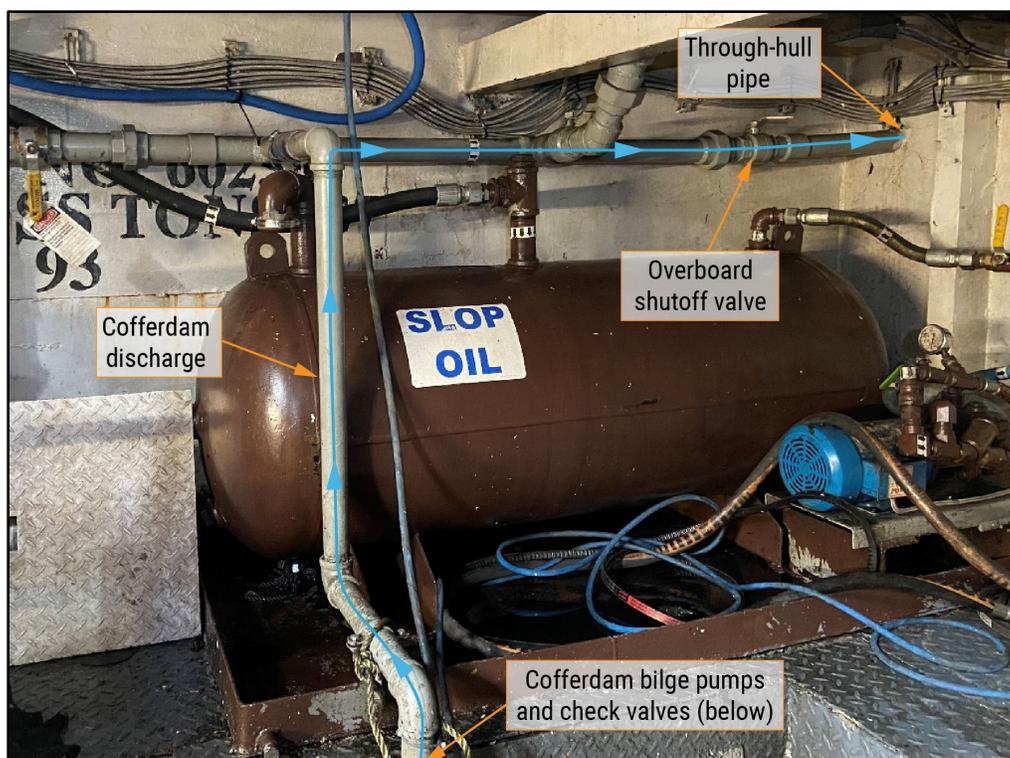
Two dedicated bilge pumps inside the cofferdam discharged any water that entered through the shaft seals. These pumps were electrically powered either through the onboard generators or shore power (the *Joanne Marie* was not typically connected to shore power when it was deactivated). Both pumps were float-activated and automatically engaged once water inside the cofferdam reached a set level. When activated, each pump routed the water through a short hose connected to a check valve that was connected to 1.5-inch Schedule 40 steel piping that discharged overboard via a through-hull pipe (see figure 5 and figure 6).

**Figure 5.** *Joanne Marie* cofferdam discharge system (facing aft). (Background source: Coast Guard)

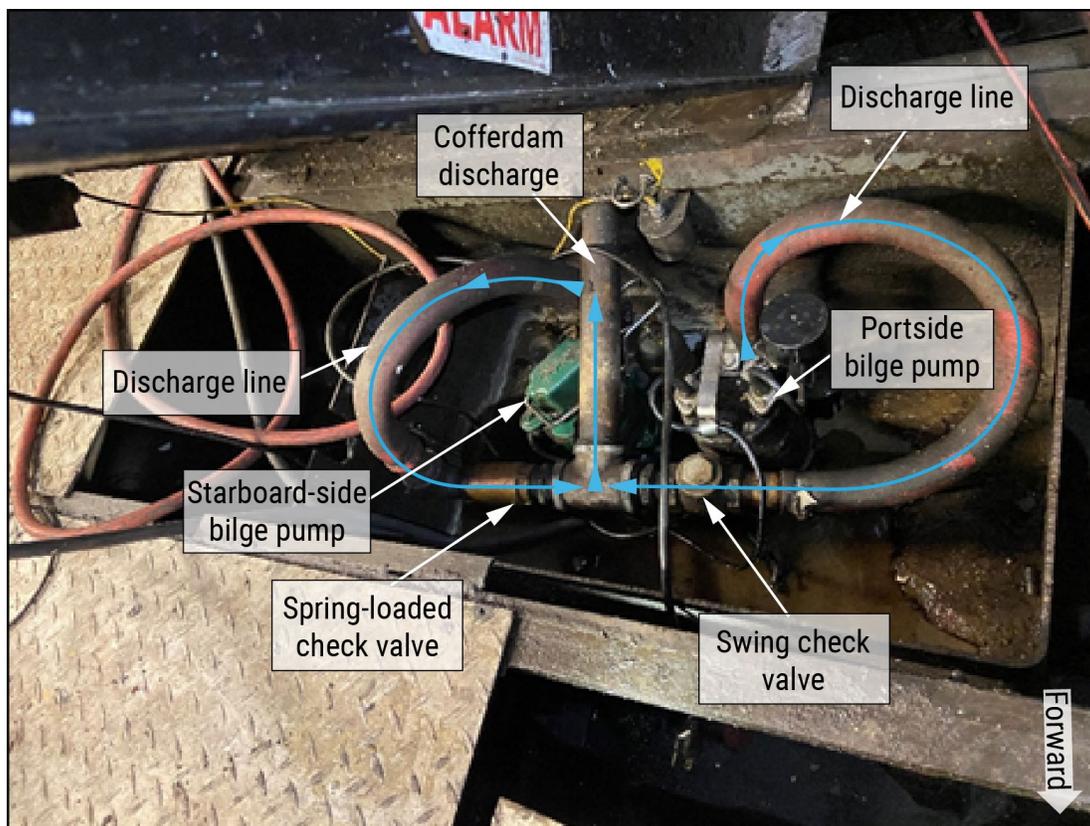
**Figure 6.** *Joanne Marie* cofferdam (looking down) with deck plate removed postcasualty, showing bilge pumps, pump discharge lines, and associated check valves. (Background source: Coast Guard)

As required by Title 46 *Code of Federal Regulations (CFR)* Subchapter M, each cofferdam bilge pump was protected by a check valve, which prevented water from backflowing into the cofferdam either from outside water entering through the through-hull pipe, or from water that remained in the system when the pumps turned off.<sup>3</sup> The starboard-side pump was protected by a spring-loaded check valve, and the portside pump was protected by a swing check valve.

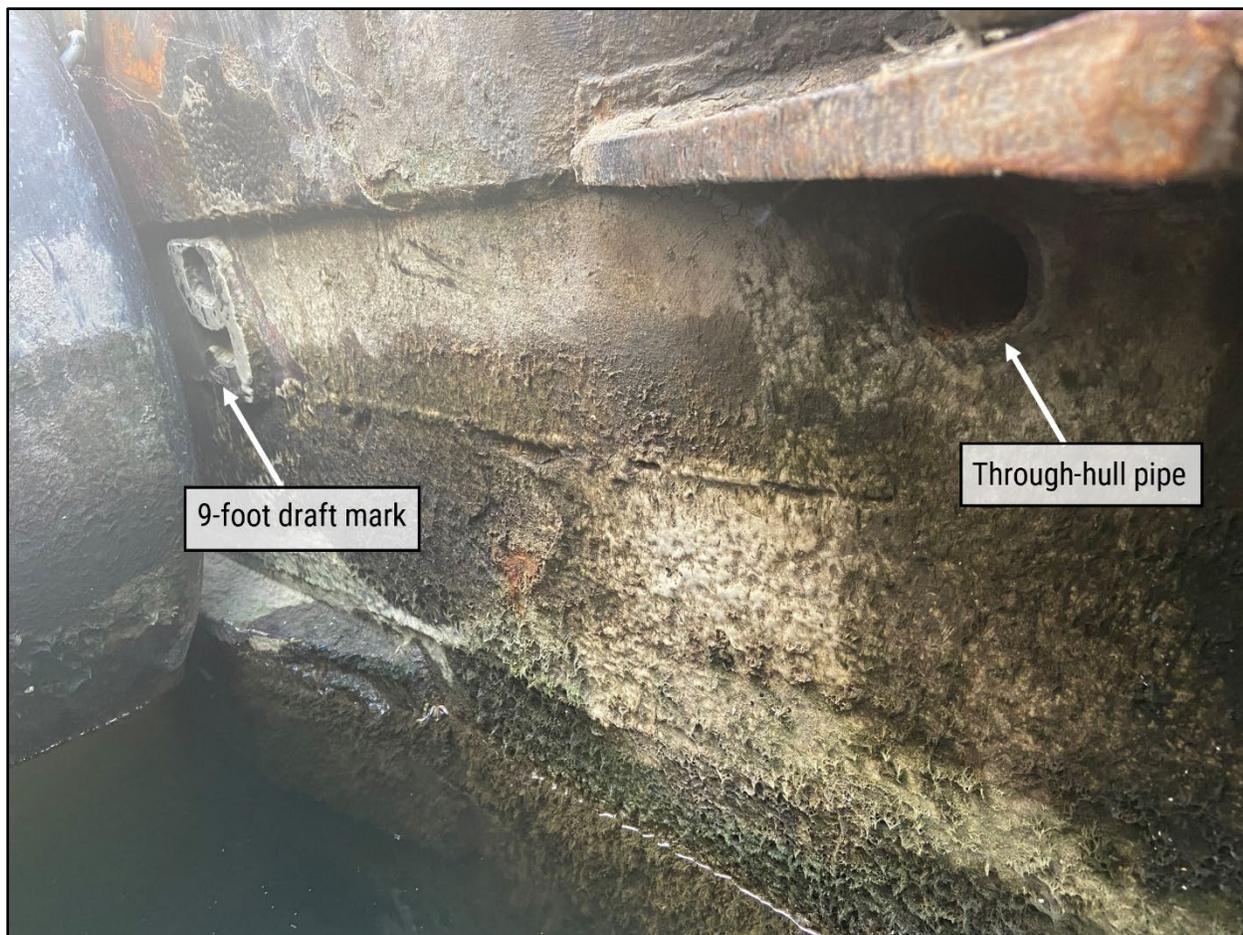
The through-hull pipe for the cofferdam overboard discharge was located on the port quarter of the vessel above the 9-foot draft marking on the hull (see figure 7). As required by Subchapter M, the discharge system was equipped with an overboard

shutoff valve immediately before the through-hull pipe.<sup>4</sup> The port captain stated the valve was typically kept in the open position when the *Joanne Marie* was moored; the valve was open when the vessel was deactivated before the sinking.

**Figure 7.** *Joanne Marie* through-hull pipe for the cofferdam pumps' overboard discharge on the port quarter with 9-foot draft mark shown postcasualty. (Background source: Coast Guard)

The vessel's typical operating draft was estimated to be about 9 feet 2 inches. The port captain did not note the *Joanne Marie*'s draft during his rounds of the vessel on June 23 or June 24, and there were no records of the vessel's draft at the time it was deactivated on June 23. Therefore, investigators were unable to definitively determine the vessel's draft and, subsequently, the exact height of the through-hull pipe for the cofferdam overboard discharge above the waterline when the vessel was deactivated. A company representative stated that the draft of the *Joanne Marie* was 8 feet when the fuel tanks were 62% full. However, on the day the vessel was deactivated, the daily boat log showed that the fuel tanks were 75% full—which equated to over 18,000 additional pounds of fuel. Given the weight from the additional fuel, the vessel's draft on the day it was deactivated was likely greater than 8 feet and closer to the estimated normal operating draft of 9 feet 2 inches. This draft placed the through-hull pipe—which was located about 9 feet above the keel—near or potentially below the waterline. Therefore, because the opening of the through-hull pipe was so close to the waterline, water would have been able to enter the discharge line from a variety of sources, including the wake from passing vessels or a small list.

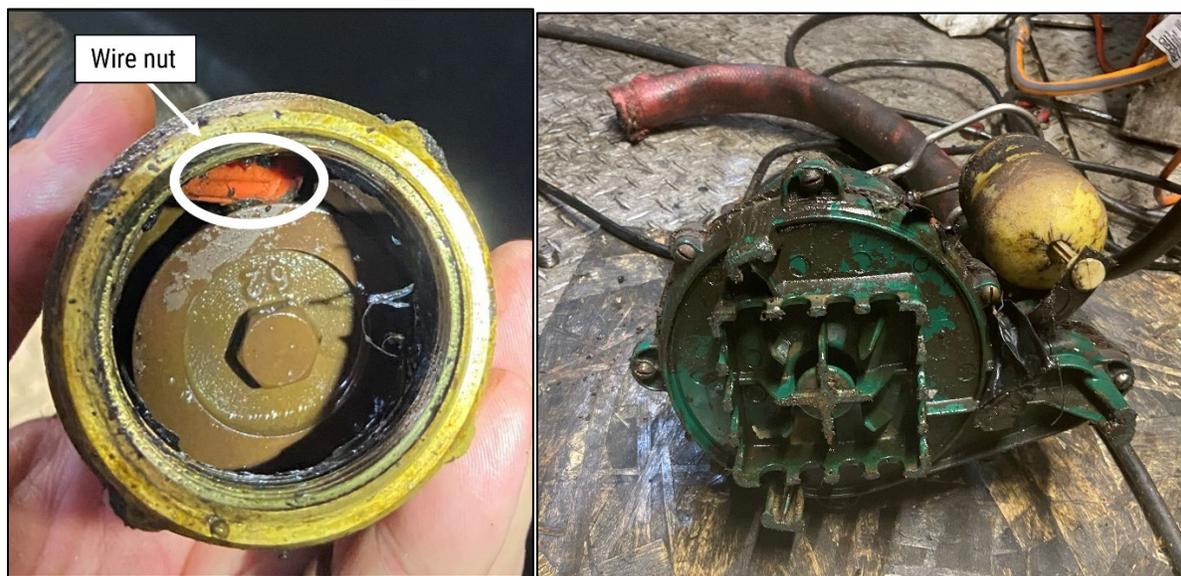
Following the casualty, the Coast Guard and company personnel removed the bilge pump discharge check valves and the starboard bilge pump protected by the spring-loaded check valve. They found that the spring-loaded check valve was stuck in a partially open position due to a lodged twist-on electrical wire connector, commonly called a wire nut (see figure 8). The wire nut was about 0.5 inches wide and 0.88 inches in height. The Coast Guard retained the bilge pump and check valves for further examination.

**Figure 8.** Spring-loaded check valve shown with lodged wire nut (*left*) and associated cofferdam bilge pump with inlet shown with strainer removed (*right*). (Source: Coast Guard)

On July 14, Coast Guard investigators and representatives from the vessel's operating company examined the removed check valves and starboard bilge pump. The bilge pump functioned normally when connected to a power source, and there were no issues identified with the internal components. After the wire nut was removed from the spring-loaded check valve, the check valve functioned normally. The swing check valve from the other bilge pump was not obstructed and functioned normally.

With the wire nut removed, the Coast Guard and company representatives evaluated the fittings on the bilge pump, including the strainer and pump mechanism, to determine if the wire nut could have passed through the bilge pump and into the spring-loaded check valve. The Coast Guard and company representatives found that the wire nut was sufficiently small to pass through the pump inlet strainer, pump impeller, and the discharge line into the check valve. The

Each pump also had a check valve on its individual discharge line before the lines combined. After the casualty, investigators found that a wire nut had lodged in a spring-loaded check valve on the starboard-side bilge pump discharge line,

obstructing the valve and forcing it to remain partially open (the swing-type check valve on the portside bilge pump worked properly). Investigators could not determine how the wire nut had entered the cofferdam. The wire nut may have been inadvertently dropped or fallen into the cofferdam when the deck plate covering the cofferdam was removed for regular maintenance. The Coast Guard and company representatives found that the wire nut was small enough to pass through the cofferdam bilge pump inlet strainer, so when the cofferdam bilge pump activated, the wire nut was pulled through the strainer and subsequently the pump impeller and discharge line before reaching the spring-loaded check valve. The spring-loaded design of the check valve held the wire nut in place, leaving the valve in a partially open position and susceptible to backflow.

The National Transportation Safety Board determines that the probable cause of the flooding and partial sinking of the *Joanne Marie* was the ingress of water into the engine room through a through-hull pipe located near the waterline due to an obstructed spring-loaded check valve on a cofferdam bilge pump discharge. Contributing to the sinking were inadequate procedures for securing unattended vessels.

Following the casualty, the operating company of the *Joanne Marie* investigated the sinking and determined that the partially open spring-loaded check valve, open overboard shutoff valve, and open fuel tank crossover valve (which allowed “fuel to gravitate from one side to the other”) all contributed to the water ingress and subsequent sinking. As a result of the casualty, the company modified their checklist for vessels entering deactivation to include closing the overboard shutoff valve when a vessel was not connected to shore power. The company also replaced the spring-loaded check valve on the cofferdam discharge line before the through-hull pipe with a swing check valve—they believed a swing check valve would be less likely to become “jammed.”
