National Transportation Safety Board

Safety Recommendation

Date June 13, 1997

In reply refer to: A-97-38 through -40

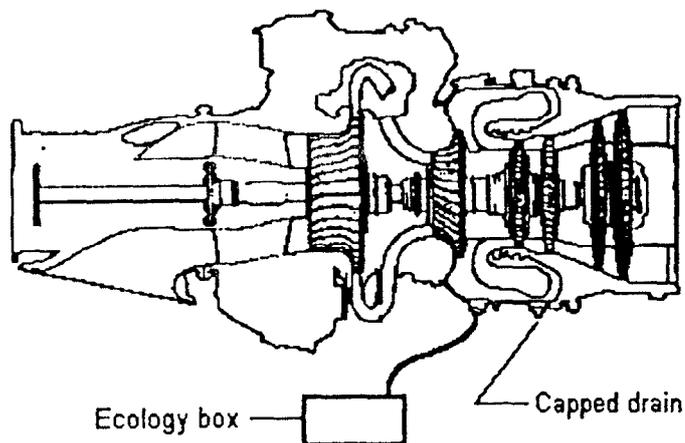
The PWC PW100 series turboprop engine gas generator case has two drain plugs, one each at the forward and rear of the case, at the 6-o'clock location,¹ to drain the unburned fuel from the fuel manifolds that has drained back through the lowest fuel nozzles into the gas generator case. These drains are intended to prevent internal fires or hot starts. Each drain plug has a "finger" seal, which closes to prevent any air leakage whenever the case is pressurized. After engine shutdown, the finger seal opens when the internal pressure in the case returns to ambient levels. The gas generator case has the two drain plugs to accommodate the installation requirement for the case drain line for the various airplane model installations.² One drain plug is connected to a drain line routed to the "ecology" tank,³ and the other drain plug is then capped to prevent fuel leakage into the nacelle.

On the EMB-120, the forward drain plug has the drain line to the ecology tank and the aft drain plug is capped. During the disassembly of the engine, it was noted that the forward drain plug had the drain line that would have been routed to the ecology tank. But the aft drain plug did not have the cap attached, and the threads of the plug were not damaged. Thus, the Safety Board concluded that the cap had not been installed before the engine failure.

Therefore, when the engine failed and shut down because of the oil-fed fire, the unburned, residual fuel in the fuel manifolds would have drained back through the fuel nozzles into the gas generator case and then out through the drain plugs at the bottom of the case. Because the airplane was climbing in a nose-high attitude, the fuel would have drained rearward through the aft drain plug and onto the deck under the engine, rather than through the forward drain into the ecology tank. Although the deck area under the engine also has an overboard drain located in the forward part of the engine bay, the fuel would have flowed aft because of the airflow through the nacelle and the nose-up climb attitude. The fuel could have then been ignited by the heat from the hot exhaust pipe in the aft section of the engine nacelle.

Issue an airworthiness directive to require an immediate one-time inspection of all Pratt & Whitney of Canada PW100 series turboprop engines to ensure that the gas generator case drain line and the plug are correctly installed. (Class I, Urgent Action) (A-97-38)
