# National Transportation Safety Board

## Safety Recommendation

**In reply refer to:** A-12-47

On February 8, 2012, American Airlines flight 837, a Boeing 767-300ER airplane, equipped with General Electric Aircraft Engines (GEAE) CF6-80C2B6 engines,<sup>1</sup> experienced a fire in the right engine shortly after taking off from John F. Kennedy International Airport (JFK), Jamaica, New York. The pilots reported that as the airplane was climbing through 9,000 feet, they heard a thump that was followed a few seconds later by a right engine fire warning. The pilots stated that they shut down the engine and discharged both fire bottles into the engine's nacelle before the fire warning was deactivated. The pilots stated that they declared an emergency and returned to JFK where they performed a single-engine, overweight landing without further incident. The airplane was operating on an instrument flight rules flight plan as an international passenger flight in accordance with the provisions of 14 *Code of Federal Regulations* (CFR) Part 121 from JFK to Port au Prince, Haiti. There were no injuries to the 201 passengers, 9 flight attendants, and 3 pilots on board.<sup>2</sup>

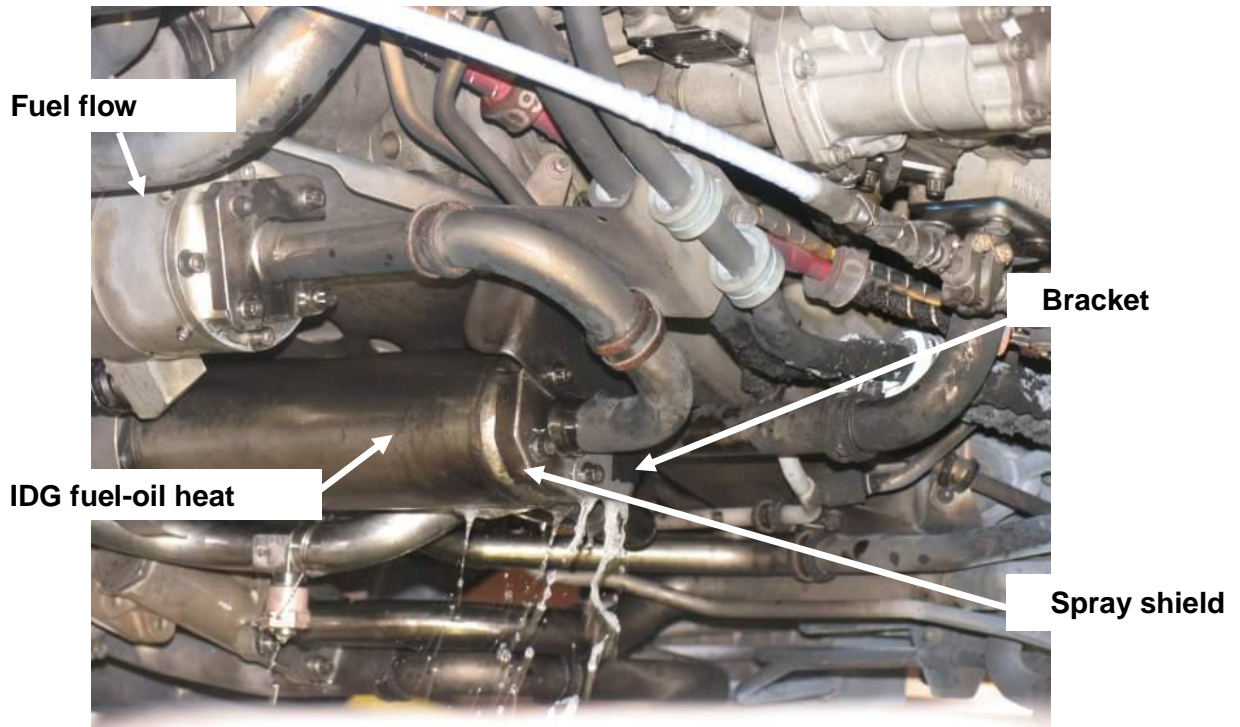
The NTSB's examination of the engine revealed soot on its exterior and thermal damage to the interior surface of the right thrust reverser cowl. Numerous wires and cables on the lower half of the engine showed signs of insulation that had been burned away or partially melted. When the engine was subjected to the troubleshooting procedure known as wet motoring<sup>3</sup> to check for fuel leaks, fuel sprayed from the front of the integrated drive generator (IDG) fuel-oil heat exchanger<sup>4</sup> under the spray shield and support bracket (see figure 1). Close examination of the front of the IDG fuel-oil heat exchanger revealed that the two-part support bracket and spray shield was misassembled, with the bracket having been installed over the spray shield

**Figure 1.** View of IDG fuel-oil heat exchanger showing leaking fuel when the engine was wet-motored. (GE photo)

Issue an airworthiness directive to require the incorporation of General Electric Aircraft Engines Service Bulletin 73-0242, “Fuel and Control – (73-00-00) – Spray Shields and Support Bracket – Improvement,” to prevent fires on CF6-80C2 engines due to misassembly of the two-piece support bracket and spray shield on the front of the integrated drive generator fuel-oil heat exchanger. (A-12-47)

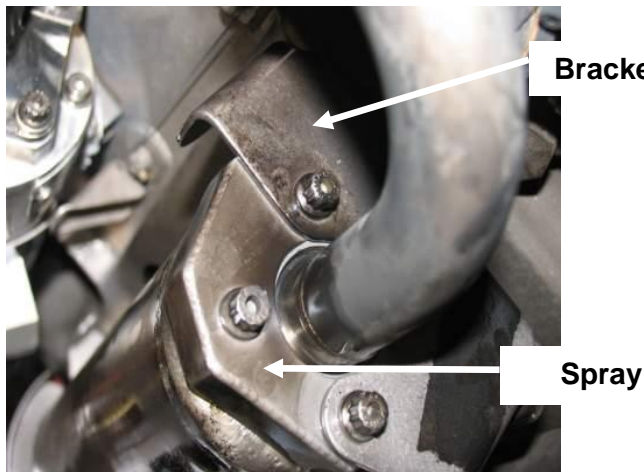
(see figure 2) rather than the shield being installed over the support bracket (see figure 3) as indicated in maintenance instructions.

**Figure 2.** Close up view of the misassembled two-piece bracket and spray shield on the incident engine showing bracket installed over spray shield. (GE photo)

Although the retaining bolts on the front of the IDG fuel-oil heat exchanger were at the proper torque levels, the reversed positions of the support bracket and spray shield distorted the fuel tube flange, resulting in an inadequate clamping of the seal between the fuel tube flange and the IDG fuel-oil heat exchanger body. Examination of the seal revealed that a 0.9-inch-long arc of the rubber part of the seal was missing. The inadequate clamping of the seal between the fuel tube flange and body of the IDG fuel-oil heat exchanger resulted in high pressure fuel being able to blow out part of the seal, causing the leakage.

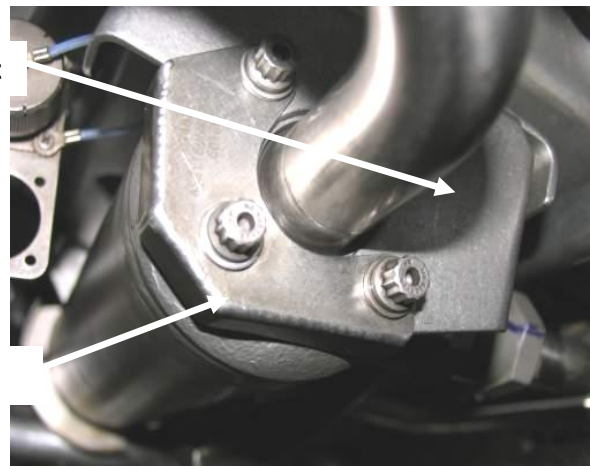
**Figure 3.** Close up view of correctly assembled two-piece bracket and spray shield showing the shield installed over the bracket. (GE photo)
