National Transportation Safety Board

Safety Recommendation

Date: December 15, 2004

In reply refer to: A-04-64 through -67

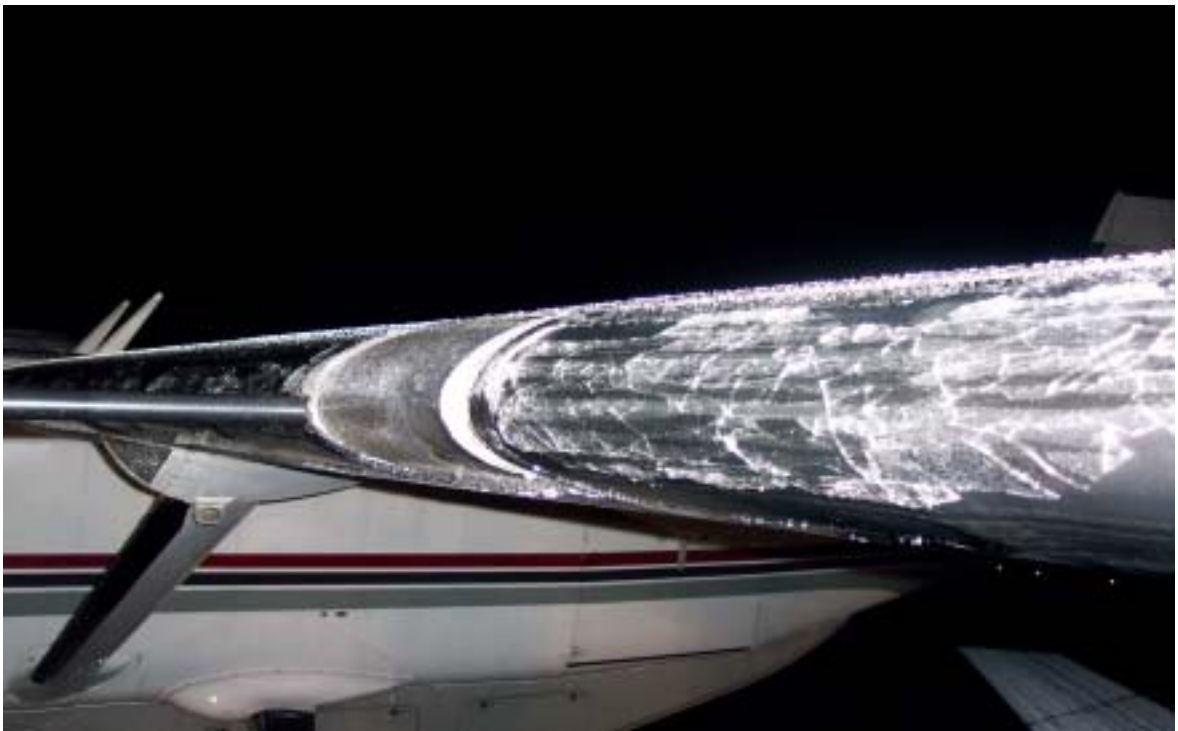
Because of the deteriorating conditions and accumulating ice, the pilot requested and received clearance to divert to BGR. The pilot stated that, as he descended in rain and sleet, the windshield became completely covered with ice and that he observed ice on the left wing aft of the deice boots. He further stated that the airplane's controls felt "sluggish." The pilot also stated that he did not extend the flaps for the landing and that he maintained a faster-than-normal airspeed during the approach to avoid a stall. In addition, the pilot stated that, because he had no forward visibility, he looked out the airplane's left window during the landing to judge the airplane's height above the runway. Postincident examination of the windshield anti-ice system revealed that it was capable of normal operation. Photographs taken before the airplane was moved off the runway showed ice on the deice boots and ice accumulations aft of the wing deice boots on the upper and lower surfaces of the wing (see figures 1 and 2).

Figure 1. Photograph of the left wing leading edge, showing ice accumulation aft of the deice boot.

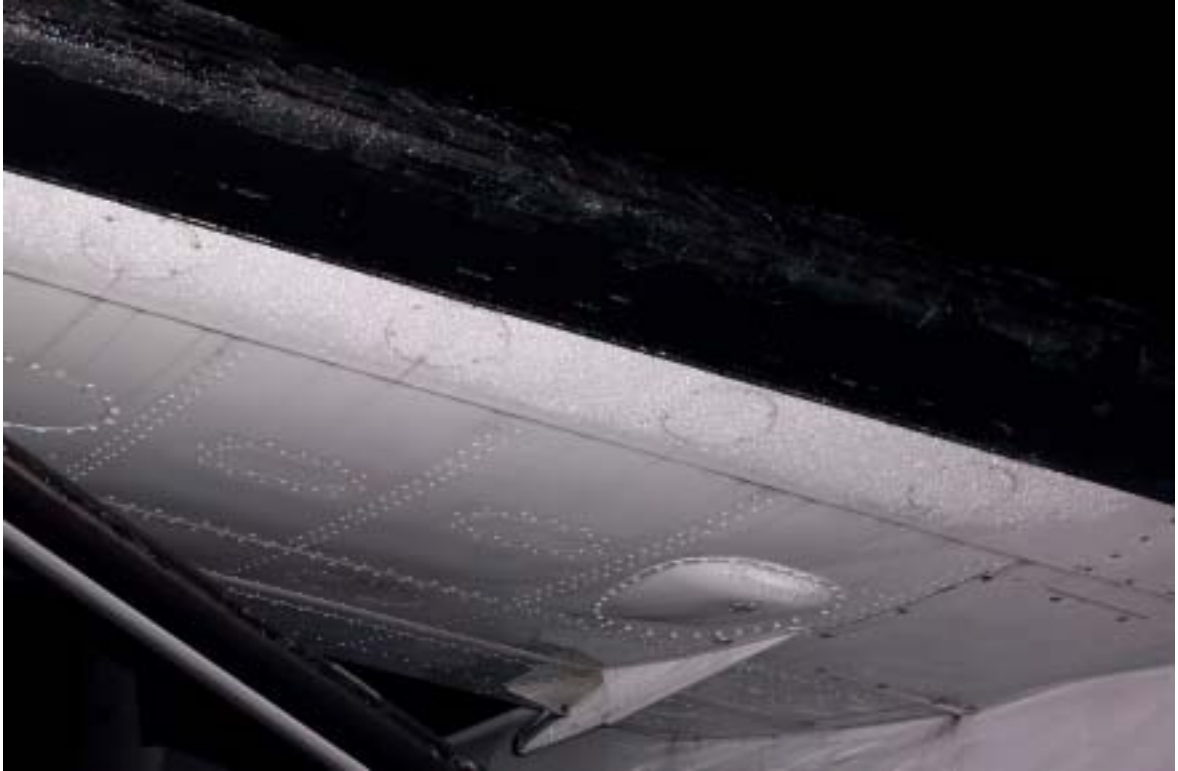
Figure 2. Photograph of the right wing lower surface, showing ice accumulation aft of the leading edge deice boot.
