SAFER SEAS DIGEST

LESSONS LEARNED FROM MARINE ACCIDENT INVESTIGATIONS
LESSONS LEARNED FROM MARINE ACCIDENT INVESTIGATIONS

2016

NATIONAL
TRANSPORTATION
SAFETY BOARD

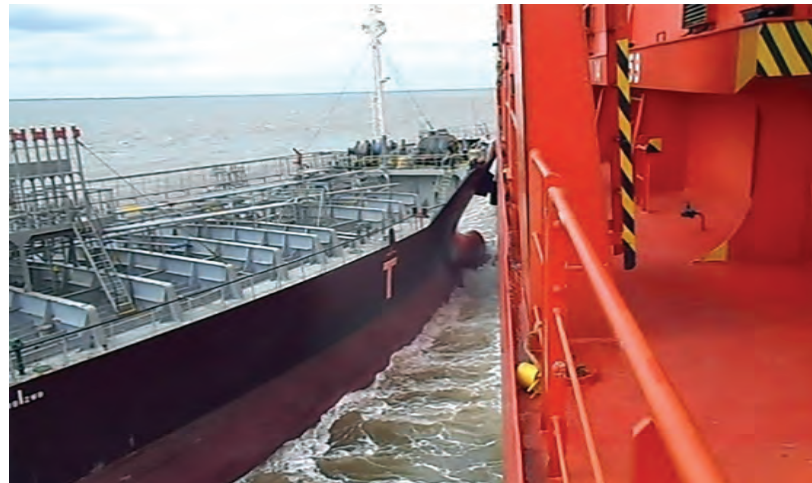
Figure 13: Video screen capture of tanker *Chembulk Houston's* bow and anchor in contact with containership *Monte Alegre*.

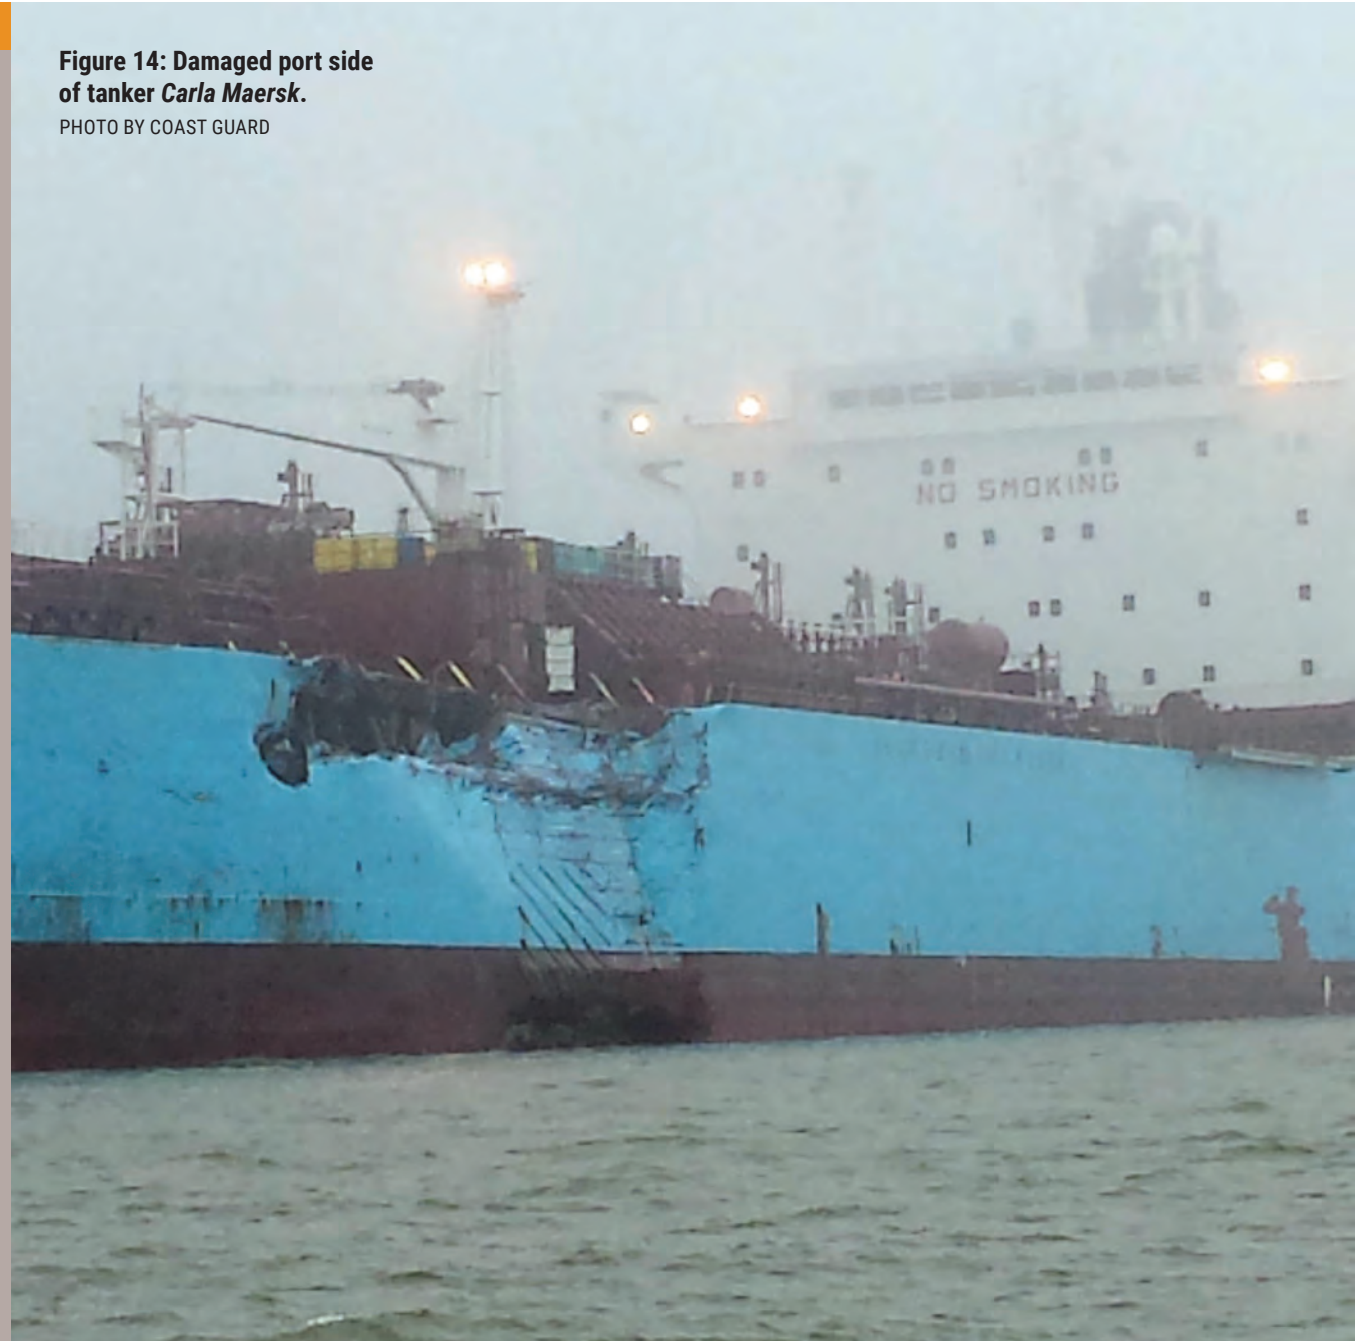
**Figure 14: Damaged port side
of tanker *Carla Maersk*.**

At 1230, the bow of the *Conti Peridot* struck the port side of the *Carla Maersk* just forward of midship. The collision ruptured several ballast tanks and cargo tanks on the *Carla Maersk* and damaged the bow on the *Conti Peridot*. An estimated 88,200 gallons of methyl tertbutyl ether spilled from the *Carla Maersk*, and the two vessels sustained about \$8.2 million in total damage.
