# Analysis of Asset 459 Cell 5

CORPORATE RESEARCH

PROJECT: 13CA50802 (Extend)

May 31, 2014

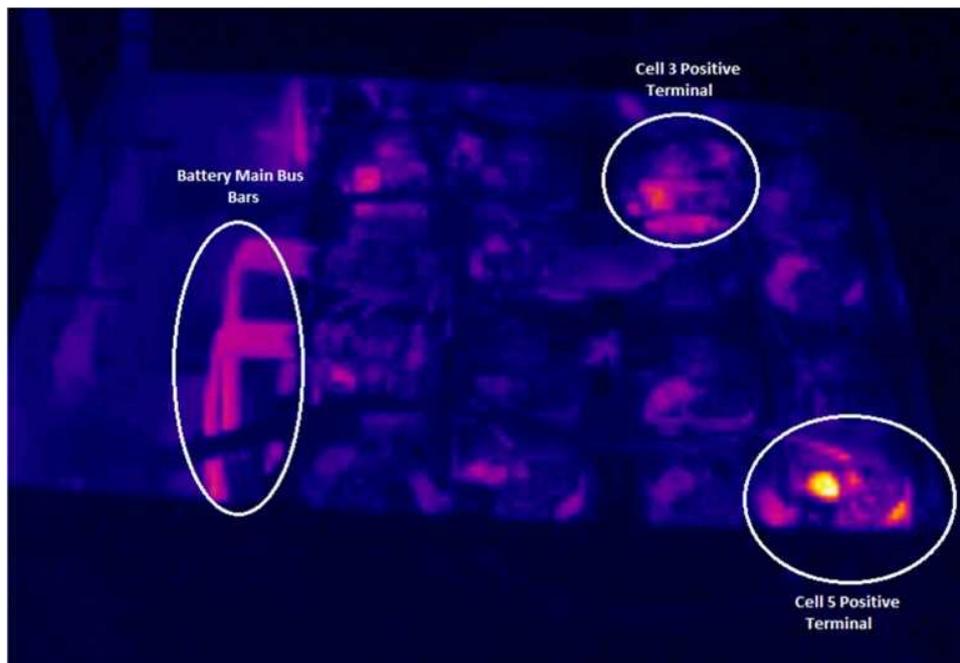
In the battery level tests of simulated APU start on Battery #459<sup>1</sup>, high temperatures were recorded on the aluminum rivets (positive terminal) of cell 3 and cell 5, as shown in Figure 1. The high temperatures on cell 5 were of particular concern as the cell got even much higher temperature than cell 3. The peak temperatures measured with attached thermal couples on the positive rivet of cell 459-5 during the APU cycle test are listed in Figure 2. The cell peak temperature on the rivet has reached more than 100°C in most of the cycles, and the recorded highest temperature was 157°C, which is already beyond the melting point of the separator<sup>2</sup> in the LVP65 cell design.

**Figure 1. Infrared thermal image of Battery 459 during APU loading**

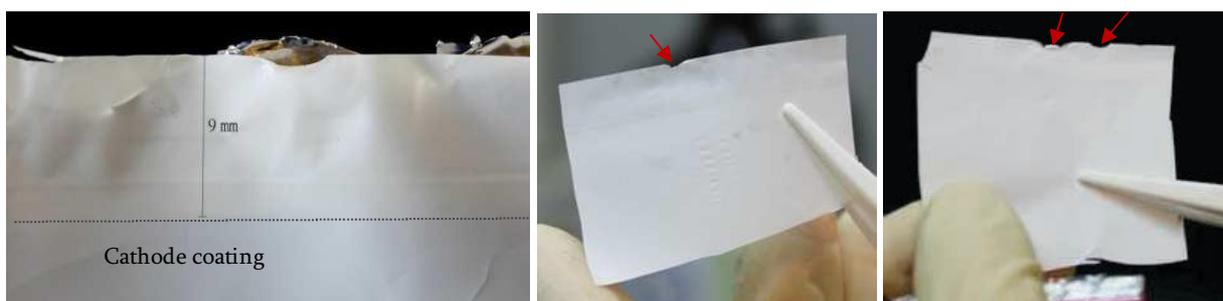
Since the peak temperatures on the 459-5 cell's rivet has been detected to reach over 130°C several times during APU start simulations (Figure 2), some irreversible damages might occur on the materials once the heat passed along with the current collector and down to the winding. A physical inspection was conducted to review the unwound jelly rolls. From the photos shown in Figure 7, few spots with shrunk or melted separators could be observed from visual inspection. The spots were about 1 to 2 mm wide and less than 1 mm tall. Such shrinkage might be resulted from the separator in contacting with the hot current collectors.

**Figure 7. Shrunk separator observed in the jelly rolls in Battery 459 Cell 5**

Although the melted separator found in this report have not reached to the point to cause direct contact between the aluminum and copper electrodes, it is very likely that if the cell keeps operating with the high temperature near the rivet, the melting separator will continue and cause the short circuit of the electrodes then followed by thermal runaway.

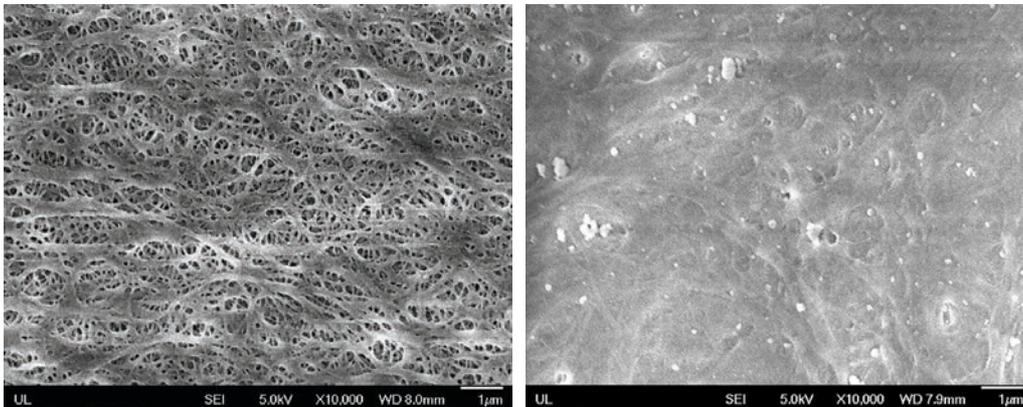
Typical separators used in lithium ion cell have high density of open pores for ion transportation. On the regions adjacent to these shrunk separators, however, the pores were closed, as shown in the SEM images in Figure 8. These observed shrunk separators were generally close to the welded current collector near the cell cover. It is also the evidence to show the heating source to cause the overheating is not from inside of cell (ex. windings) but from cell top casing.

**Figure 8. SEM Images of separators. Left: open pores on normal site; right: close pores near shrunk separator**

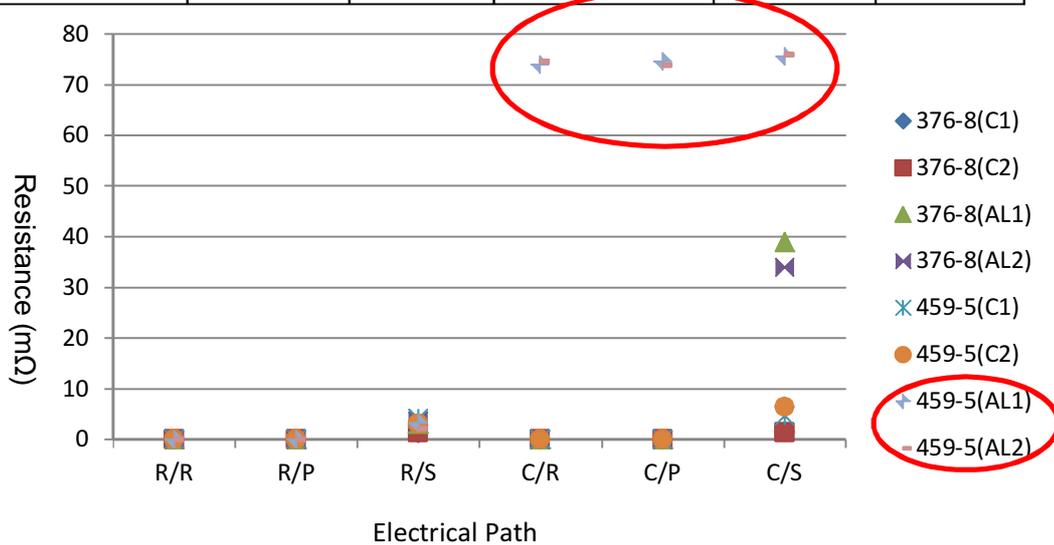
Figure 9. Plot of the electrical resistance for various contact path

According to the results, the paths from rivet to rivet and from rivet to plate have very low resistance, which suggests there is no deterioration or interruption in the path for both Cell 376-8 and Cell 459-5. The resistance from rivet to the terminal screw is higher than rivet to others because the screw should be fixed by a nut to form a good ohmic contact. In Figure 9, we can find that the resistances of 459-5(AL1) and 459-5(AL2) are higher than 376-8(AL1) and 376-8(AL2). Because the path from AL rivet to Cu terminal screw is good, therefore the problem contributing to the high resistance is between AL current collector and AL rivet.

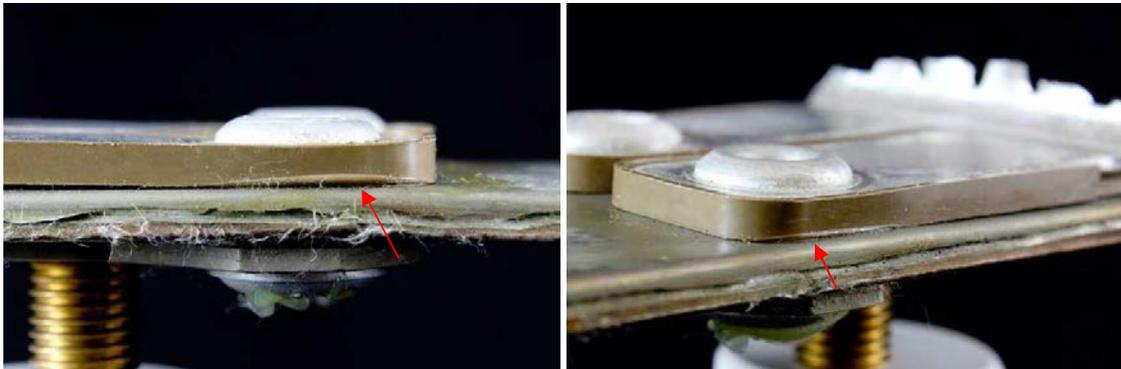
From the microscope inspection of the cell cover disassembled from DPA as shown in Figure 10 and Figure 11, the insulation material for the negative and positive terminals, ■■■ revealed deformation near the cover plate. As the glass transition region for the ■■■ is around 80 ~110°C, we can see that the overheat during the APU start tests have induced irreversible damage on ■■■ material. The deformation of the packing material may result in potential risk of cell leakage.

Figure 10. Images of positive terminal, showing deformed ■■■ insulator

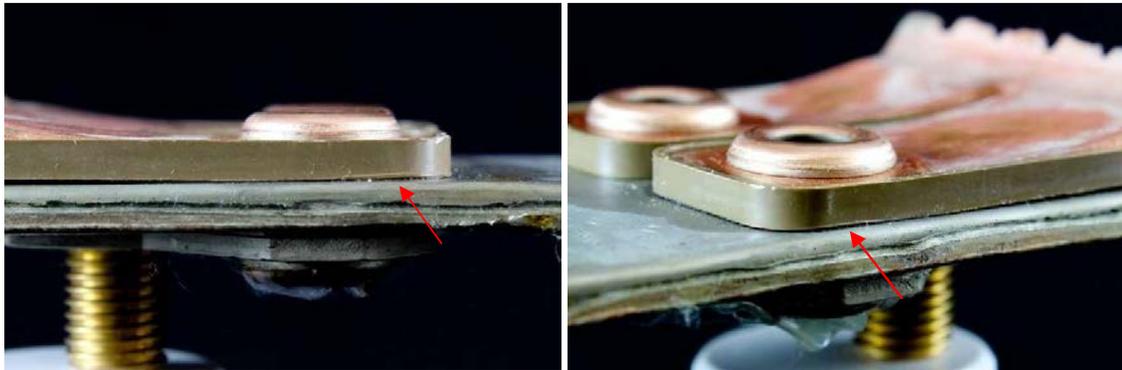
Figure 11. Images of negative terminal, showing deformed [REDACTED] insulator

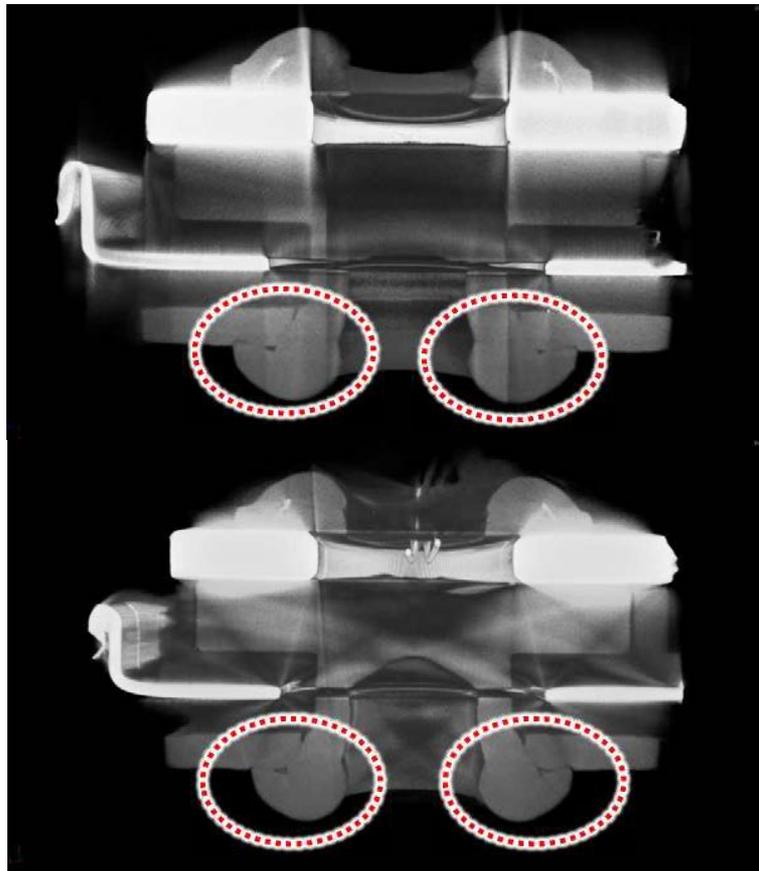
The CT scan images of cell rivets for Battery 459 Cell 5 and another normal Battery 376 Cell 8 as a reference are shown in Figure 12. Comparing the cross-sectional images of the rivet, bigger gaps can be observed from the contact interface of the rivet and current collector of Battery 459 cell 5 and the conjunction line is more obvious than a normal sample, which may result in high contact resistance due to poor connection and create localized hot spots during charge/discharge cycling.

**Figure 12. CT Scan image of negative terminal on Battery 459 cell 5 (Top: The crosssection view of conjunction between rivet and current collector and positive terminal in cell 376-8, which is normal sample; Bottom: The crosssection view of conjunction between rivet and current collector and positive terminal in cell 459-5, which is the abnormal sample)**

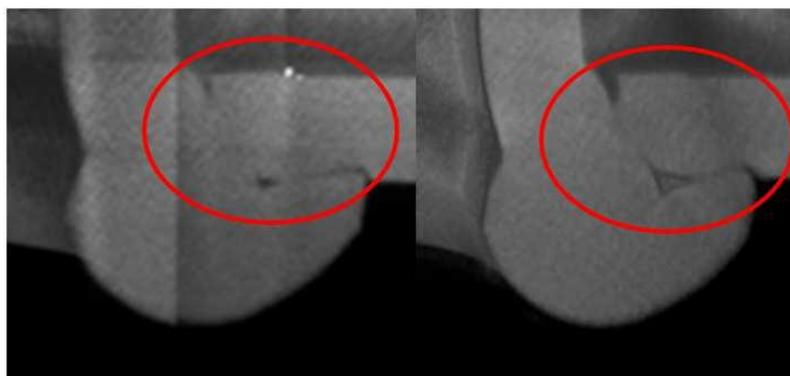
A closer view of the right-side marked area in Figure 12 that is further shown in Figure 13. We can see more clearly about the difference between the reference (376-8) and this abnormal (459-5) samples.

**Figure 13. Closer view of Figure 13 (Left: normal sample, cell 376-8; Right abnormal sample, cell 459-5)**
