National Transportation Safety Board

Aircraft Accident Brief

Accident Number: DCA07MA003
Operator: Private Owner
Aircraft and Registration: Cirrus SR20, N929CD
Location: Manhattan, New York City
Date: October 11, 2006
Adopted On: May 1, 2007

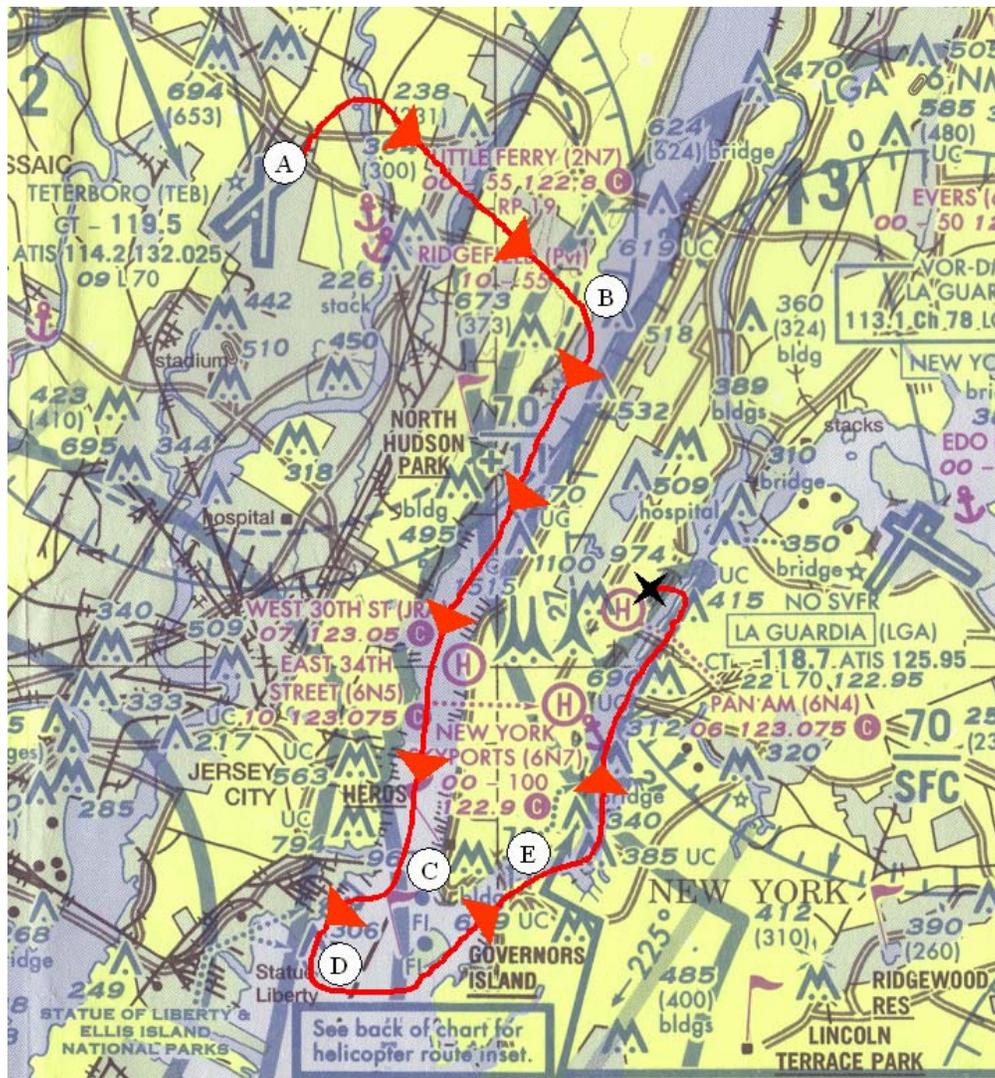
The accident airplane departed Teterboro Airport (TEB), Teterboro, New Jersey (see point A in figure 1, which shows the accident flight track), about 1429 and was cleared for a visual flight rules (VFR) departure. According to air traffic control (ATC) transcripts, the pilots acknowledged that they were to stay out of the New York class B airspace.³ After takeoff, the accident airplane turned southeast and climbed to an altitude of about 600 to 800 feet.⁴ When the flight reached the western shore of the Hudson River (see point B in figure 1), it turned to the south, remaining over the river, then descended to 500 feet.⁵ The flight continued southbound

over the Hudson River until abeam of the southern tip of Manhattan (see point C in figure 1), at which point, the flight turned southwest bound.⁶ Radar data from John F. Kennedy International Airport (JFK), Jamaica, New York; Newark International Airport (EWR), Newark, New Jersey; and Westchester County Airport (HPN), White Plains, New York, indicated that the accident airplane's altitude varied from 500 to 700 feet for the remainder of the flight.

Figure 1. Accident flight track for N929CD.

About 1436, the airplane flew around the Statue of Liberty (see point D in figure 1) then headed to the northeast, at which point, it proceeded to fly over the East River (see point E in

figure 1).⁷ About 1 mile north of the Queensboro Bridge, the airplane made a left turn to reverse its course. Radar contact was lost about 1442. The airplane impacted a 520-foot tall apartment building at 524 East 72nd Street, 333 feet above street level (see figure 2).

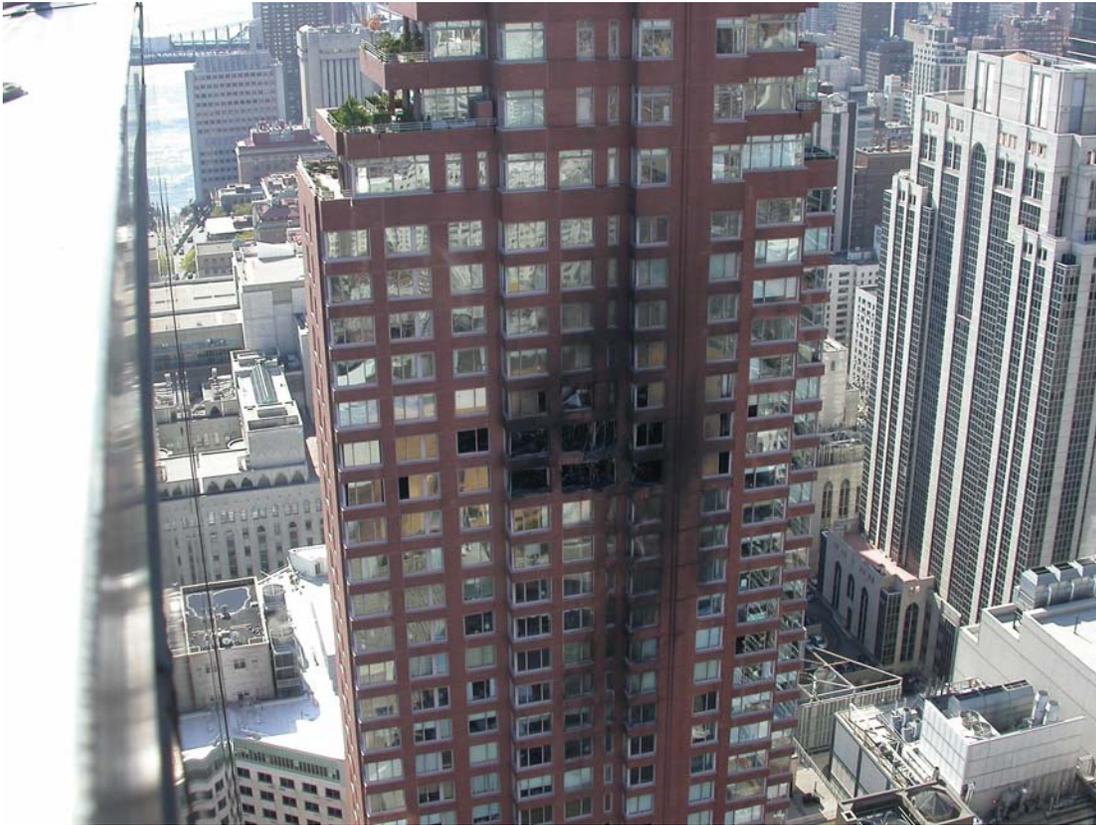
Figure 2. Photograph of apartment building that N929CD impacted.

The airplane impacted the 32nd and the 33rd floors of the north face of an apartment building located at 524 East 72nd Street. The engine, propeller, the right portion of the engine mount, and the nose landing gear strut were found in an apartment on the 32nd floor. The engine was found inverted with the propeller separated. The engine and propeller exhibited thermal damage and were coated with ash, debris, and fire-extinguishing agent.

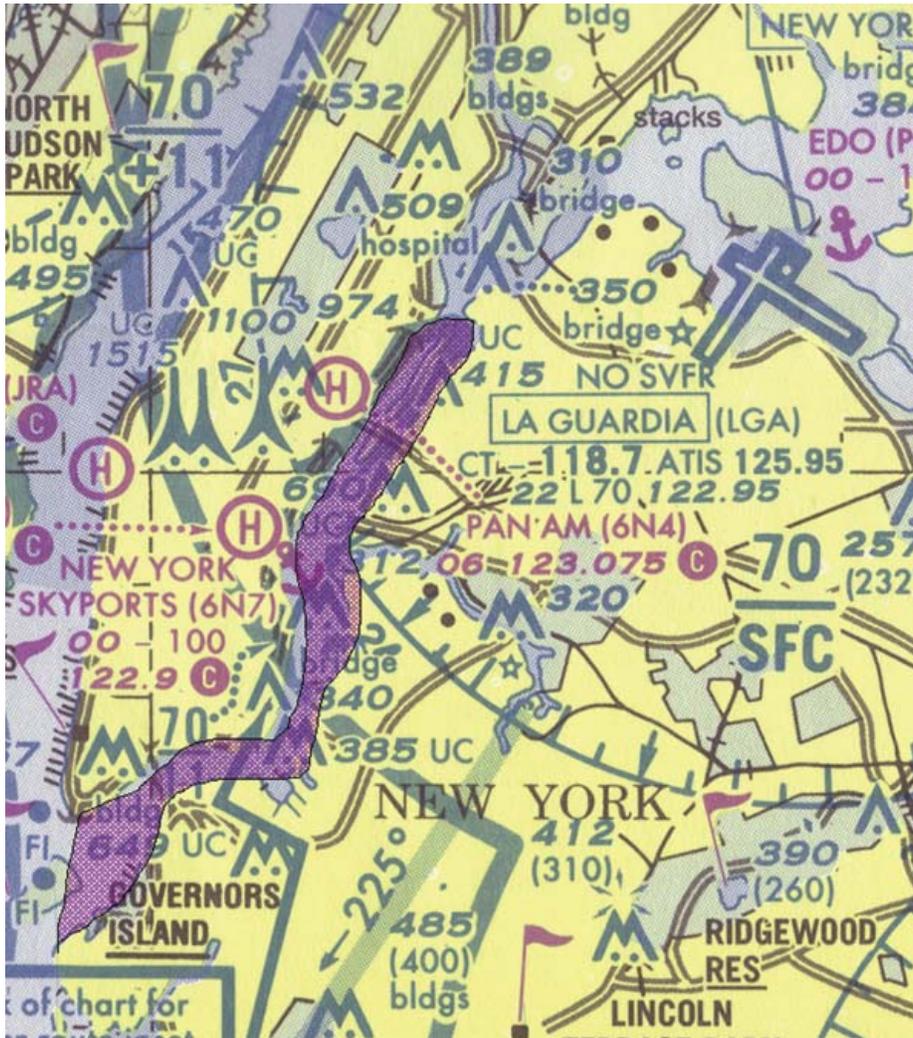
VFR operations are authorized below the class B airspace surrounding Manhattan Island in designated zones called the Hudson River and East River exclusion areas (the shaded area in figure 3 outlines the East River exclusion area, where the accident occurred). These exclusion areas were first defined in 1971. The FAA stated that the purpose of the Hudson and East River

Figure 3. Map depicting New York East River class B exclusion.

Since the accident, the FAA issued Notice to Airmen (NOTAM) 6/3495 temporarily prohibiting fixed-wing aircraft, such as the accident airplane, from operating in the East River class B exclusion area where the accident occurred unless authorized and controlled by ATC. The East River class B exclusion is in effect, but its use is limited to helicopters and seaplanes that are taking off and landing at nearby sea bases. This prohibition is intended to prevent airplane pilots from encountering a situation in which they must attempt a 180° turn or other abrupt maneuver to avoid penetrating controlled airspace and states the following:

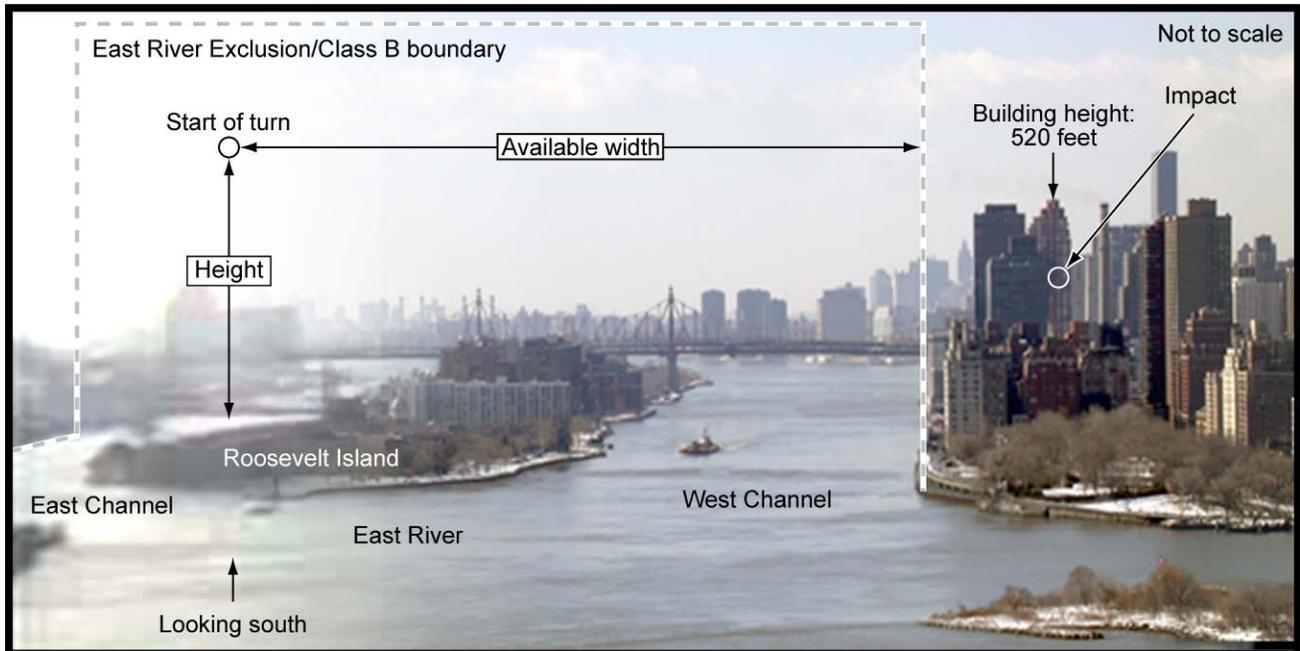
The pilots did not aggressively bank the airplane throughout the turn nor did they use the full available width of the river. Radar data indicate that the airplane was in the middle of the

East Channel at the start of the 180° turn (see figure 5) as opposed to beginning the turn from the eastern shoreline. Although it cannot be determined whether the pilots were aware of the wind's effect on the execution of the 180° turn, they should have been able to observe the difference in the ground track and heading during the flight to determine that there was a wind from the east and compensate for westward drift. Alternatively, the pilots could have dramatically improved the turning performance by transitioning to the west side of the East River, taking advantage of the full width of the river, and making a right turn into the easterly wind. By starting the turn on the west side of the river and turning into the wind, a minimum bank angle of 35° would have been needed, rather than the minimum 50° required by turning in the direction of the wind.

Figure 5. Photo illustration depicting the available width for the turn maneuver and the approximate location of N929CD at the beginning of the turn maneuver.
