National Transportation Safety Board

Aviation Accident Brief

Accident Number: NYC05MA039
Operator: LifeNet, Inc.
Aircraft and Registration: Eurocopter EC-135 P2, N136LN
Location: Oxon Hill, Maryland
Date: January 10, 2005
Adopted On: December 4, 2007

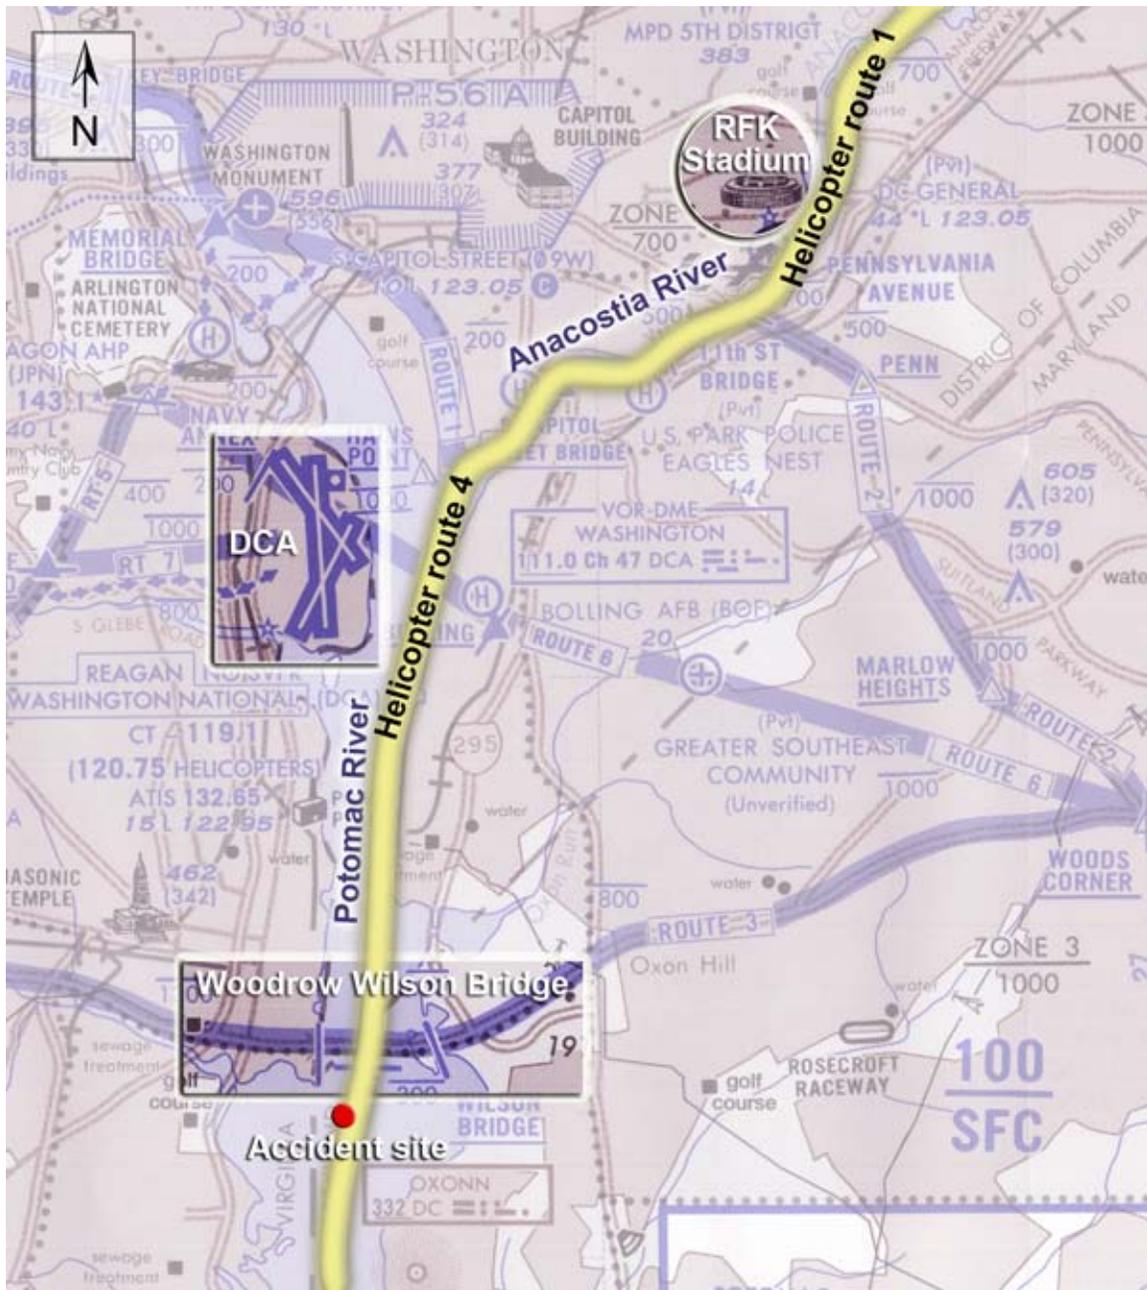
Examination of FAA ATC radar data showed that the helicopter intercepted a segment of published helicopter route 1, followed it southwest to intercept helicopter route 4, and then flew southbound along the Potomac River toward Woodrow Wilson Bridge (see figure 1).

Figure 1. Helicopter route chart with routes 1, 4, and select landmarks highlighted.
