Runway Overrun
American Airlines Flight 2253
Boeing 757-200, N668AA
Jackson Hole, Wyoming
December 29, 2010

NTSB/AAR-12/01
PB2012-910401

Aircraft Incident Report

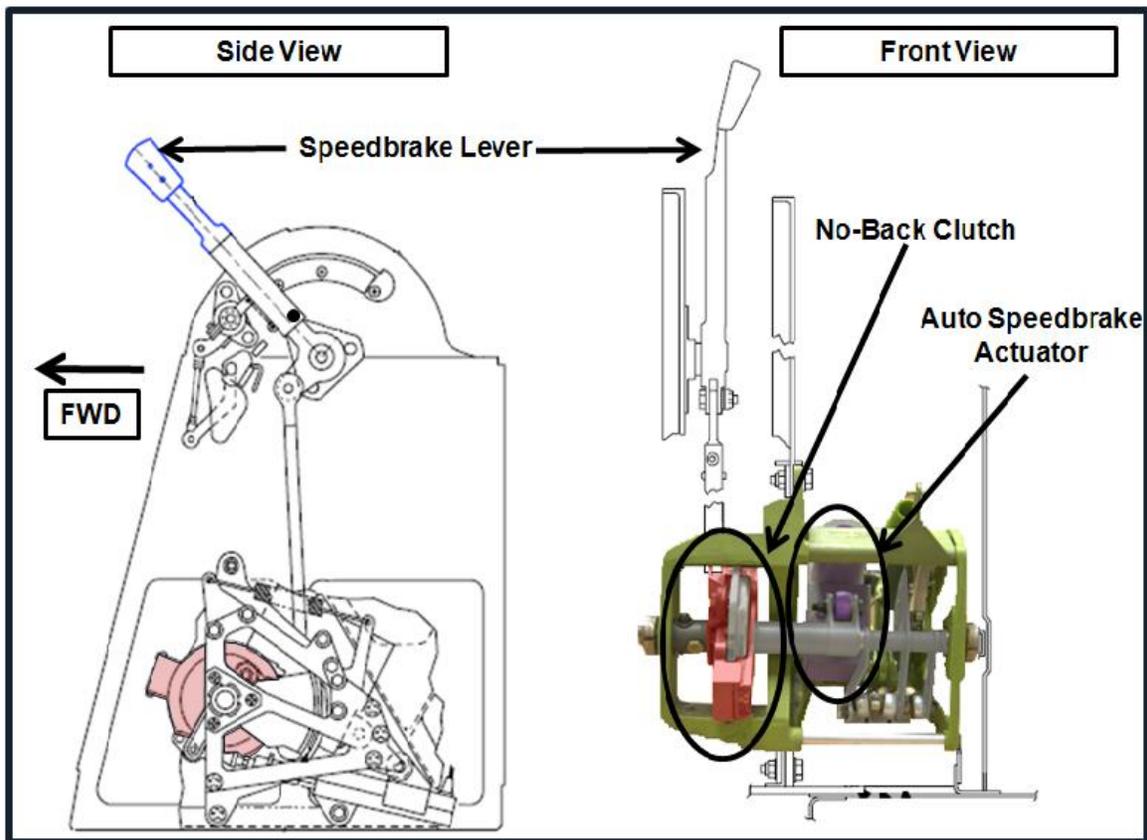
Initial examination and testing of the incident airplane’s automatic speedbrake system and its components revealed no evidence of a malfunction that would have prevented normal operation during the incident landing.³³ However, the automatic speedbrake mechanism was removed and examined after the incident airplane experienced another automatic speedbrake system nondeployment on March 31, 2011.³⁴ This examination revealed a latent assembly defect in the no-back clutch mechanism³⁵ that intermittently prevented the speedbrake actuator from automatically driving the speedbrake lever beyond its armed detent to extend the speedbrakes. Specifically, one of the four speedbrake lever braking pins was improperly secured, which allowed it to intermittently rotate within its assembly and prevented the no-back clutch from transmitting the torque from the automatic speedbrake actuator to the speedbrake lever. Additional testing showed that this condition would only occur when the actuator was attempting to drive the speedbrake lever towards the “up” (speedbrakes extended) position and would not occur when the actuator was retracting the speedbrake lever. Further, it was noted that this defect only affected the speedbrakes’ automatic deployment function and would not have prevented the pilots from manually deploying the speedbrakes. Figure 4 contains two diagrams showing the cockpit center console, the speedbrake lever and its linkages, and components of the automatic speedbrake system. The no-back clutch mechanism has been highlighted in the side view

Figure 4. Two diagrams showing the cockpit center console, the speedbrake lever and its linkages, and components of the automatic speedbrake system. The no-back clutch mechanism has been highlighted in the side view diagram on the left. A photograph of the speedbrake actuator and no-back clutch mechanisms has been superimposed on the front view to show those components' relative positions within the center console.

The NTSB concludes that a manufacturing defect in the incident airplane’s speedbrake no-back clutch mechanism prevented the speedbrakes from automatically deploying during the incident landing.
