Loss of Control at Takeoff
Air Methods Corporation
Airbus Helicopters AS350 B3e, N390LG
Frisco, Colorado
July 3, 2015

Accident Report

NTSB/AAR-17/01
PB2017-101425

Aircraft Accident Report

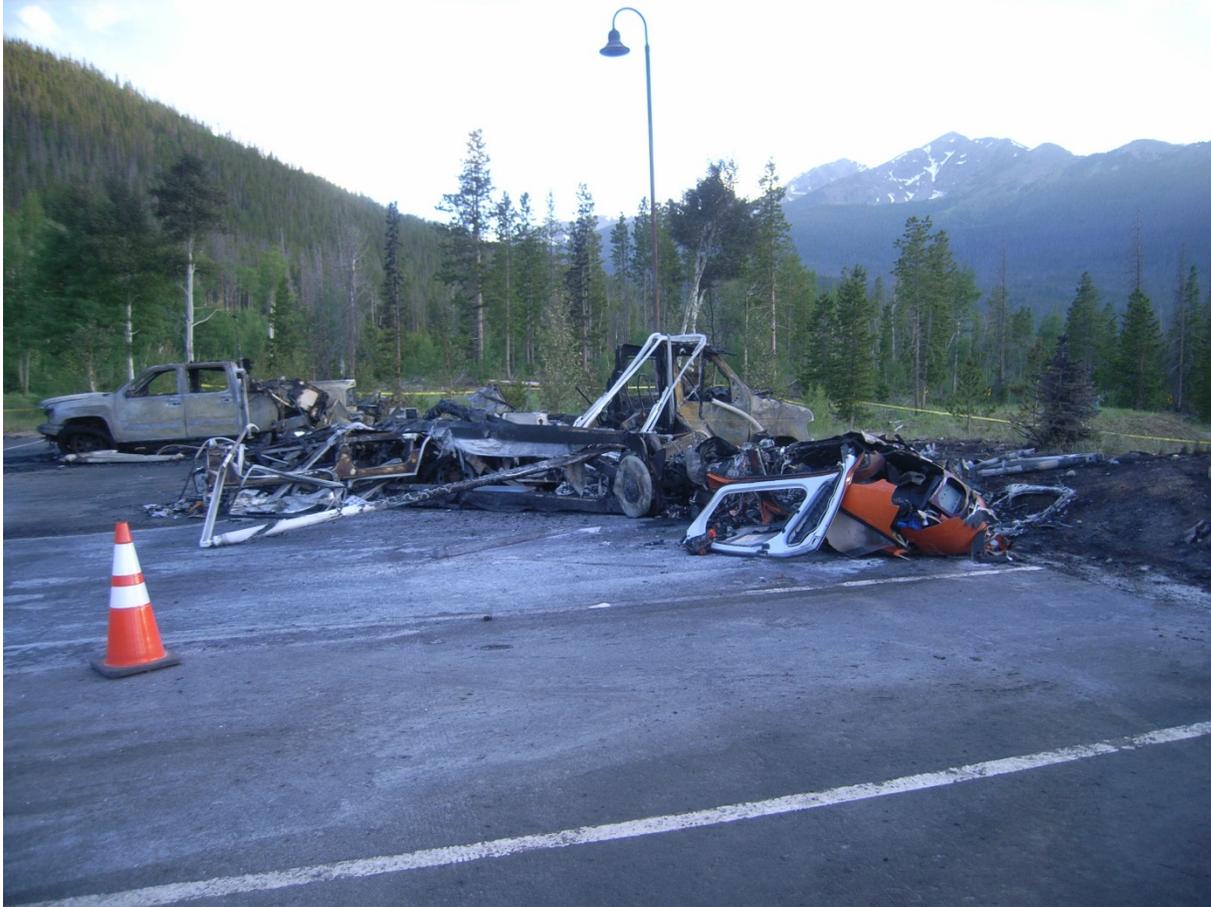
Figure 1. Main wreckage site.

A surveillance video capturing the helicopter’s descent and ground impact showed fuel flowing from the wreckage just after impact and then the onset of a postcrash fire. The postcrash fire consumed or severely damaged most of the helicopter and resulted in extensive thermal injuries to the pilot and one of the flight nurses. Although the helicopter was manufactured in March 2013, it was not subject to the improved crashworthiness requirements regarding crash-resistant fuel systems that became effective in November 1994. The helicopter was not subject to these requirements because it was certificated according to the regulations that were in effect in

The video capturing the ground impact (from the camera in the medical center parking lot) showed fuel flowing from the wreckage and the onset of a postcrash fire 3 seconds after impact. The postcrash fire spread and consumed or severely damaged most of the helicopter wreckage, including the main fuselage and tailboom (as further explained in section 1.3). Table 1 lists events that the video captured regarding the helicopter's flight and impact with the ground, and figure 1 shows the main wreckage site.

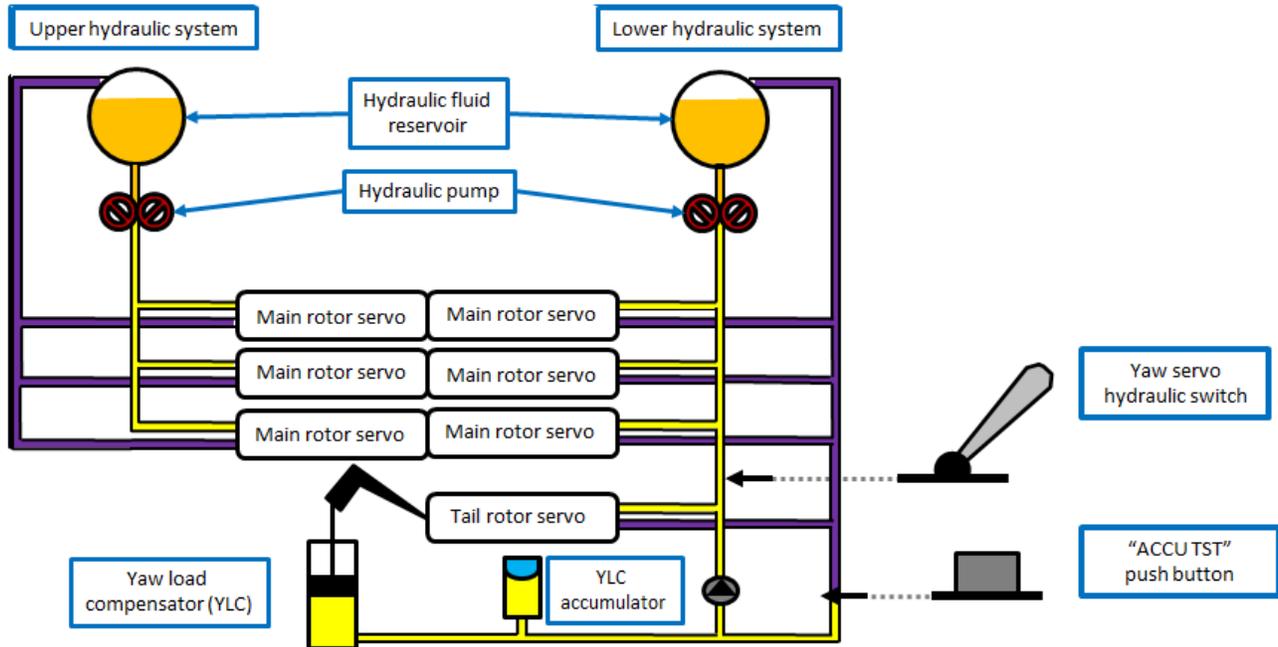
Figure 3. AS350 B3e dual hydraulic system.

As previously stated, the AS350 B3e is equipped with an upper and a lower hydraulic system.²³ The dual hydraulic setup provides hydraulic assistance redundancy to the main rotor servo controls in case one of the hydraulic systems were to fail.²⁴ The tail rotor servo control, yaw load compensator, and its accumulator are powered only by the lower hydraulic system. The yaw load compensator and its accumulator comprise a closed-loop system that would provide continuous hydraulic power assistance to the pedal controls in the event of a depressurization of the lower hydraulic system.²⁵ (The yaw load compensator is biased toward the right pedal because a right pedal input is needed to counteract the main rotor torque effect.) Figure 3 shows the hydraulic system configuration of the accident helicopter.

The hydraulic isolation electrovalve, installed on the transmission deck, provides a means to isolate the tail rotor hydraulic circuit from the lower hydraulic system in the event of a tail rotor servo control malfunction. Actuation of the hydraulic isolation electrovalve is controlled by a yaw servo hydraulic switch located on a control block installed at the forward end of the collective stick (see figure 4 in section 1.3.5.1). During normal operation, the hydraulic isolation electrovalve is in the open position, and the yaw servo hydraulic switch is on.

The yaw load compensator assembly contains an accumulator test electrovalve that allows hydraulic pressure to discharge from the yaw load compensator and accumulator when the “ACCU TST” push button, located on the cockpit center console, is depressed. Operating procedures for the AS350 B3e at the time of the accident indicated that the “ACCU TST” push button should be depressed during a ground check of the yaw load compensator accumulator (see section 1.3.5.1) or as part of emergency procedures for a tail rotor control failure. During normal operations, the accumulator test electrovalve is in the closed position, and the “ACCU TST” push button is raised.

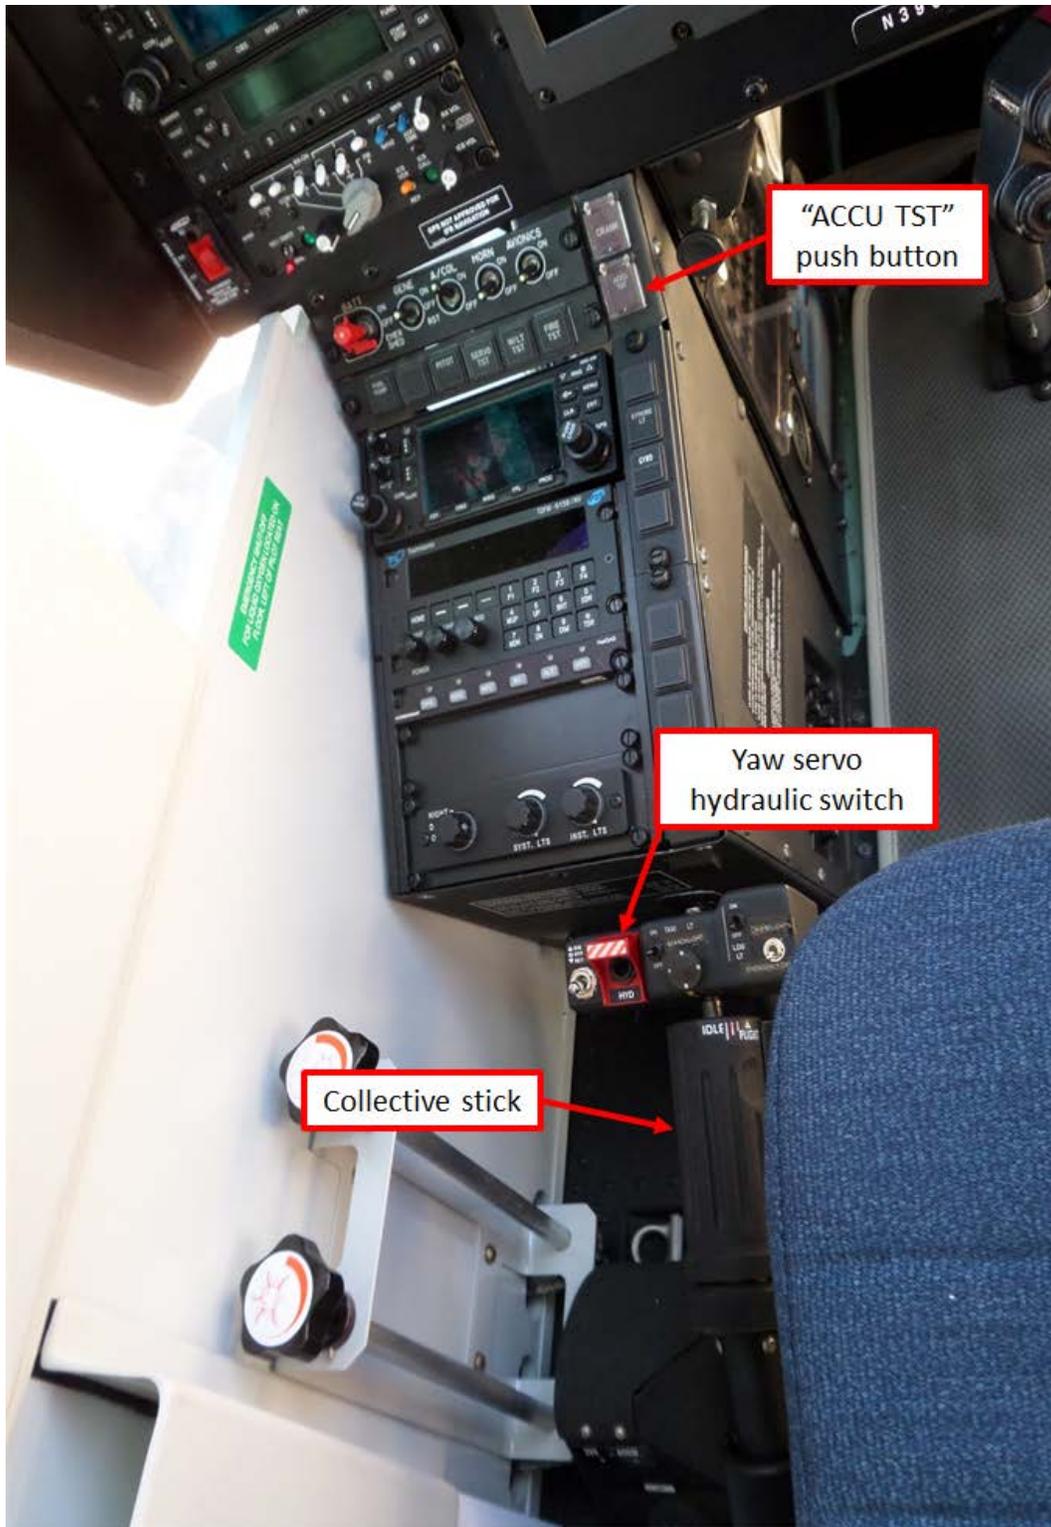
Figure 4. Yaw servo hydraulic switch and "ACCU TST" push button.

X-ray scans of the remaining collective stick control block and the “ACCU TST” push button were performed at the NTSB’s Materials Laboratory in Washington, DC. The position of collective stick control block switches (including the yaw servo hydraulic switch) and the “ACCU TST” push button switch could not be determined because of the damage to the components resulting from the accident.

Because the hydraulic isolation electrovalve was not recovered in the wreckage (it had likely been destroyed by the postcrash fire), the NTSB could not determine if the valve had malfunctioned. However, even with a hydraulic isolation electrovalve malfunction, a correctly configured tail rotor hydraulic circuit, with a functioning yaw load compensator, could provide partial hydraulic assistance to the pedals.²⁸ Although the yaw servo hydraulic switch was found in the forward position, the position of the internal switch mechanism at the time of impact could not be determined due to thermal damage. In addition, because of damage from impact forces and the postcrash fire, the internal switch position of the “ACCU TST” push button at the time of impact could not be determined.

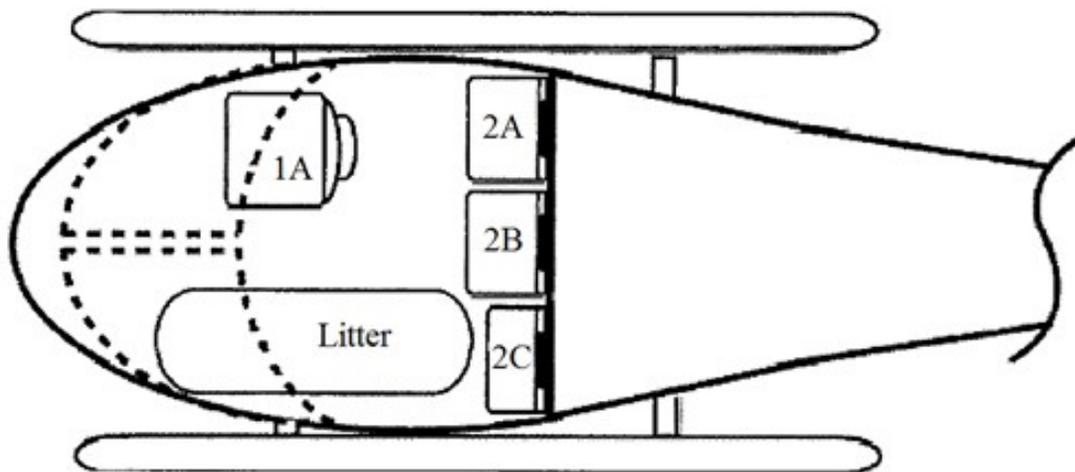
Figure 5. Occupant seating positions on N390LG.

The pilot, age 64, sustained blunt force and thermal injuries, including second- and third-degree skin burns and thermal lung injuries. He succumbed to his injuries about 75 minutes after the accident occurred. The flight nurse in the left aft seat, age 45, sustained blunt force and thermal injuries, including 90% total body area partial- and full-thickness burns.⁶ The flight nurse in the right aft seat, age 32, sustained blunt force injuries but no thermal injuries.⁷

The helicopter was equipped with four occupant seats and one patient litter, as shown in figure 5. The pilot's seat was located at the front of the cabin on the right side. The litter was adjacent to the pilot's seat on the left side of the helicopter next to an emergency exit door. The three forward-facing medical crewmember seats were mounted to the aft bulkhead.

Note: The pilot was in seat 1A, the flight nurse who sustained blunt force injuries only was in seat 2A, and the flight nurse who sustained blunt force and thermal injuries was in seat 2C.

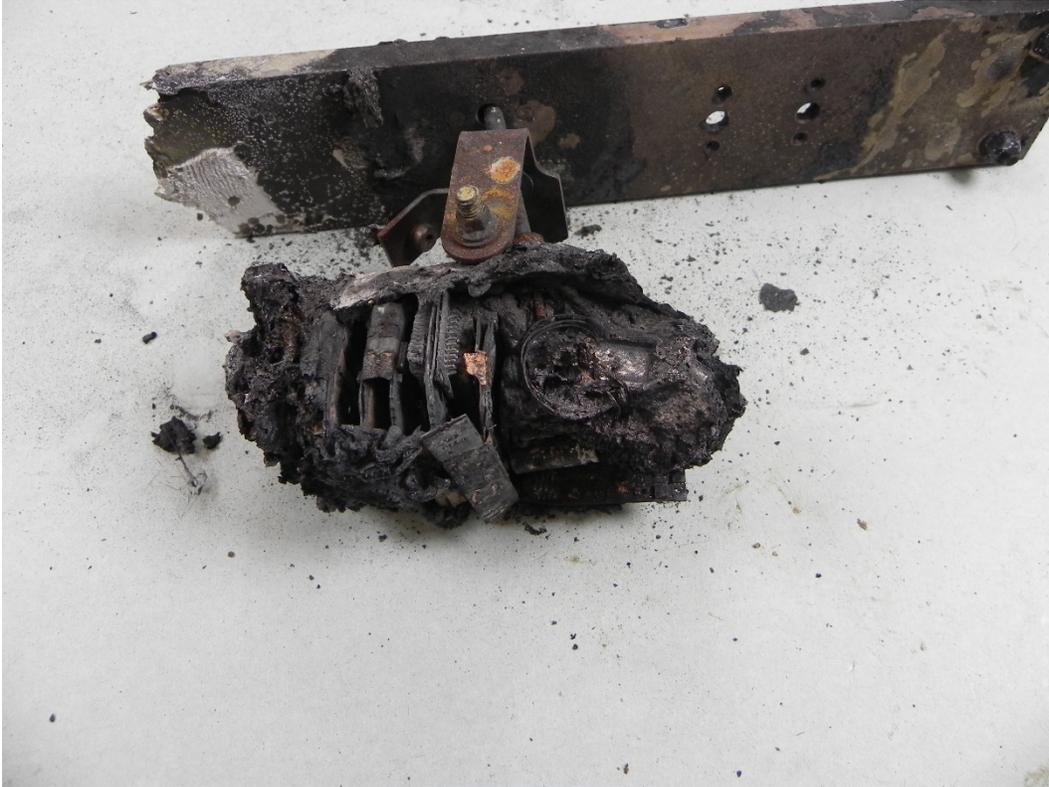
Figure 6a. Postaccident condition of onboard image recorder.

Postaccident examination of the helicopter's Appareo device showed that the device sustained extensive heat damage. Figure 6a shows the condition of the Appareo device upon arrival at the NTSB's vehicle recorders laboratory, and figure 6b shows an exemplar Appareo Vision 1000 onboard image recorder for comparison purposes. The SD memory card was removed from the Appareo device. The silicon memory device (internal to the SD card) was cracked and fractured throughout, so data recovery from the SD card was not possible. The Appareo device's internal NVM module was then removed, and the two NVM chips were removed from the internal memory device chassis. One chip (referred to as NVM chip 1) exhibited bubbling on, and cracking along, its plastic packaging surface. The other chip (referred to as NVM chip 2) exhibited heavy bubbling on its plastic packaging surface. The bubbling and cracking were indicative of high-temperature heat damage.

X-ray images of both NVM chips revealed a region of broken bond wires in the upper left portion of NVM chip 1 and no visible defects in NVM chip 2. A binary readout attempt of NVM chip 2 was performed but failed; an error message that is typically associated with failures due to internal damage to the chip was displayed. No further attempts were made to read out either NVM chip.

- **Lack of requirements to install, on smaller aircraft, flight recorder systems that protect recorded data from crash impact damage and postcrash fire damage.** The NTSB issued a series of recommendations to the FAA between 1999 and 2013 regarding the need for crash-resistant flight recorder systems on new and existing aircraft that were not already required to have such recorders. The FAA stated that rulemaking to mandate recorders on such aircraft was not a viable option because of significant costs and the limited ability to assess benefits. As a result, the FAA began promoting the voluntary equipage of onboard image recorders for these aircraft. Most smaller aircraft involved in the NTSB's investigations do not have a crash-resistant flight recorder. Although the NTSB has investigated accidents in which aircraft were voluntarily equipped with image recorders, the data were not recovered during some of these investigations because the recorders did not comply with the FAA's related TSO, which addresses crash resistance to protect recorded data from impact and postcrash fire damage. These situations have affected the NTSB's ability to fully identify the safety issues involved in accidents and the actions to prevent the accidents from recurring.
