Inadvertent Activation of the Fuel Shutoff Lever
and Subsequent Ditching
Liberty Helicopters Inc., Operating a FlyNYON Doors-Off Flight
Airbus Helicopters AS350 B2, N350LH
New York, New York
March 11, 2018

NTSB/AAR-19/04
PB2020-100100

Aircraft Accident Report

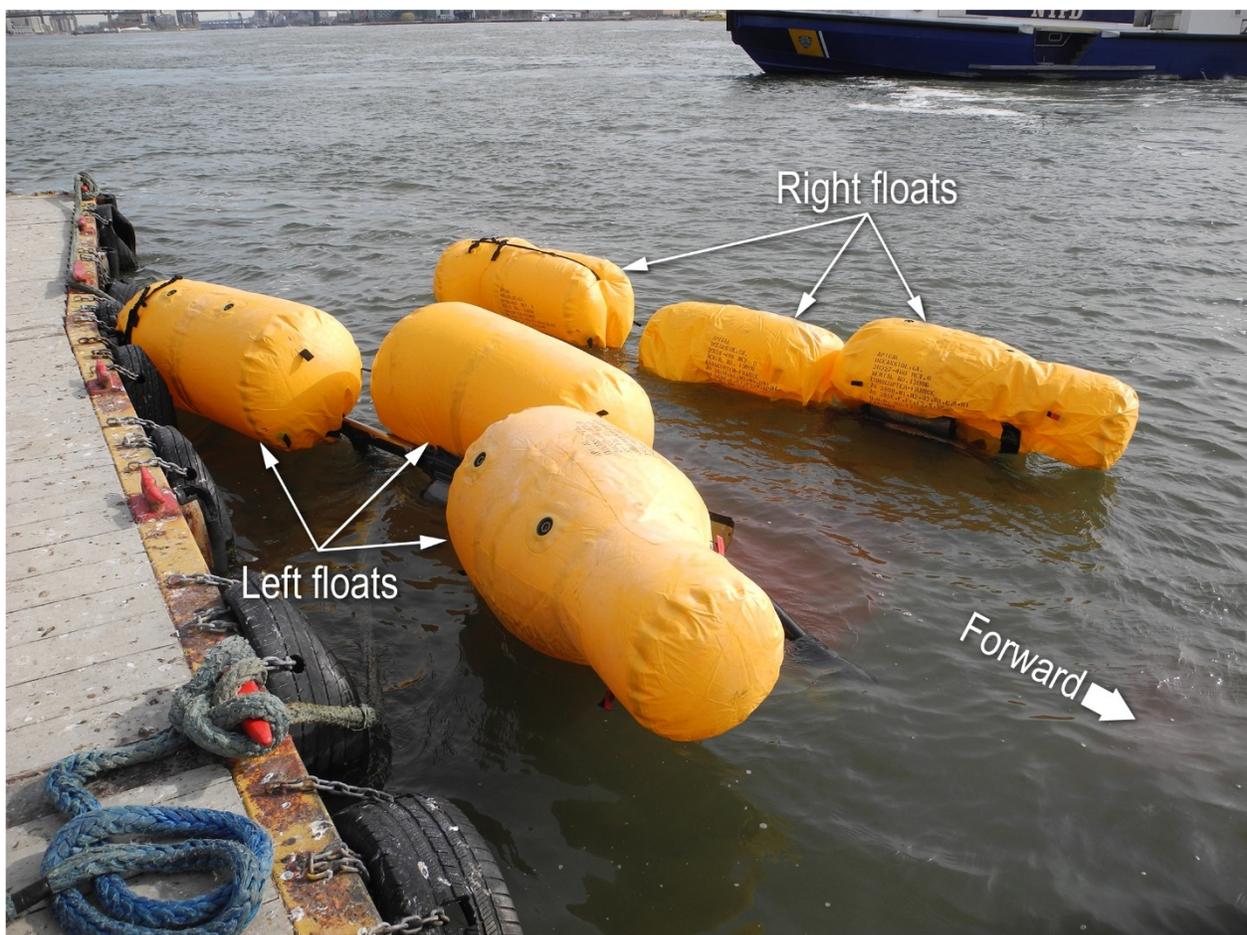
After the emergency response activities were completed (see section 1.8.2), the wreckage was moved and secured to a pier. The day after the accident (before the wreckage was recovered from the water), the helicopter’s six floats (three mounted on each skid) were visible on the surface. The three right floats appeared to be less inflated than the three left floats (see figure 4).

Figure 4. Emergency floats visible above inverted, submerged wreckage.

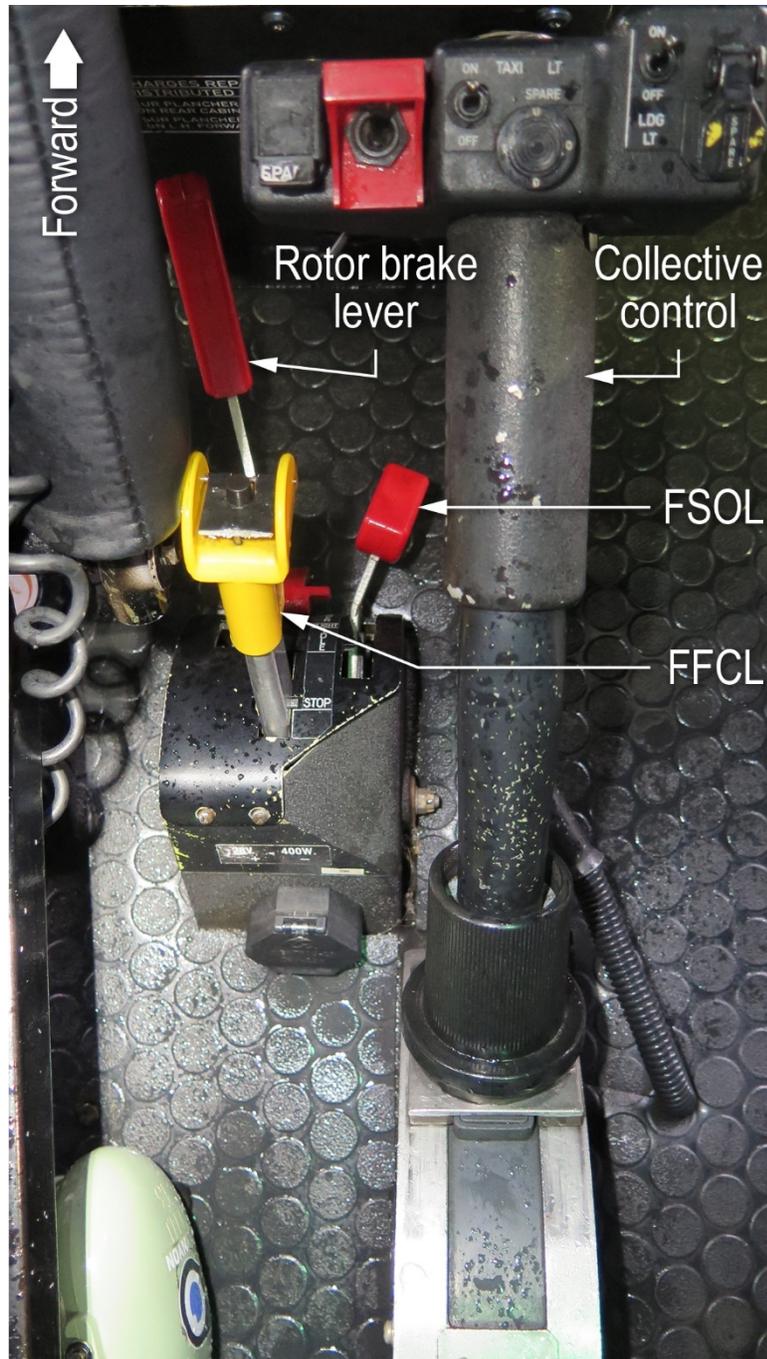
Figure 5. FSOL and other floor-mounted controls in the accident helicopter.

During postaccident examination, the FSOL was found positioned forward and down with the snap wire broken adjacent to the fuel control plate hole. Examination of a fractured segment of the wire using a scanning electron microscope revealed elongation deformation and other features consistent with ductile overstress.

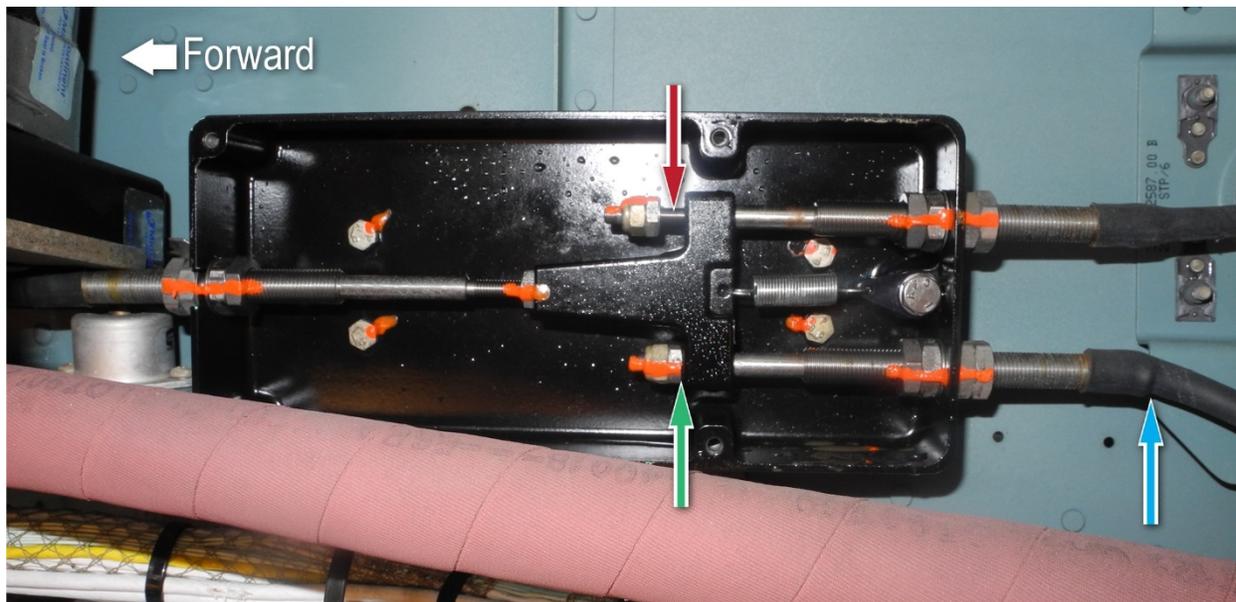
The pull-cable routing from the activation handle to the dual cable block in the junction box was continuous, and the handle shear pin was not present. The aft-upper and aft-lower cables were attached to the dual cable block in the junction box, and their routing was continuous to the left and right reservoir assemblies, respectively. The exterior cover (sheathing) of the cables exhibited no anomalous damage. The pull-cable rigging met the specified 0.625-inch minimum travel requirement for the pull-cable clevis at each valve assembly.

The accident helicopter's aft-upper cable exited the junction box aligned about horizontal, and the aft-lower cable showed a downward bend about 30° from horizontal. Inside the junction box, the aft-upper cable showed a gap of about 0.25 inch between its jam nut and the dual cable block surface, and the aft-lower cable showed no gap between its jam nut and the cable block (see figure 8).

Figure 8. View inside the junction box for the accident helicopter's emergency flotation system.

Note: A gap between the dual cable block surface and the jam nut of the aft-upper cable (for the left reservoir assembly) is indicated by the red arrow, the lack of a gap between the block surface and jam nut of the aft-lower cable (for the right reservoir assembly) is indicated by the green arrow, and the blue arrow indicates the downward bend of the aft-lower cable.

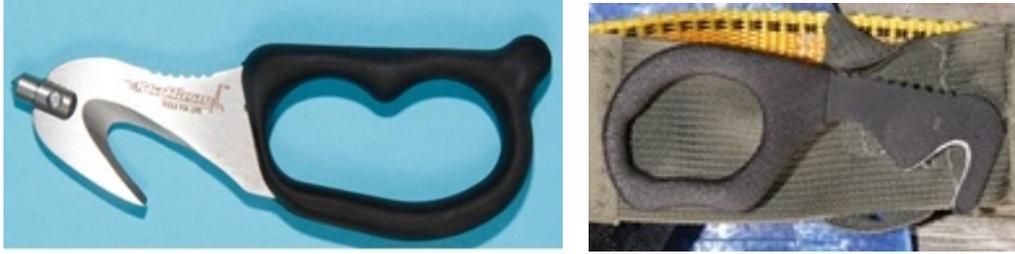
Figure 11. Two types of cutting tools recovered from the accident flight.

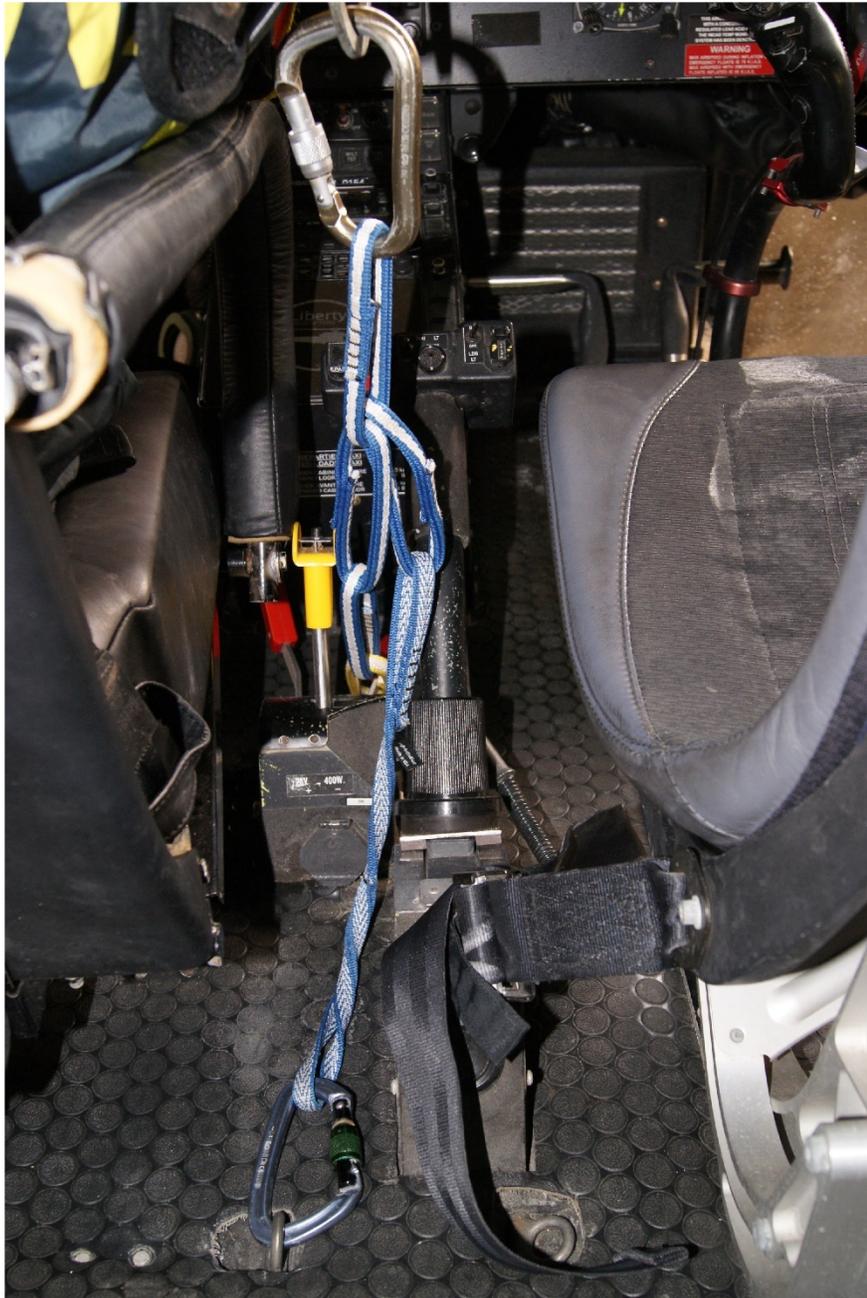
Figure 14. Front passenger's tether from the accident flight with top locking carabiner inserted through third webbing loop (from floor) with three excess loops hanging as a tail.

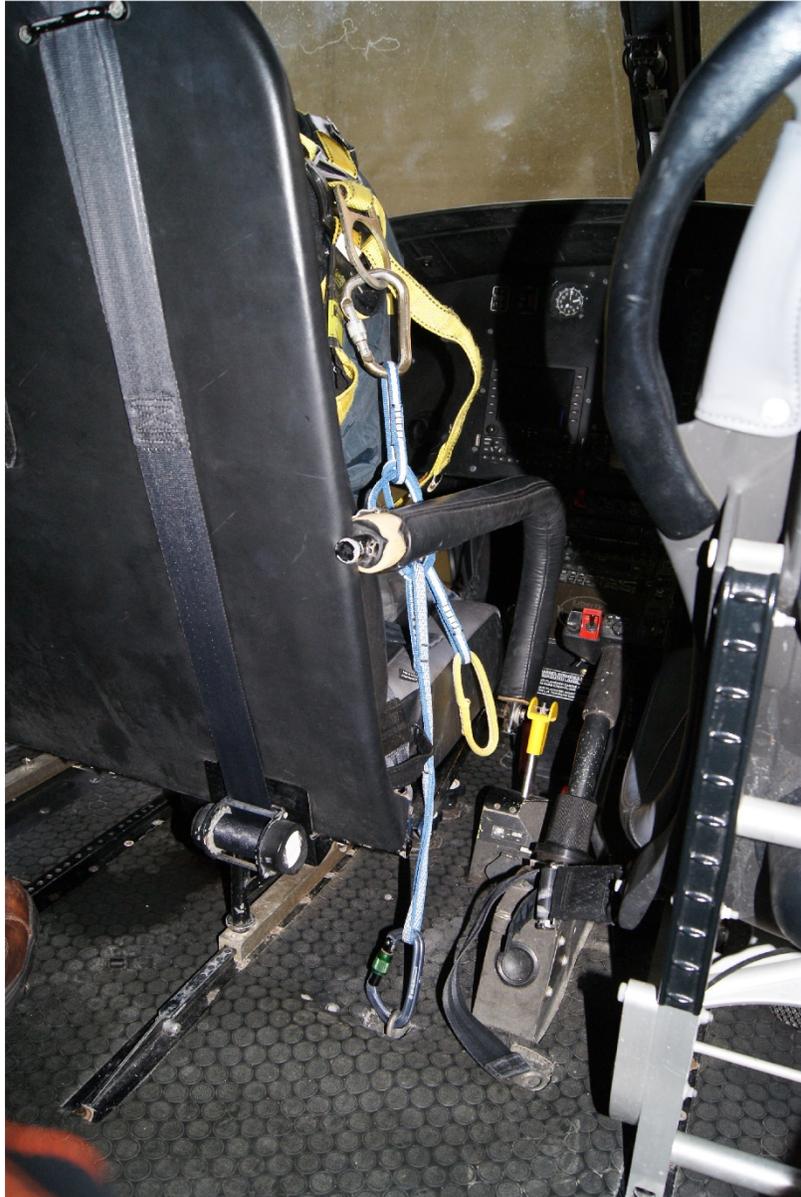
Figure 16. Front passenger's tether (attached to exemplar occupant) routed under the armrest.

When the exemplar occupant leaned back while facing outboard to assume body positions similar to those of the front passenger (as captured by the onboard video), the loops of the tether tail dangled into the floor-mounted controls.³²
