Helicopter Air Ambulance Collision with Terrain
Survival Flight Inc.
Bell 407 Helicopter, N191SF
near Zaleski, Ohio
January 29, 2019

NTSB/AAR-20/01
PB2020-101001

Aircraft Accident Report

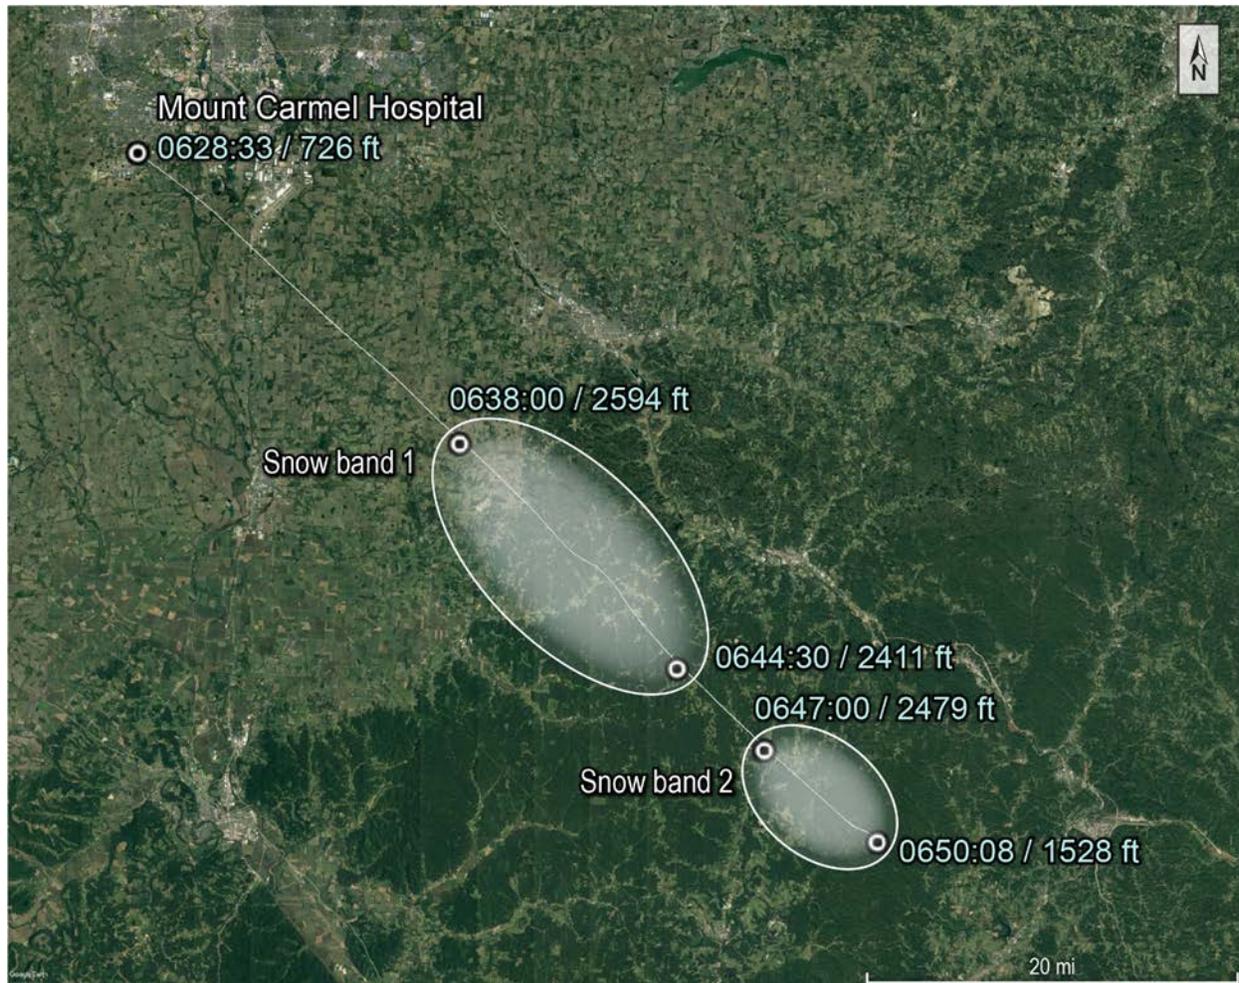
in a southeast direction for about 22 minutes, flying through two snow bands en route to the destination hospital. During the encounter with the second snow band, the pilot likely encountered instrument meteorological conditions (IMC) due to reduced visibility in snow. Shortly after the encounter with the second snow band, the helicopter flew a path consistent with a 180° descending left turn, which may have indicated the pilot was attempting to perform an escape maneuver to exit inadvertent IMC. However, she did not command the helicopter to climb, and it continued to descend until the last moments of the flight. The helicopter impacted trees on the reciprocal heading of the flightpath.

Figure 2. Flightpath of N191SF (white line) depicting the portions of snow bands that surrounded the flightpath.

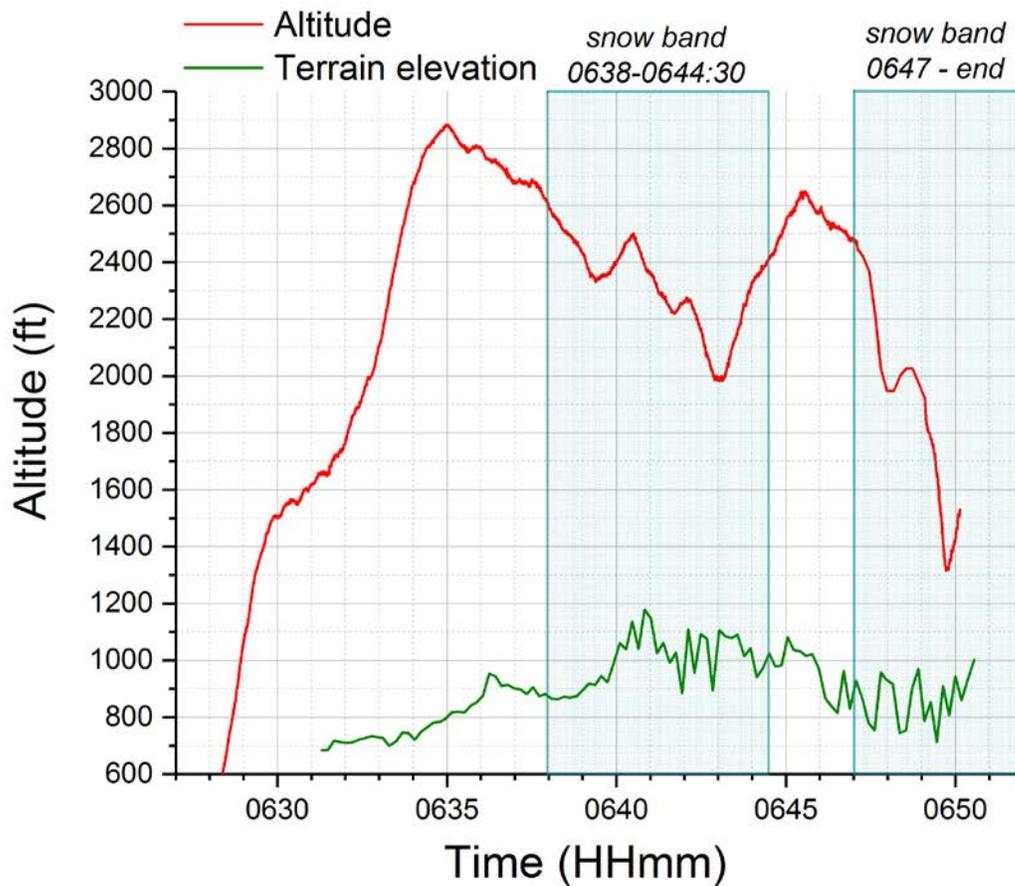
Figure 3. Graph depicting the accident helicopter's altitude (red line), encounter with snow bands (gray shaded areas), and terrain elevation (green line).

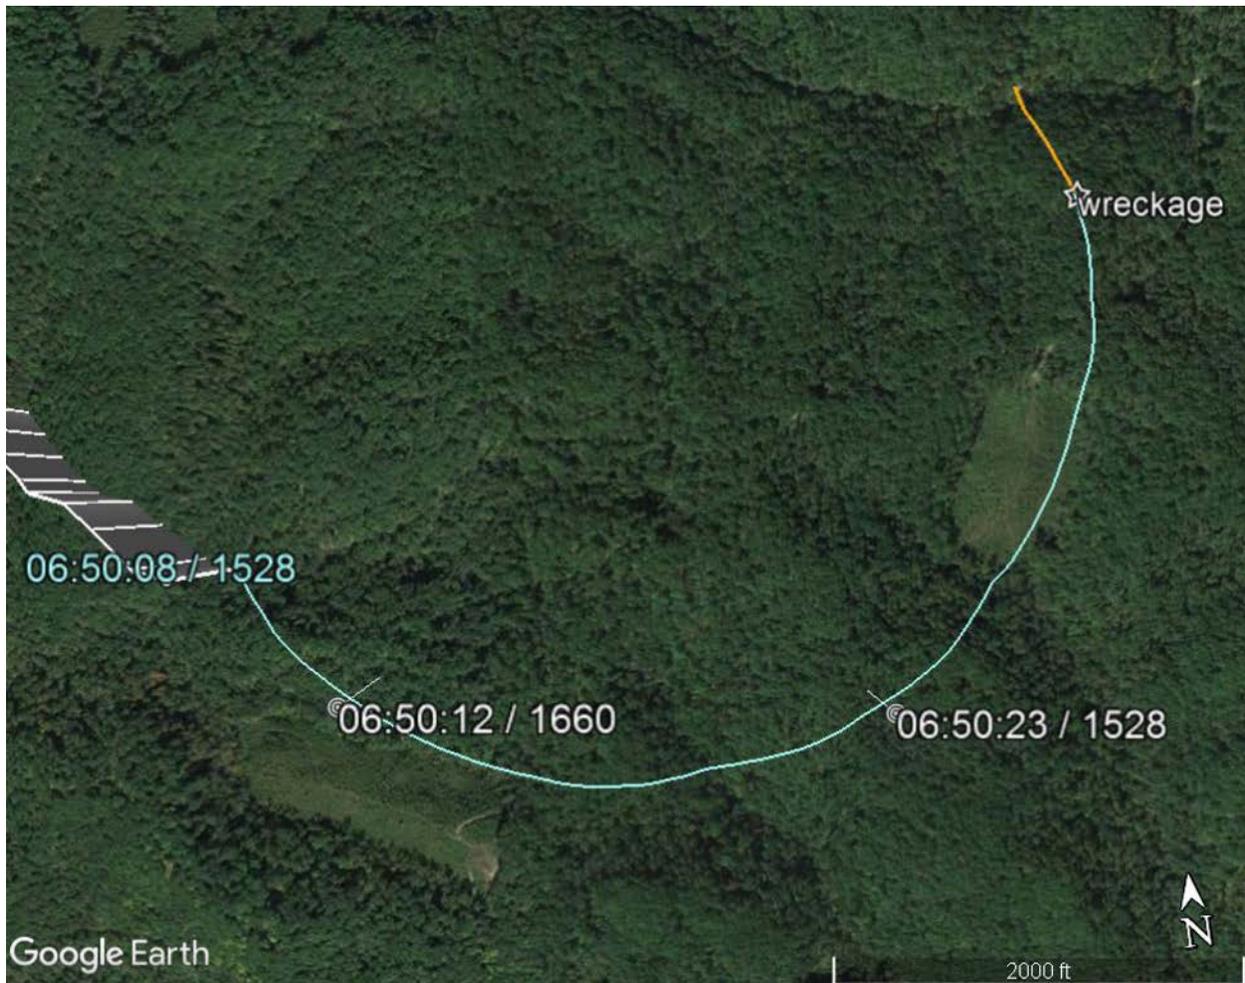
The helicopter continued to fly for about 30 seconds after the onboard data ended; two additional satellite data points (the second of which indicated the helicopter had begun to descend again) and the wreckage location were aligned roughly along the arc of a 0.7 nm diameter circle (see figure 4). The wreckage was oriented in the opposite heading of the initial flightpath.

Figure 4. End of N191SF's flightpath (green line) showing the opposite heading orientation of the wreckage location and debris field (orange line).

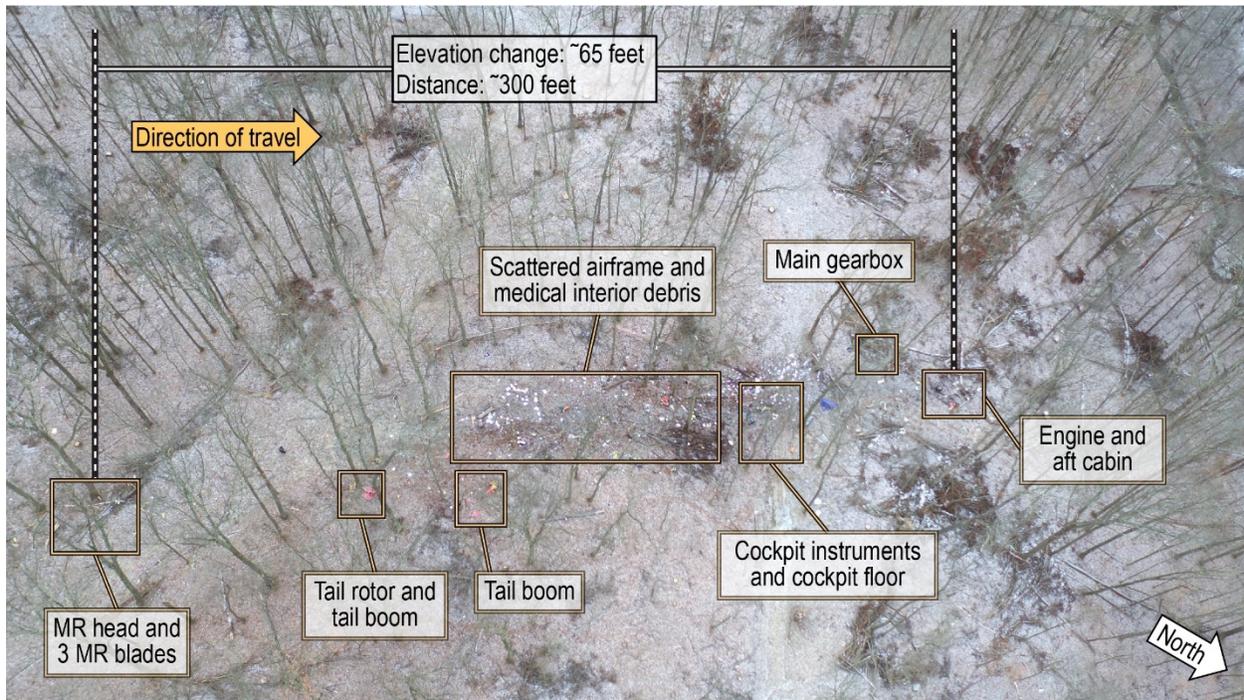
Examination of the accident site revealed that the helicopter initially collided with a tree at a height about 30 ft above the ground on a heading of about 345°. The wreckage path extended about 600 ft downslope, beginning with the front-left skid tube and followed by the main rotor hub and blades, tail boom and tail rotor, cockpit, cabin, and the engine and transmission deck (see figure 6). Broken tree branches were found near the front-left skid tube. The main rotor hub, with three of the four main rotor blades attached, was found about 300 ft downslope of the front-left skid tube. The fourth main rotor blade was embedded in a tree near the main rotor hub. All components of the helicopter were accounted for at the accident site. There was no evidence of a postcrash fire, and a strong smell of fuel was noted.

Figure 6. Aerial view of the accident site detailing the wreckage debris distribution.

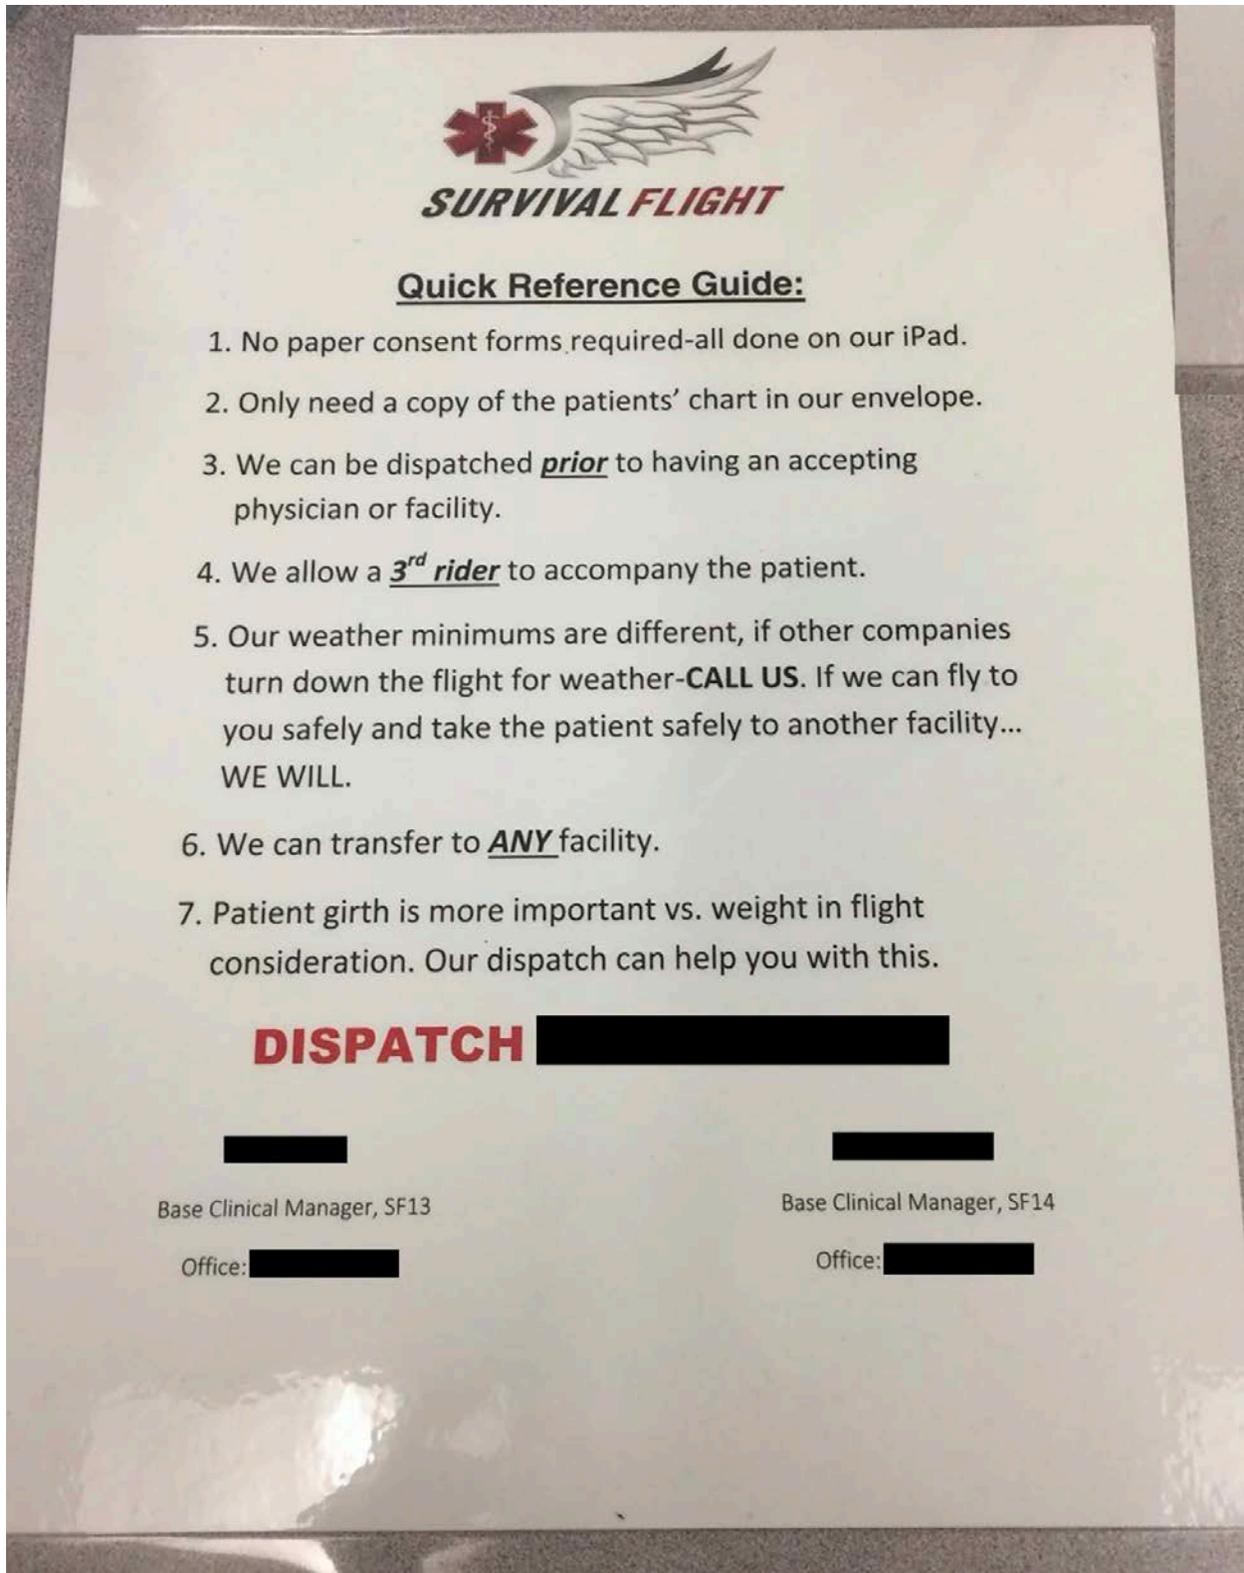
⁵⁷ In an HAA operation with one pilot and two medical crewmembers, “three to go, one to say no” is a practice in which any one of the three crewmembers involved in the operation may cancel a flight if they do not feel the flight can be conducted safely. Two pilots and four medical personnel mentioned the “three to go, and one to say no” policy during interviews.

Figure 7. “Quick Reference Guide” distributed by Survival Flight.

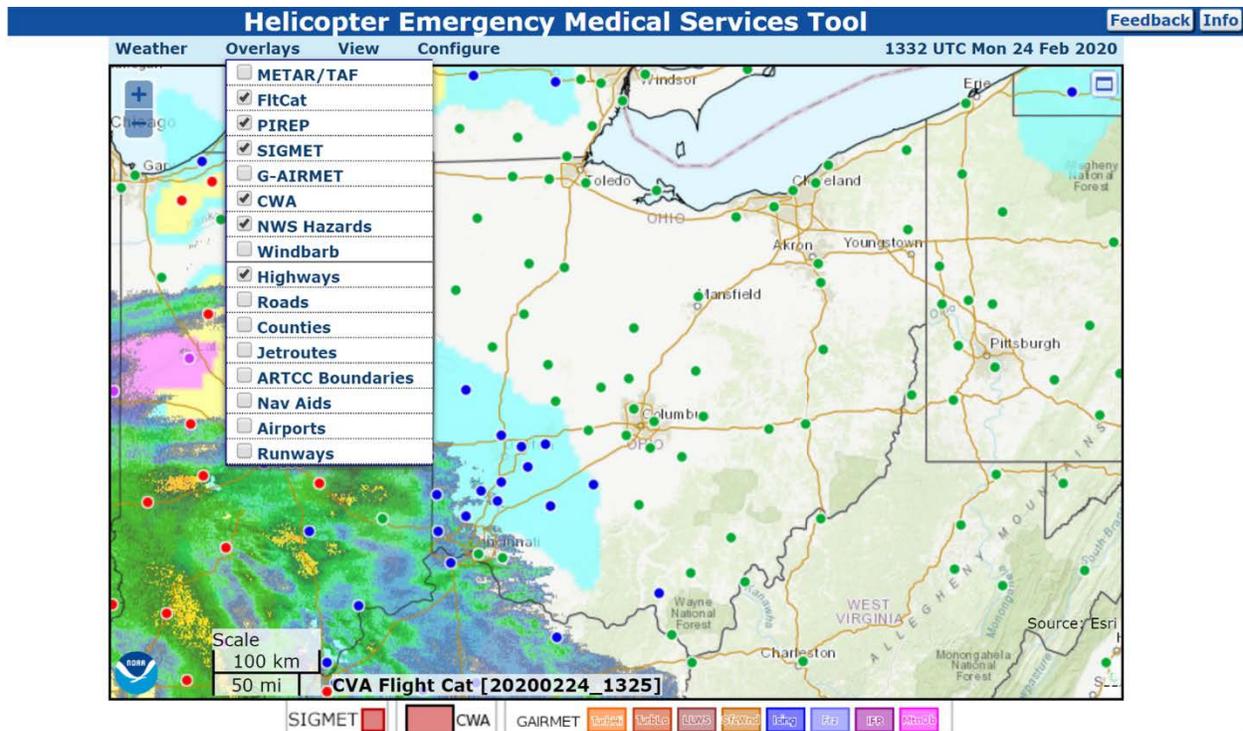
While AIRMETs or other en route forecast information are not displayed by default, these sources of information are accessible on the HEMS Weather Tool (see figure 8). To access the graphical AIRMETs, a box must be checked on the HEMS Weather Tool.

Figure 8. Exemplar HEMS Weather Tool displaying overlay options

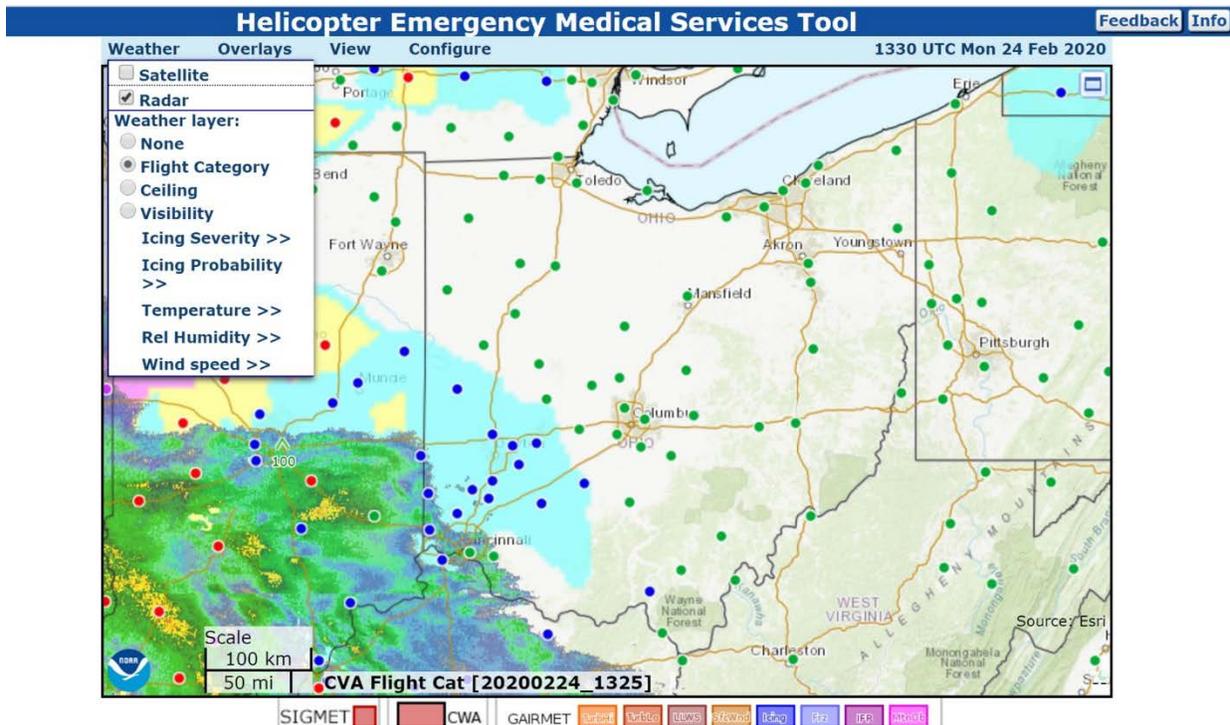
The investigation also noted that the default overlay setting for the HEMS Weather Tool includes flight category, PIREPs, SIGMETs, and MRMS weather radar information (see figure 9).

Figure 9. Exemplar HEMS Weather Tool default setting with flight category and radar precipitation selected.

However, MRMS weather radar information does not include TDWR information. The MRMS weather radar imagery incorporates information only from the network of WSR-88D weather radars. Although WSR-88D and TDWR both show precipitation, they use different equipment settings to do so; therefore, the HEMS Weather Tool does not always show all potential precipitation along a flightpath.⁹⁶

- [Require the National Weather Service \(NWS\) to add terminal doppler weather radar data to the HEMS Weather Tool overlay \(as recommended in Safety Recommendation A-20-19 to the NWS\). \(A-20-16\)](#)

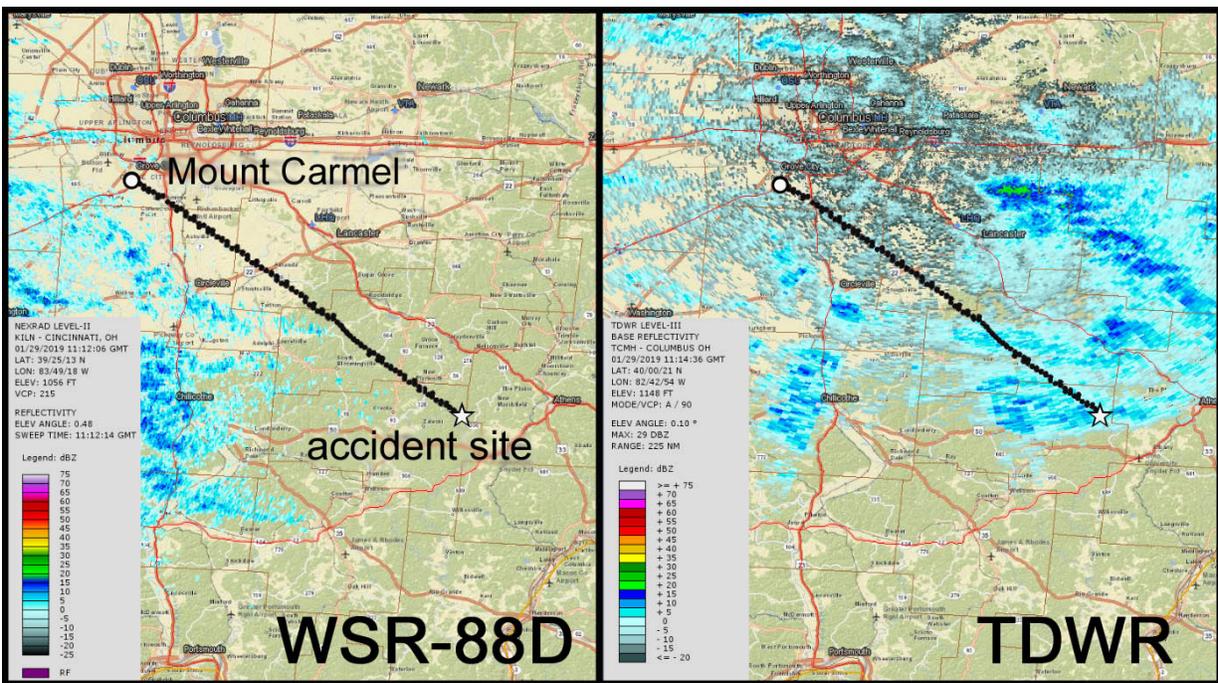
Because the WSR-88D only covered altitudes between 4,980 ft and 11,880 ft over the accident site, the snow showers identified on the TDWR were not detected or displayed on the HEMS Weather Tool above the accident site. Although recorded data showed that the TDWR from Columbus detected bands of precipitation along the route of flight, this was not an information source available in the HEMS Weather Tool (see figure 10).

Figure 10. Comparison of WSR-88D data vs. TDWR data at the time of the flight request

- [Install the latest software on your terminal doppler weather radars \(TDWR\) and require the National Weather Service \(NWS\) to distribute Level II TDWR data to all of its users \(as recommended in Safety Recommendation A-20-18 to the NWS\) so they will have access to the most accurate precipitation information. \(A-20-15\)](#)

- [Require the National Weather Service \(NWS\) to provide capability in the HEMS Weather Tool to graphically display areas of weather radar limitations, including areas where beams may lack low-altitude coverage, areas that lack radar coverage, and areas of beam blockages \(as recommended in Safety Recommendation A-20-20 to the NWS\). \(A-20-17\)](#)
