AIRCRAFT ACCIDENT REPORT

EXECUTIVE JET AVIATION, INC.

LEAR JET L23A, N434EJ

REPORT NUMBER: NTSB-AAR-71-3

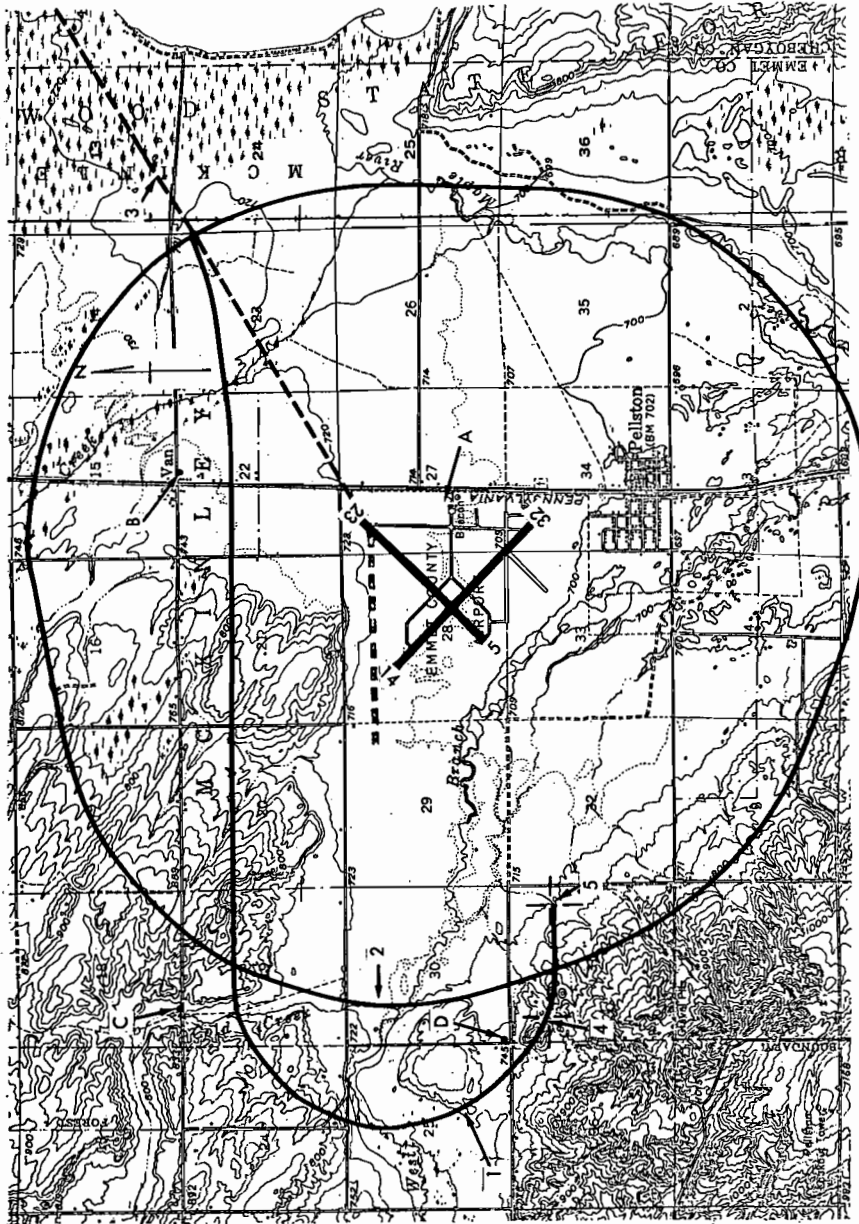
ACCIDENT SITE AND WITNESS LOCATION CHART
EXECUTIVE JET AVIATION, INC. LEAR JET
MODEL L-23A N434EJ
Pellston, Michigan May 9, 1970

1. Approximate flight path according to witnesses.
2. Circling approach area (TERPS).
3. Inbound course from VOR.
4. Initial impact point.
5. Final impact point and main wreckage.

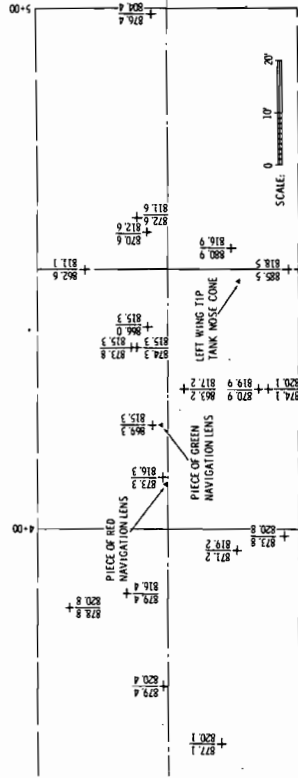
LAN VIEW OF INITIAL IMPACT AREA
 COORDINATES 45°33'43"N - 86°51'02"W

At the initial impact site, the path of the tree damage was 254 feet long and 45 feet wide. Within this area were found the red and green navigation light lenses, landing light lens, vortex generators, and the left wingtip fuel tank nose cone. None of the recovered pieces from this area revealed any evidence of fire. None of the vegetation in the area was burned.

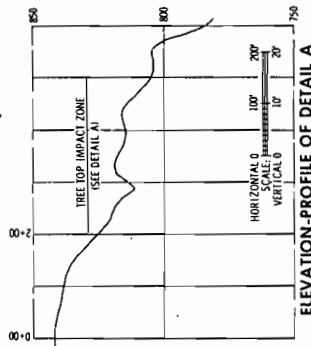
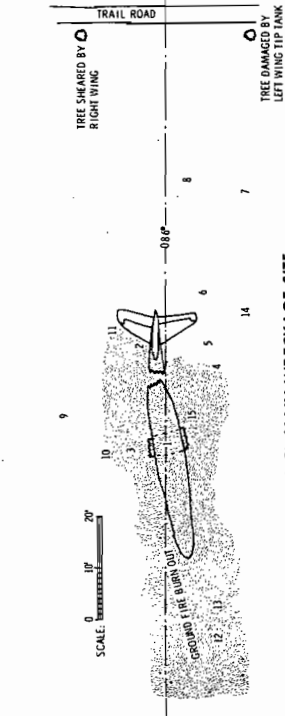
DETAIL C: MAIN WRECKAGE SITE

The wreckage at the main impact site was confined to an area measuring approximately 130 feet by 50 feet. From cuts on the trees, the lateral attitude of the aircraft was determined to be approximately 37° left wing down. Similarly, the descending angle of the aircraft through the trees

1. FUSELAGE - PASSENGER CABIN
2. IMPERNAUGE
3. RIGHT WING
4. LEFT WING
5. NOSE GEAR
6. LEFT MAIN GEAR
7. LEFT TIP FANK
8. LEFT WING LEADING EDGE
9. RIGHT FLAP
10. RIGHT TIP FANK FIN
11. RIGHT MAIN GEAR
12. NOSE GEAR ACTUATOR
13. LEFT MAIN GEAR
14. NOSE GEAR UPPER STRUT & STEERING HOUSING
15. LOCATION OF BURNED LEFT WING
