**Aircraft Accident Report - Allegheny  
Airlines, Inc., BAC 1-11, N1550,  
Rochester, New York, July 9, 1978**

**(U.S.) National Transportation Safety Board, Washington, DC**

1. Report No. NTSB-AAR-79-2	2. Government Accession No.	3. Recipient's Catalog No.	
4. Title and Subtitle Aircraft Accident Report - Allegheny Airlines, Inc., BAC 1-11, N1550, Rochester, New York, July 9, 1978		5. Report Date February 8, 1979

ALLEGHENY AIRLINES, INC.  
BAC 1-11, N1550  
ROCHESTER, NEW YORK  
JULY 9, 1978

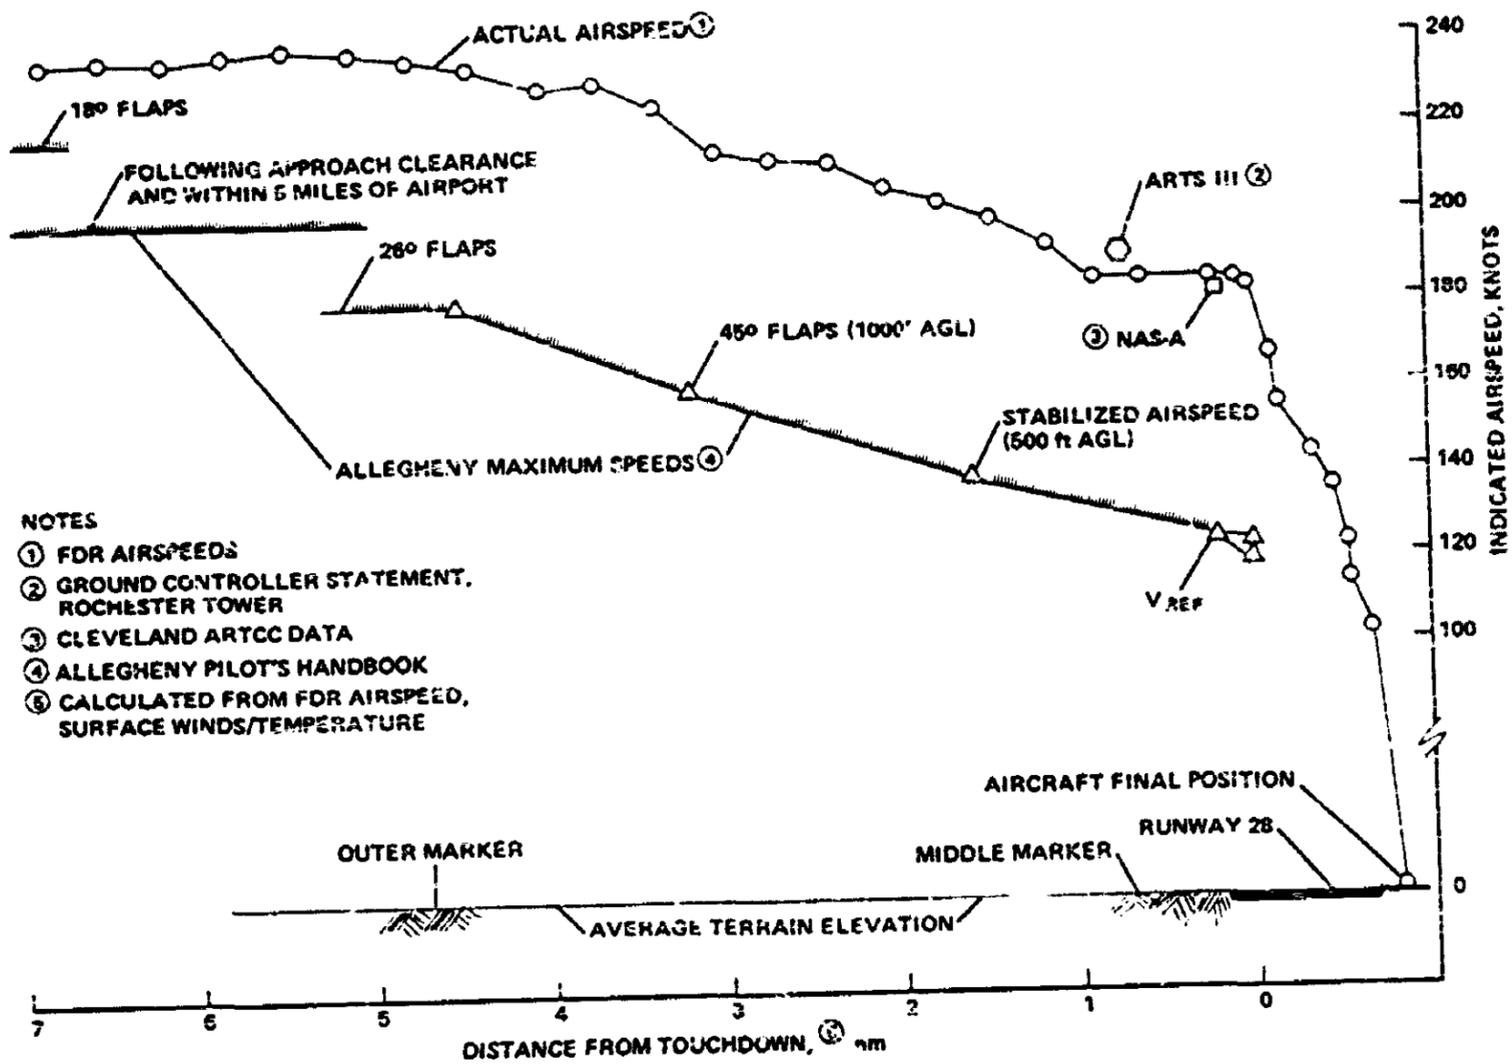
**NATIONAL TRANSPORTATION SAFETY BOARD**  
**WASHINGTON, D.C.**  
**COMPARISON OF AL-453 AIRSPEEDS WITH**  
**ALLEGHENY MAXIMUM SPEEDS**  
**ALLEGHENY AIRLINES, SAC 1-11, N1550**  
**ROCHESTER, NEW YORK**  
**JULY 9, 1978**

According to flight data recorder (FDR) information, the aircraft crossed the runway threshold at a speed of about 184 kns indicated airspeed (KIAS)--61 kns above Vref. About 1750:08, the aircraft's nose wheel touched down on the runway about 2,540 ft down the runway at 163 kns. This was followed by the touchdown and subsequent failure of the right main landing gear tires at a point about 3,000 ft down the runway at a speed of about 159 kns. This was followed by the touchdown and subsequent failure of the left main landing gear inboard tire about 3,960 ft down the runway at 143 KIAS.

8. The crew failed to comply with recommended approach and landing airspeeds.
9. The approach was not made according to prescribed procedures and was not stabilized.

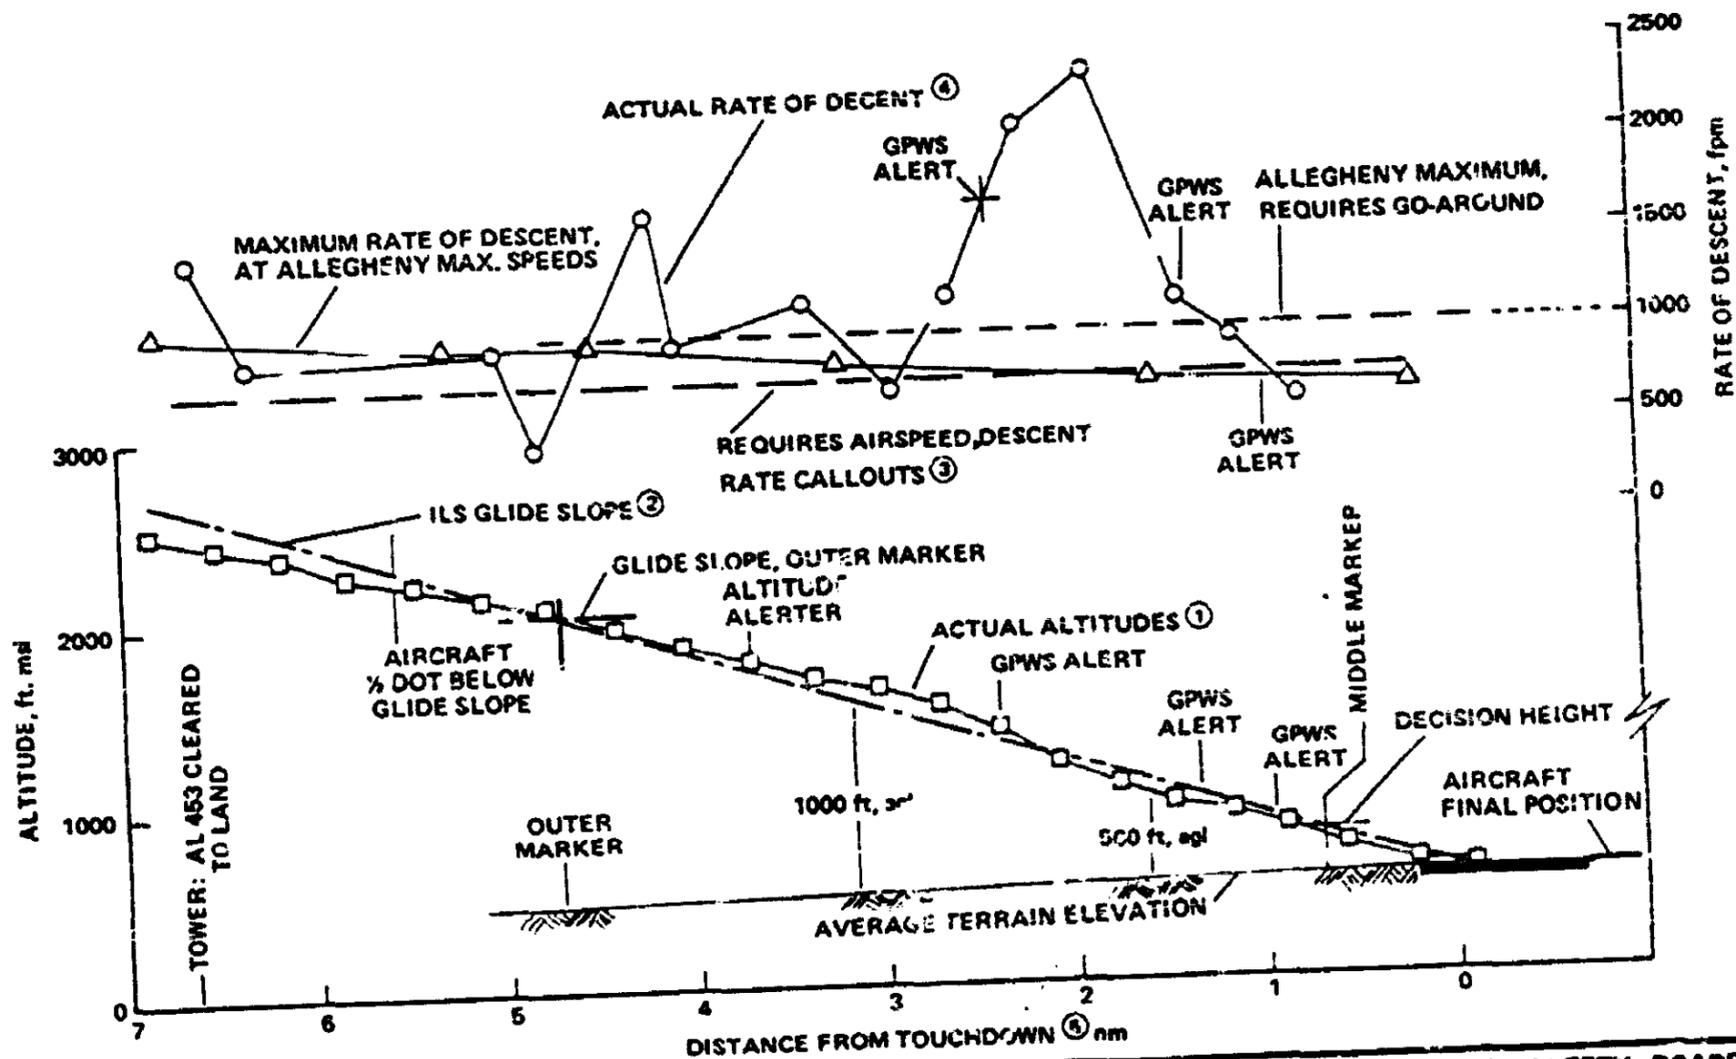
**COMPARISONS OF AL-453 ALTITUDES  
 AND RATES OF DESCENT WITH  
 ALLEGHENY AIRLINES, MAXIMUM LIMITS  
 ALLEGHENY AIRLINES, BAC 1-11, N1550  
 ROCHESTER, NEW YORK, JULY 9, 1978**

The dangerously high rates of descent of over 2,000 fpm within 2 miles of the threshold and the first GPWS alert should have indicated to the crew that the approach was improper and that a missed approach was necessary. None of the three GPWS alerts caused the crew to take the necessary corrective action even though company procedures dictated otherwise.

The captain was obviously not fully cognizant of the excessive deviations from stabilized parameters because of a breakdown in crew coordination and inadequate monitoring of cockpit instruments by both he and his first officer. Such excessive deviations from a normal approach would have caused an alert and prudent captain to execute a missed approach. Yet, when questioned, the captain stated that he never considered such an action. The far end of the runway end was visible when the flight was airborne, and cues were available for assessing the amount of runway remaining. Even after the brakes were locked, the captain had sufficient airspeed to go around. He had only to advance the power, select 18° flaps, and rotate the aircraft; yet he did not. Based on aircraft performance calculations using full reverse thrust, full ground spoilers, and maximum braking, the aircraft could not have been stopped on the remaining runway after touchdown.

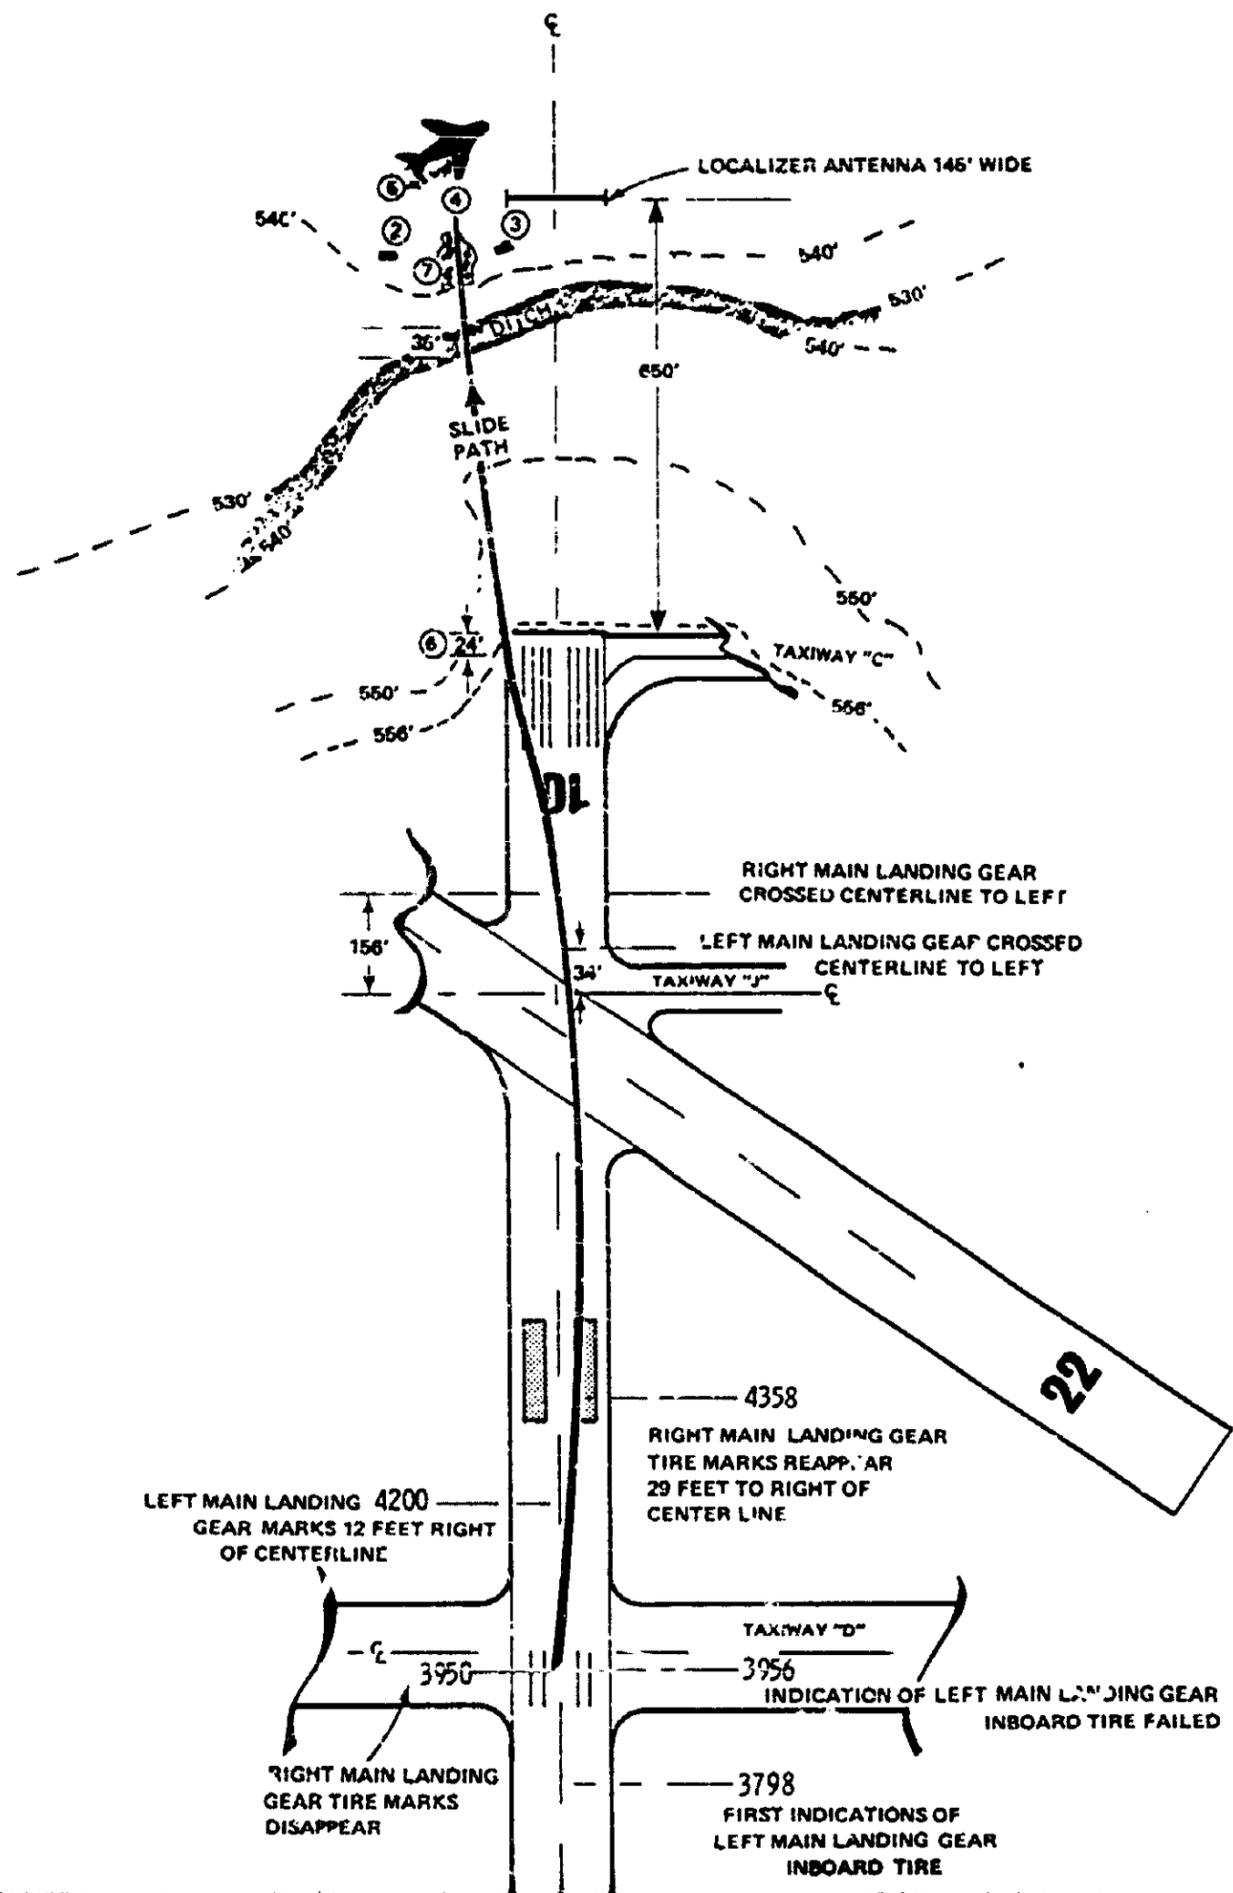
10. The captain applied brakes before the main landing gear was on the runway.
11. The captain's decision to land was improper and causal.
12. The right main landing gear contacted the runway 3,010 ft from the landing threshold at 159 kn and the left main landing gear initially contacted the runway about 3,800 ft from the threshold at 140 kn.

LEFT MAIN LANDING GEAR  
INBOARD TIRE

INDICATION THAT RIGHT OUT-BOARD MAIN LANDING GEAR TIRE FAILED

INDICATION THAT RIGHT INBOARD MAIN LANDING GEAR TIRE FAILED

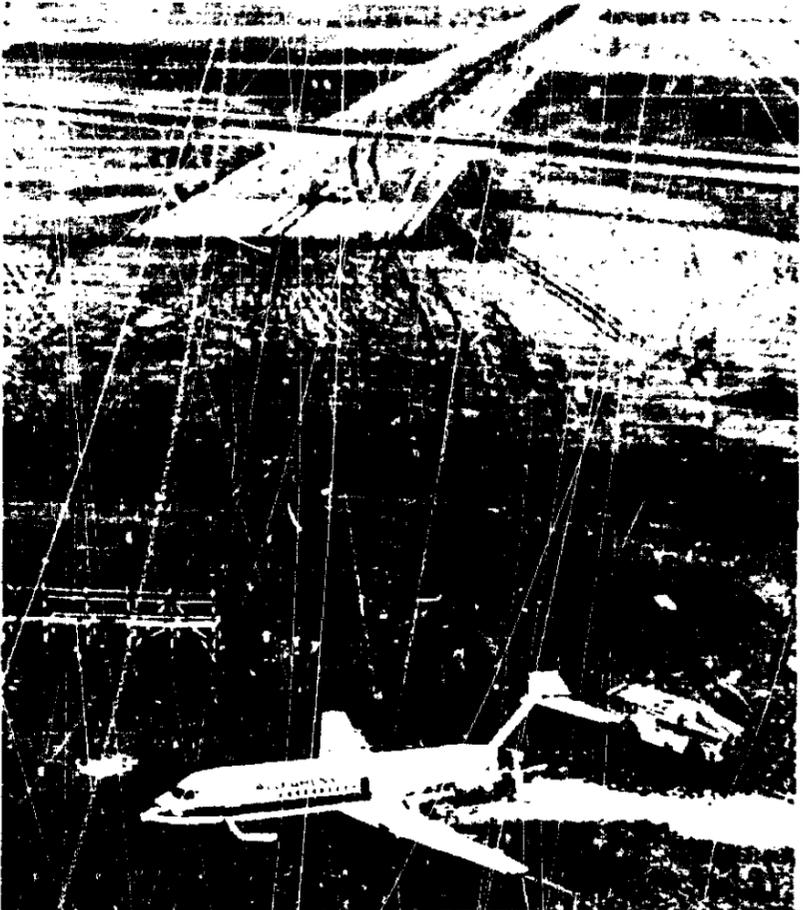
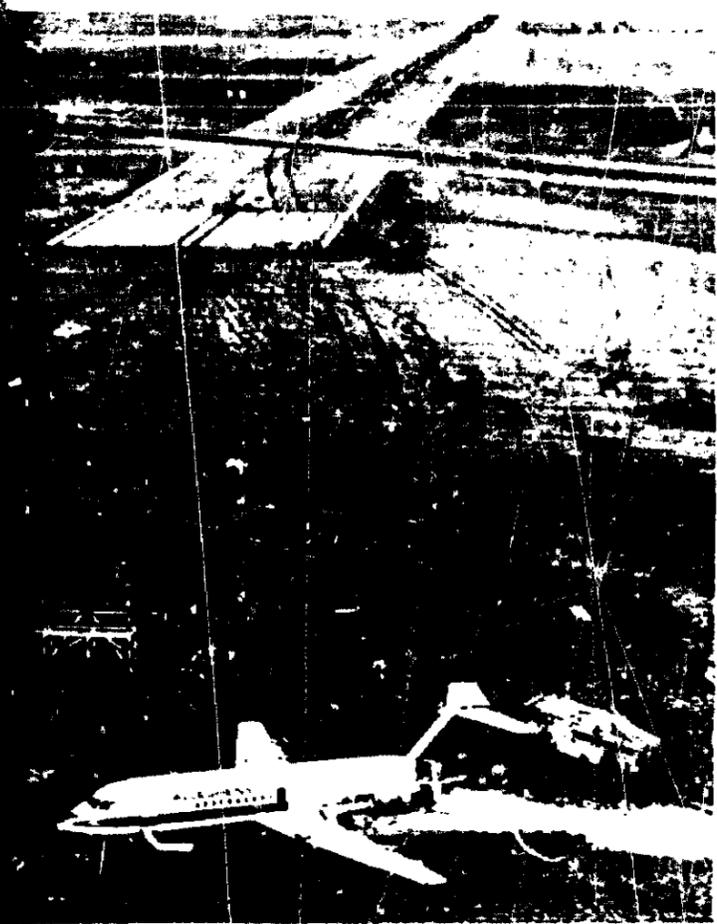
WRECKAGE DISTRIBUTION CHART  
ALLEGHENY AIRLINES, INC.  
BRITISH AEROSPACE, INC.,  
BAC-1-11 TYPE-203AE, N1550  
ROCHESTER-MONROE COUNTY AIRPORT, N.Y.  
July 9, 1978

About 7 sec after the inboard tire of the left main landing gear failed, the aircraft departed the end of the runway at a speed of about 102 kns. Following its departure from the end of the runway, the aircraft traveled about 425 ft down a gradual slope and then traversed a 35-ft-wide, 10-ft-deep drainage ditch. Impact with the drainage ditch caused the nose landing gear to collapse rearward and both main landing gear to separate from the aircraft. The aircraft continued on and came to a rest about 728 ft past the departure end of the runway, 143 ft to the left of the extended runway centerline, on a heading of 334° magnetic.

Before the aircraft came to rest, the left main landing gear was propelled over the fuselage. It impacted the top fuselage skin and came to rest adjacent to the left side of the aircraft. (See Appendix I.) The fuselage was creased and buckled in several areas. However, the empennage was not damaged.
