NATIONAL TRANSPORTATION SAFETY BOARD

AIRCRAFT ACCIDENT REPORT

**SWIFT AIRE LINES, INC.
NORD 262, N418SA
MARINA DEL REY, CALIFORNIA
MARCH 10, 1979**

NTSB-AAR-79-13

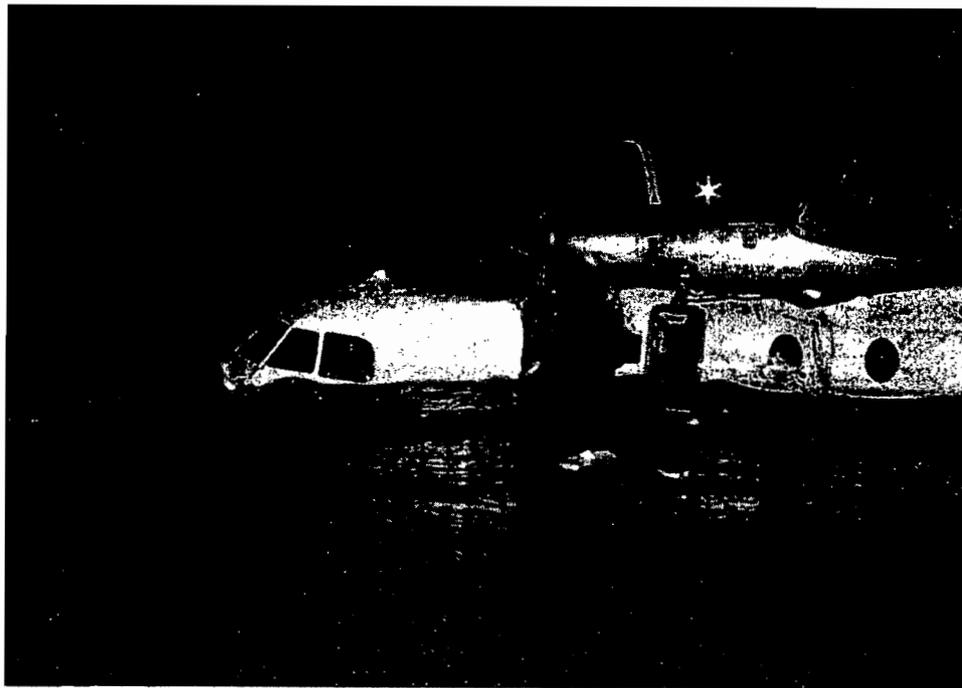
The aircraft hit the water with the landing gear retracted and the wing flaps extended to 35°; the aircraft bounced twice and came to rest in about 18 ft of water. The aircraft sank almost immediately in a nose-low attitude. The wings and tail remained above water. The extent of structural damage sustained by the aircraft as a result of impact forces could not be determined fully because the aircraft was damaged extensively during rescue efforts and during recovery of the wreckage.

Photographs taken before the wreckage recovery effort show the cockpit area partially separated from the fuselage near the production break located slightly forward of the emergency exit windows. (See figure 1.) From this production break rearward, the aircraft remained intact. The front, center, and aft fuselage underside structure was not visible in the photographs and was not examined before wreckage recovery commenced; therefore, impact damage to this structure could not be determined with any degree of certainty.

Figure 1. Aircraft wreckage before recovery from the surf. Note that the cockpit area has separated from the remainder of the aircraft.

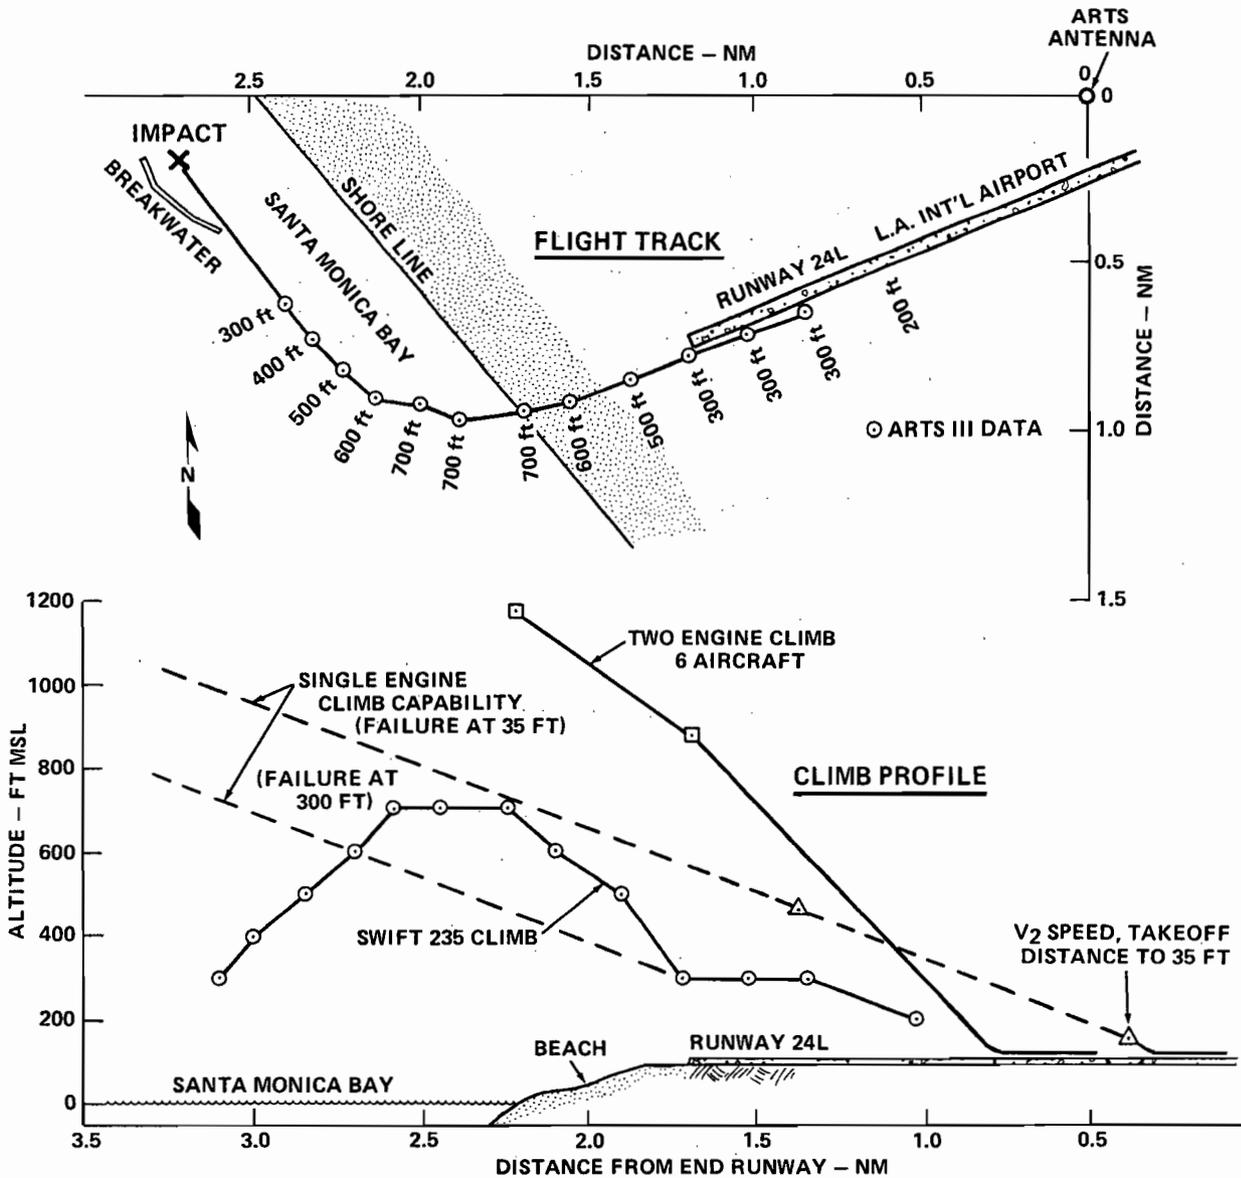
After the accident, the two-engine climb performance was recorded for six similarly loaded Nord 262 flights. (See figure 2.) These aircraft gained about 800 ft of altitude at the end of the runway and 1,200 ft at the shoreline. The expected single-engine climb performance data were extracted from the Nord 262 performance manual. (See figure 2). For Flight 235's takeoff conditions, the calculated single-engine climb gradient was 310 ft per nautical mile. This would mean that the aircraft should have crossed the departure end of the runway at an altitude of about 550 ft, or 250 ft higher than its actual crossing altitude.

Figure 2. Flight track and climb profile Swift Aire Lines, Inc., N418SA, Los Angeles, California, March 10, 1978.
