PB93-910406  
NTSB/AAR-93/05

## AIRCRAFT ACCIDENT REPORT

MIDAIR COLLISION  
MITSUBISHI MU-2B-60, N74FB, AND PIPER PA-32-301, N82419  
GREENWOOD MUNICIPAL AIRPORT  
GREENWOOD, INDIANA  
SEPTEMBER 11, 1992

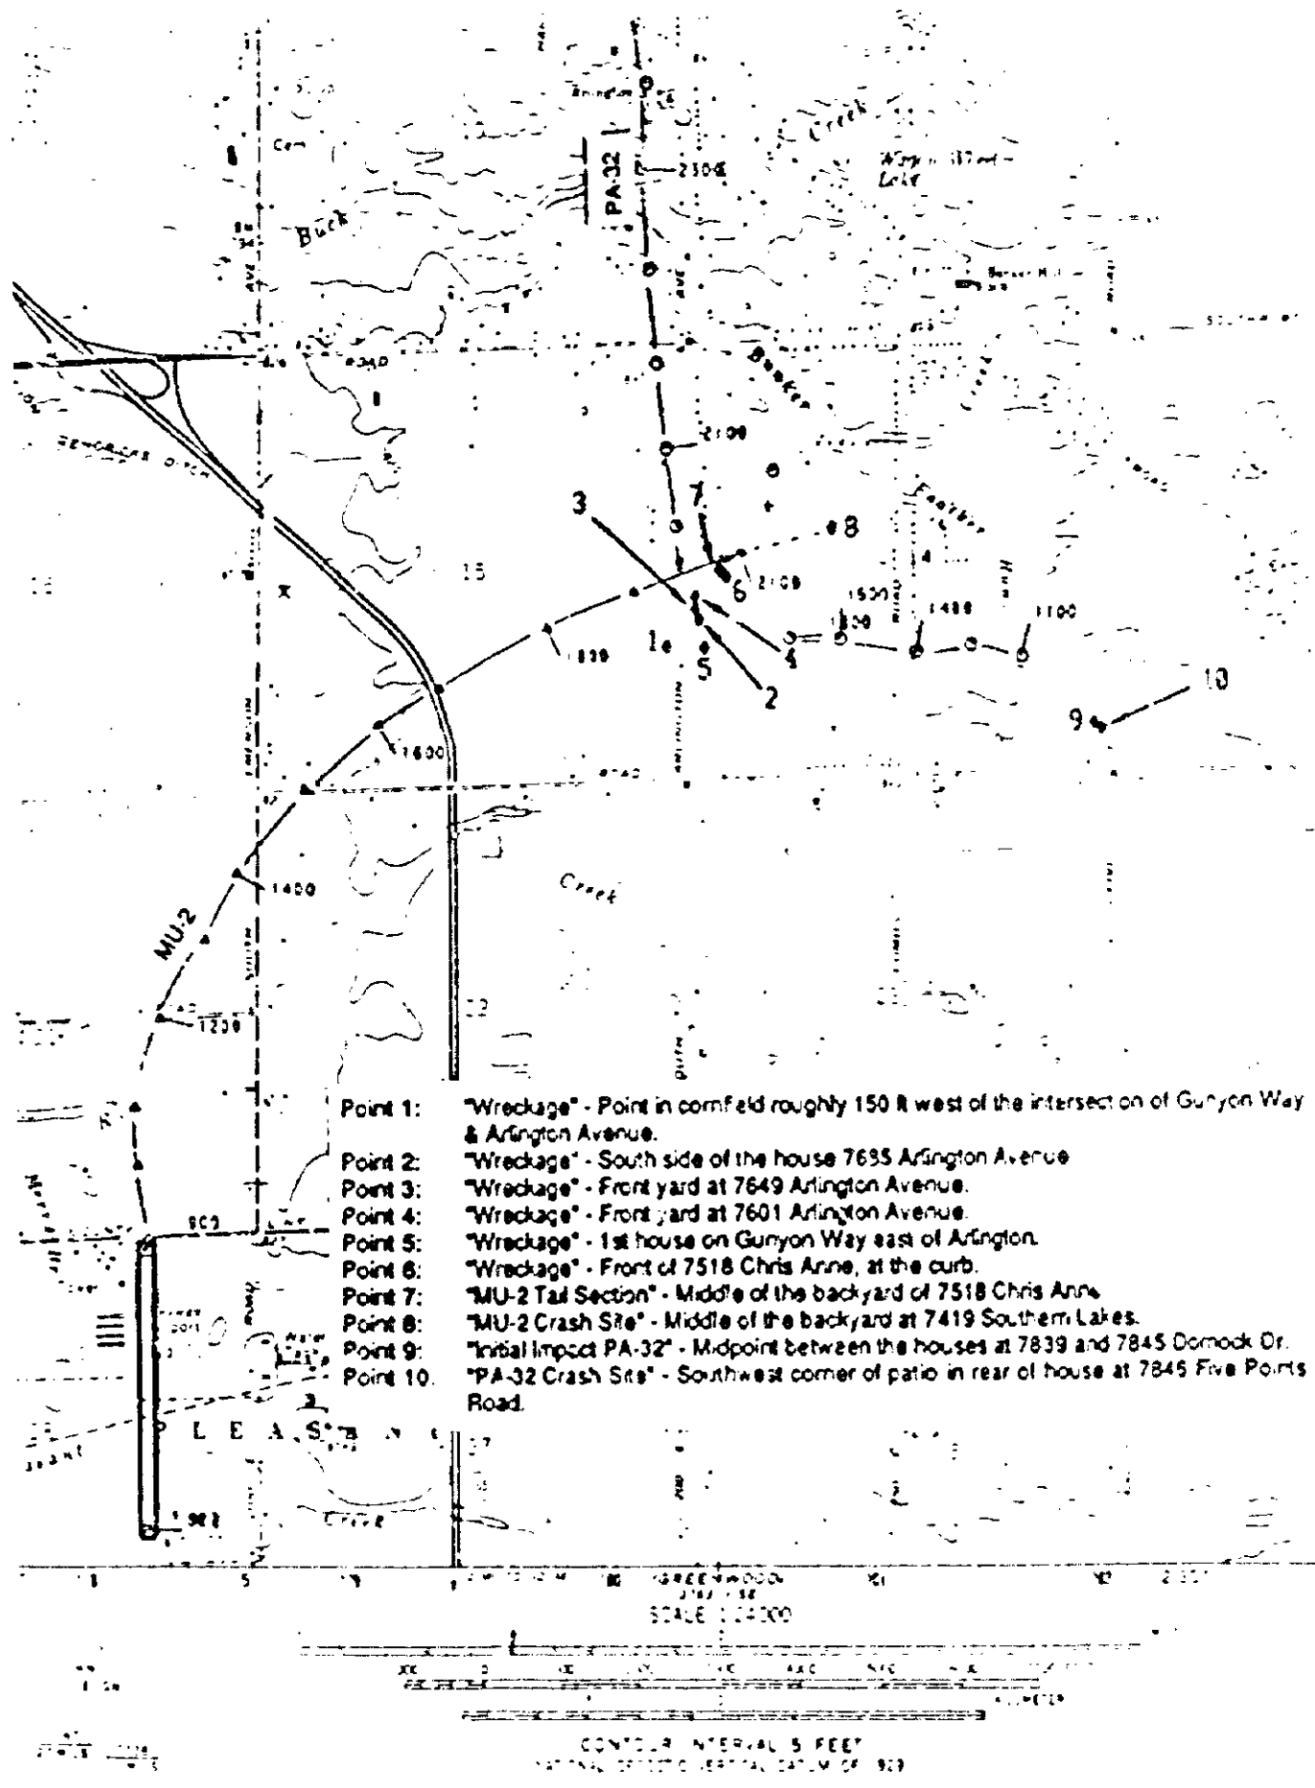
Figure 1.--Wreckage plot.

rest in a residential area about 2 miles northeast of the Greenwood Municipal Airport. The five occupants of the MU-2 were killed. The pilot of the PA-32 was killed, and the other two occupants were seriously injured. Pieces of the MU-2's left horizontal stabilizer and elevator were recovered during the search of a cornfield west of where the major portion of the MU-2's tail section came to rest. The fuselage came to rest inverted about 1/4 mile east of the tail, while the PA-32 came to rest upright in the back yard of a local resident about 1 mile east of the MU-2. (See figure 1).

Debris from the two airplanes was scattered over a rectangular residential area approximately 1/2 by 1 mile in Southern Marion County, Indiana. Three houses located on Southern Lakes Drive were damaged when the fuselage of the MU-2 came to rest in their back yards and caught fire. The PA-32 struck the roofs of two houses on Dornock Drive causing minor damage. The airplane touched down in the back yard of one of those houses, and its left wing struck and destroyed a children's playhouse. The impact separated the outboard 4 feet of the left wing

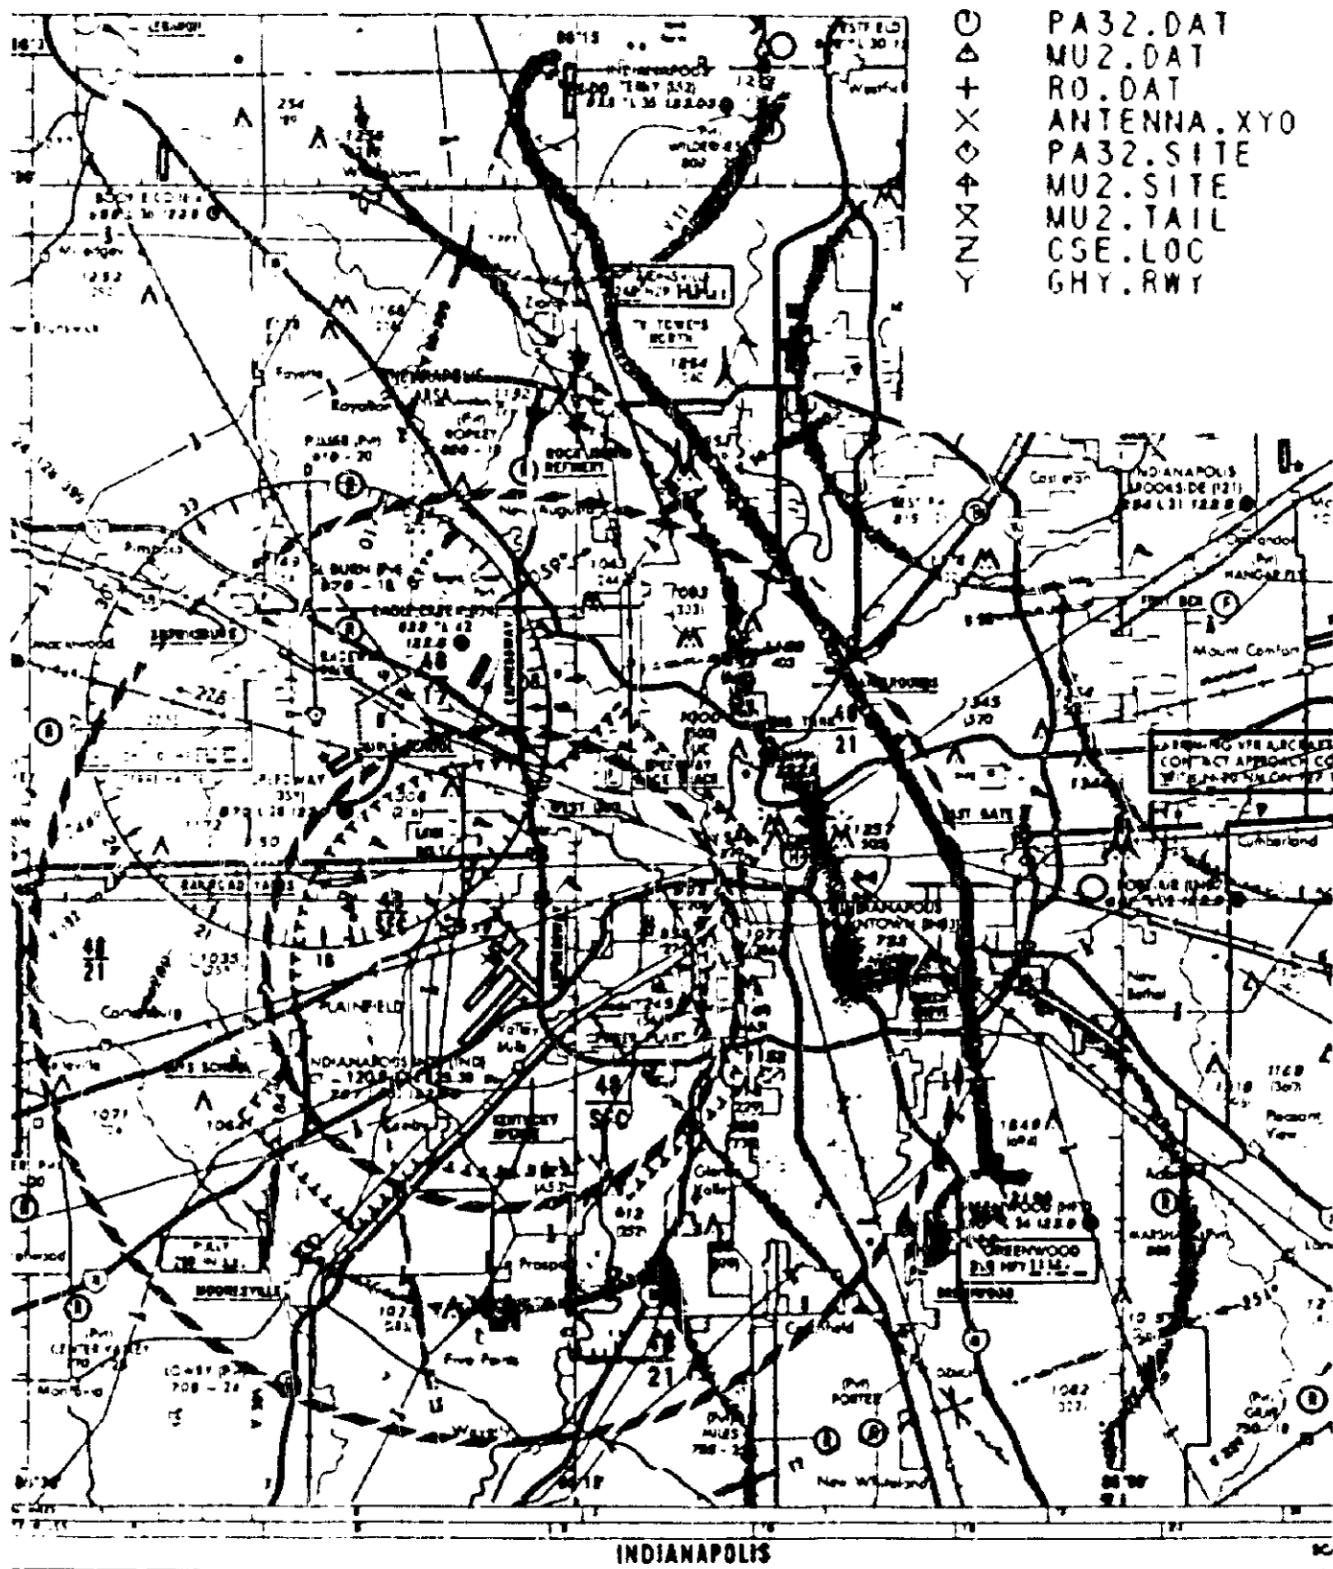
Figure 3.--Recorded radar ground track plots.

The airplanes collided about 1457 at an altitude of 2,100 feet (see figure 3 for plots of the radar data for both airplanes). The pilot-passenger on the PA-32 took control of the airplane and was able to make a controlled landing before the airplane struck ground obstacles, including three houses. Both airplanes came to

Recorded radar data indicated that at 1444:51 an airplane associated with a "1200" beacon code, assumed to be the PA-32, was directly north of Terry Airport at an altitude of 1600 feet. At 1445:33, the radar target, assumed to be the PA-32, switched to a beacon code of "0301" and continued to track to the south. At 1456:04, a "1200" beacon code target, assumed to be the MU-2, was observed approximately over Greenwood Municipal Airport at 900 feet heading northeast. At 1456:08, the radar data indicated that the PA-32 switched beacon codes to "1200" and continued to track to the south at an altitude of 2,500 feet. At 1456:51, recorded radar data indicated a beacon target report of "4564," assumed to be the MU-2, at 1,900 feet northeast of the airport. At 1456:55.47, one "4564" (last recorded radar return) and one "1200" beacon target report were recorded in close proximity to each other at an altitude of 2,100 feet, 11.4 nautical miles southeast of Indianapolis International Airport, and 2 miles northeast of the Greenwood Airport.
