AIRCRAFT ACCIDENT REPORT

**RUNWAY DEPARTURE DURING ATTEMPTED TAKEOFF
TOWER AIR FLIGHT 41
BOEING 747-136, N605FF
JFK INTERNATIONAL AIRPORT, NEW YORK
DECEMBER 20,1995**

**Adopted: December 2, 1996
Notation 6671A**

Abstract: This report explains the runway departure during attempted takeoff of Tower Air flight 41, N605FF, a Boeing 747-136 at John F. Kennedy International Airport, New York, on December 20, 1995. The safety issues discussed in this report include the adequacy of Boeing and air carrier procedures for B-747 operations on slippery runways; adequacy of flight simulators for training B-747 pilots in slippery runway operations; security of galley equipment installed on transport category aircraft; role of communications among flight attendants and between the cabin crew and the flightcrew; adequacy of Tower Air galley security training; compliance of Tower Air's maintenance department with its established procedures; failure of the FDR system to function during the accident; adequacy of the Tower Air operational management structure; adequacy of FAA surveillance and workload imposed on POIs; adequacy of runway friction measurement requirements, including correlation of run

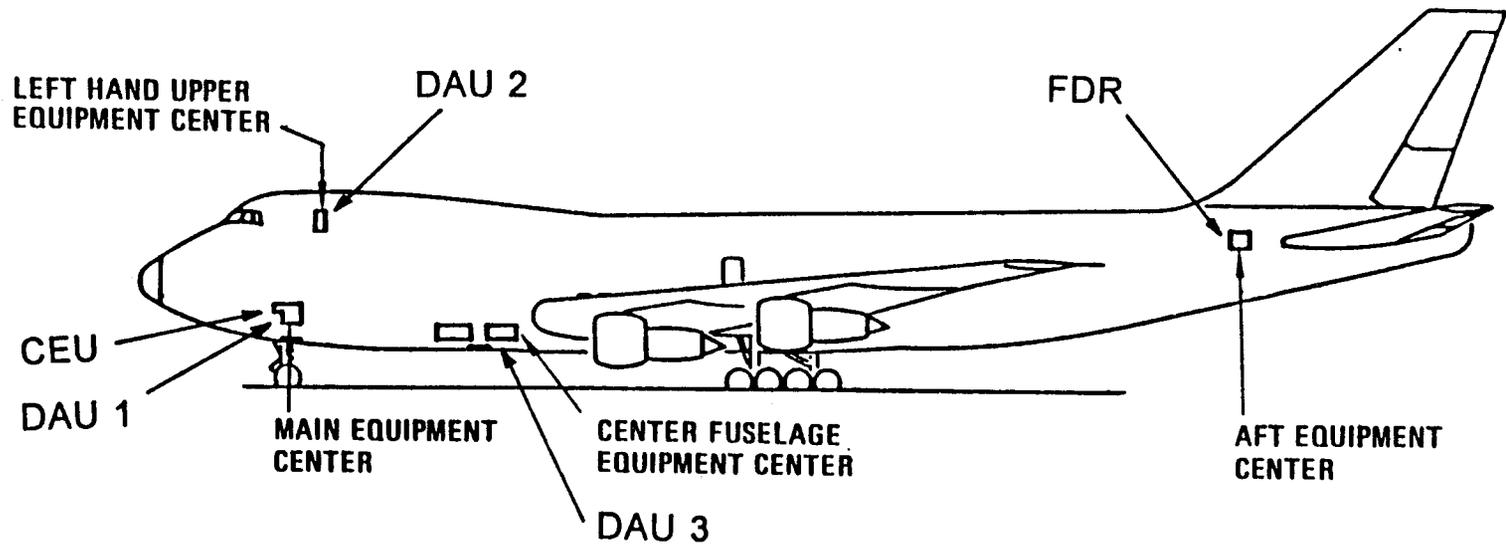
Figure 1—FDR Component Location

The aircraft was equipped with Sundstrand 573 FDR S/N 2152. The FDR was received at the Safety Board laboratory in good condition, with no signs of external or internal damage. However, the readout revealed that all parameters recorded by the FDR, except time and synchronization, lacked orderliness and reflected random values not resembling any type of flight operation. The FDR data were also transcribed at the TWA facility in St. Louis, Missouri, where the system was initially installed, but the data transcription yielded the same results. Finally, the data were provided to a private contractor, who also concluded that no meaningful data were on the tape.

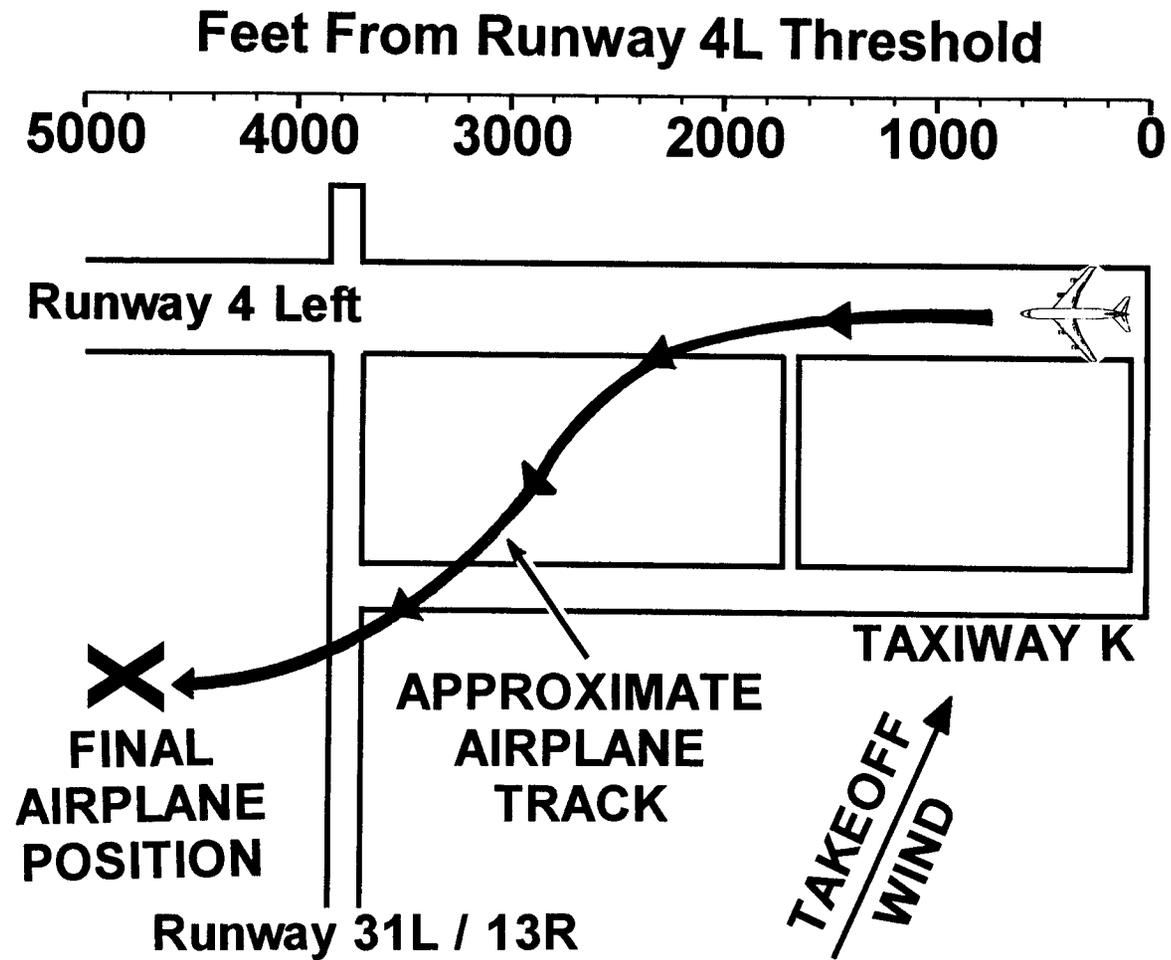
Figure 2—Airplane's Location After Skid

The first marks on the runway attributed to N605FF consisted of four pairs of black marks located approximately 2,000 feet from the threshold of runway 4L, and centered approximately 40 feet left of the runway centerline (see figure 2). The four pairs of tire marks were consistent with the tires of the airplane left main wing landing gear (LMWLG), left body landing gear (LBLG), right body landing gear (RBLG), and right main wing landing gear (RMWLG). The tire marks on the runway were continuous, and each mark was approximately 8 inches wide. No tire marks were found from the nose landing gear either on the runway or on the ground.

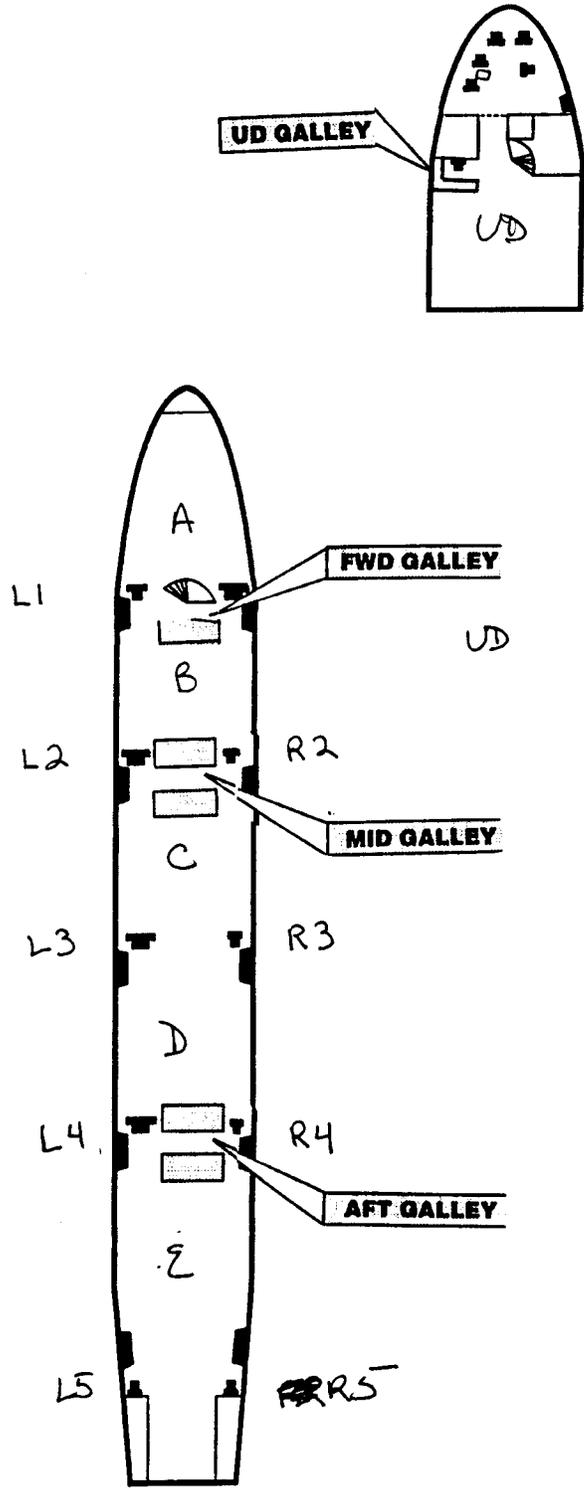
Figure 3—Cabin Layout

The cabin floor sustained substantial damage in Zone A. The floor was displaced upward approximately 2 feet in the center of the cabin at seat rows 6, 7, and 8. At least three of the four attach points for each of the seats in this area remained secured to the seat tracks, and no injuries were reported in this area.

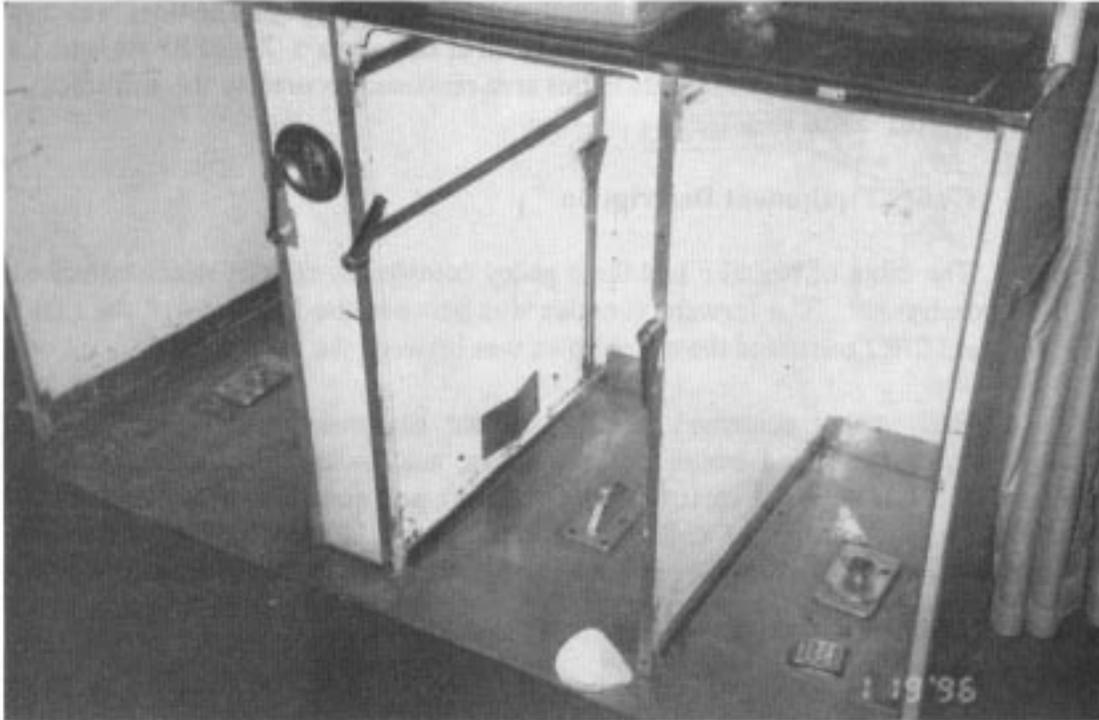
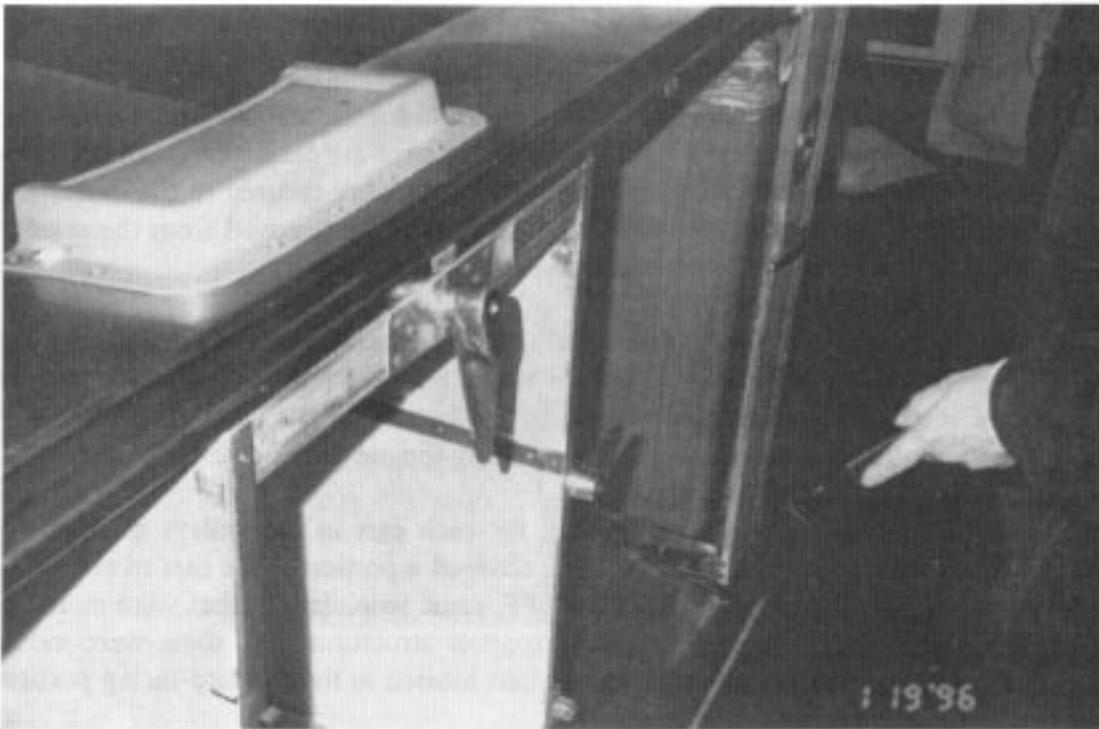
Figure 4—Galley Cart Primary and Secondary Securing Mechanisms

In contrast to the "mushroom" locking mechanism used to secure meal and beverage carts, the ice cart in each galley area of N605FF locked onto a retaining tongue mounted on the floor of the galley with a lever located on the bottom of the cart. The lever movement inserted a pin through a circular opening in the retaining tongue (see figure 4).

The L4 flight attendant stated that when the aircraft stopped abruptly, the overhead bins in Zone E opened, and luggage spilled “all over the place.” After the airplane stopped, the L4 attendant noted that the secondary latch for the ice cart on the forward-facing side of the aft galley was bent upward.
