Auxiliary Power Unit Battery Fire
Japan Airlines Boeing 787-8, JA829J
Boston, Massachusetts
January 7, 2013

Incident Report

NTSB/AIR-14/01
PB2014-108867

**National
Transportation
Safety Board**

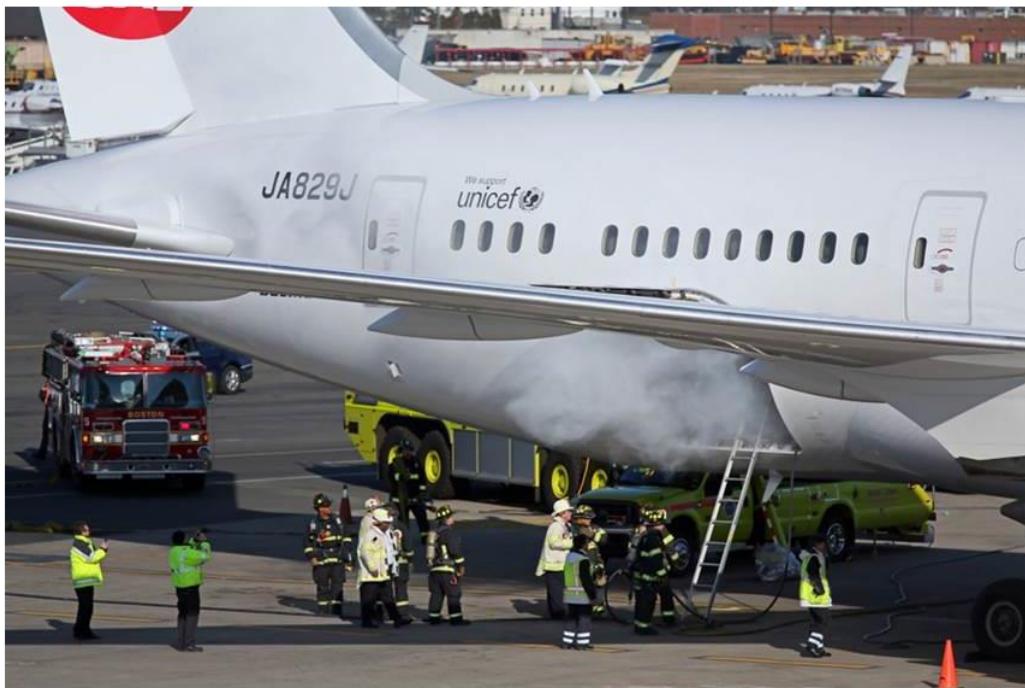
still present but was less intense than before. The airport security camera video showed smoke coming out of the airplane, as shown in figure 1, at 1040:26.

Figure 1. Photograph of smoke emanating from the incident airplane's aft E/E bay.

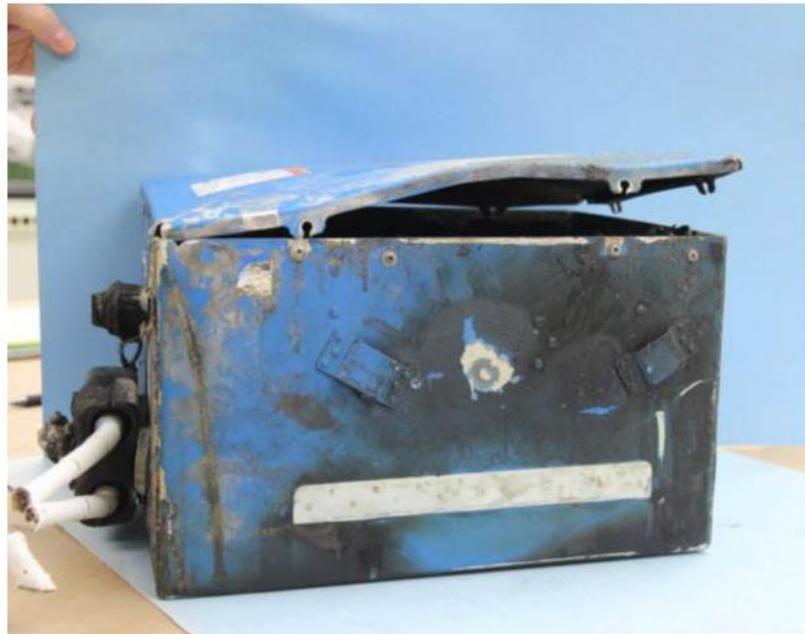
The lid on the battery case was bulged and creased. The right aft lid corner (as viewed from the front of the battery case) exhibited more soot, charring, and residue than the rest of the lid and the most damage to the lid fastening points.³³ Figure 6 shows the bulged battery case lid and side 4 of the battery case.

Figure 6. Right aft corner of the battery lid and side 4 of the battery case.

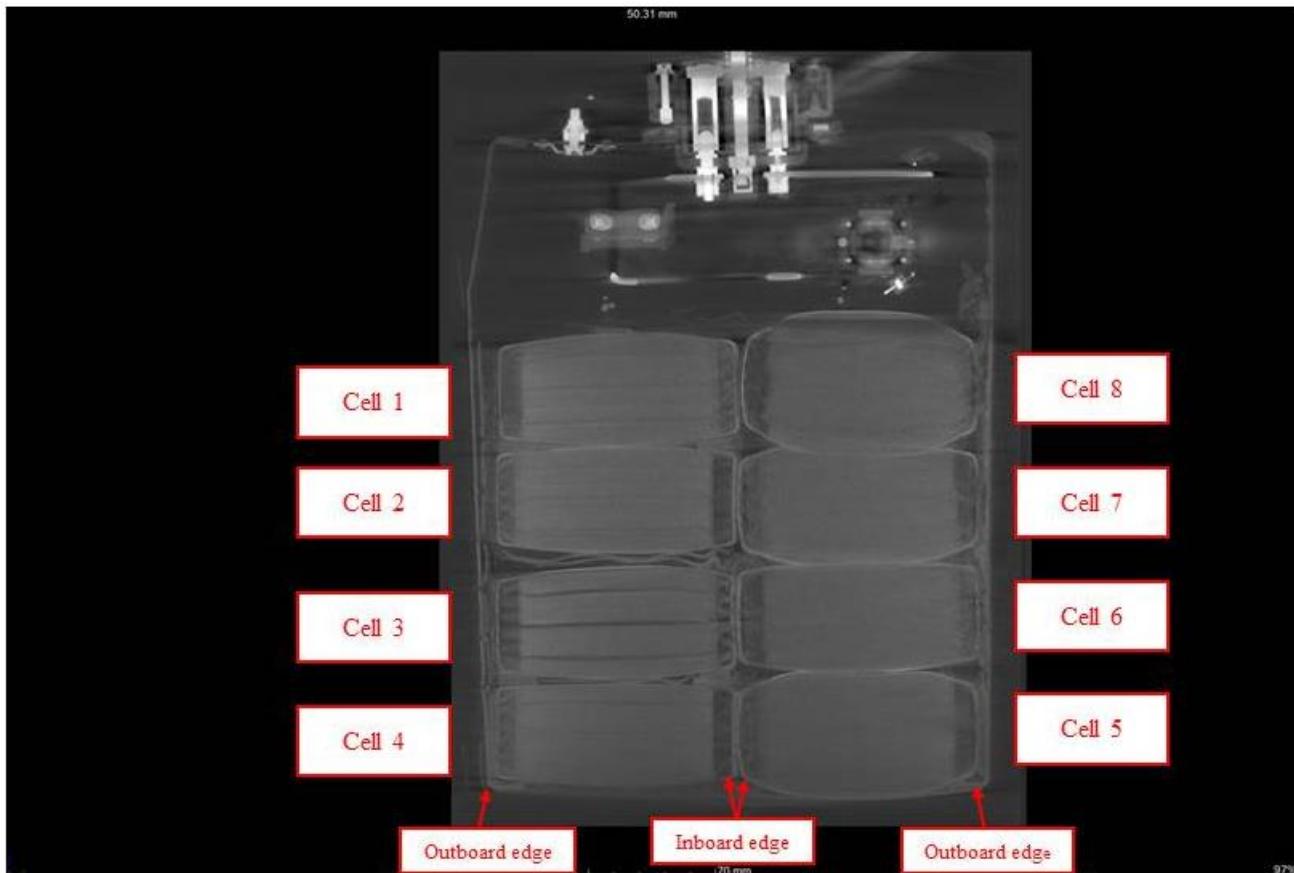
Figure 7. Cross-sectional view of the APU battery.

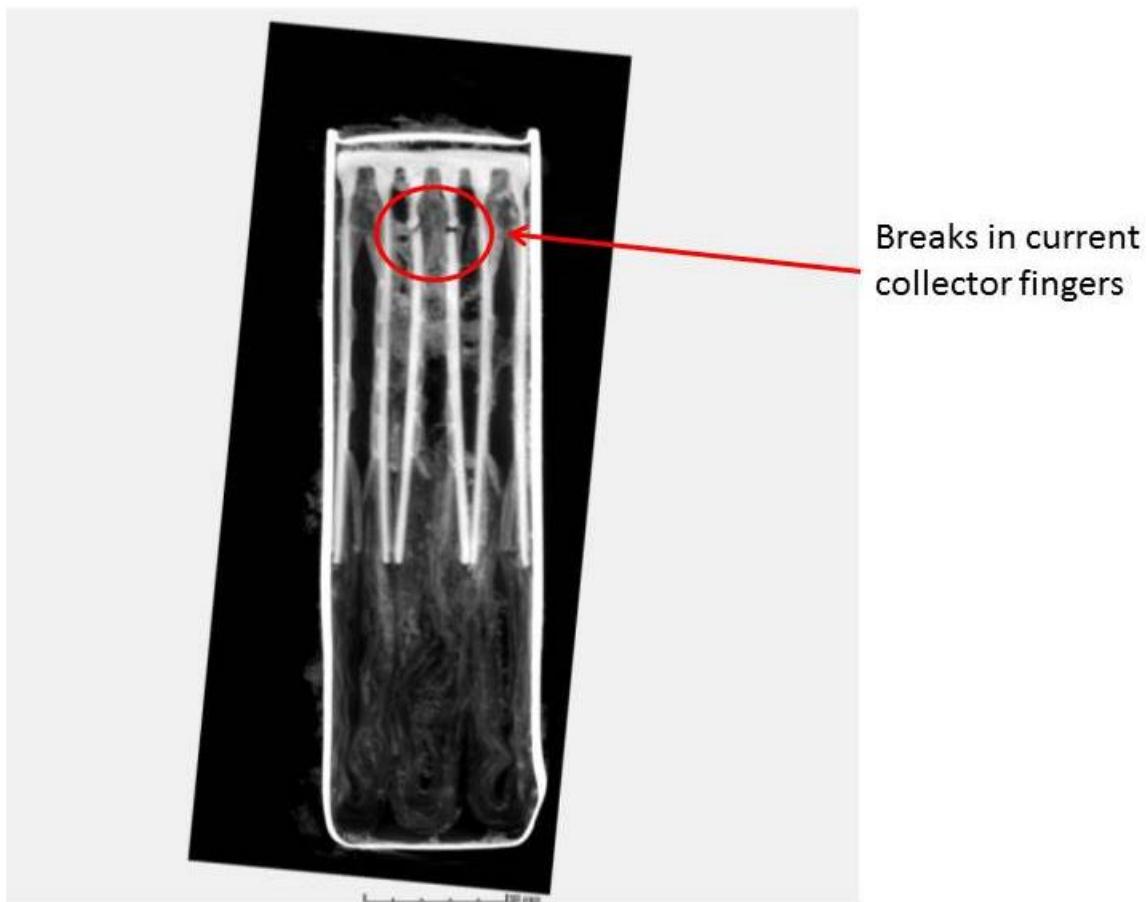
- Cell 5: Two cell wall breaches in separate locations were identified. The larger of the two breaches appeared to consist of separate smaller holes. The smaller breach appeared to consist of a single hole with some material missing from the outer cell wall around the hole. The areas inside the cell near the breaches differed from the general appearance of the cell. Also, two of the six aluminum (cathode) current collector fingers had breaks with rounded material on the ends. These breaks, as shown in figure 8, appeared as complete separations through the fingers. The current collector finger breaks occurred in the center winding. The other four aluminum current collectors and all of the copper (anode) current collectors were intact.

Figure 8. Cross-sectional view of cell 5 aluminum current collectors.

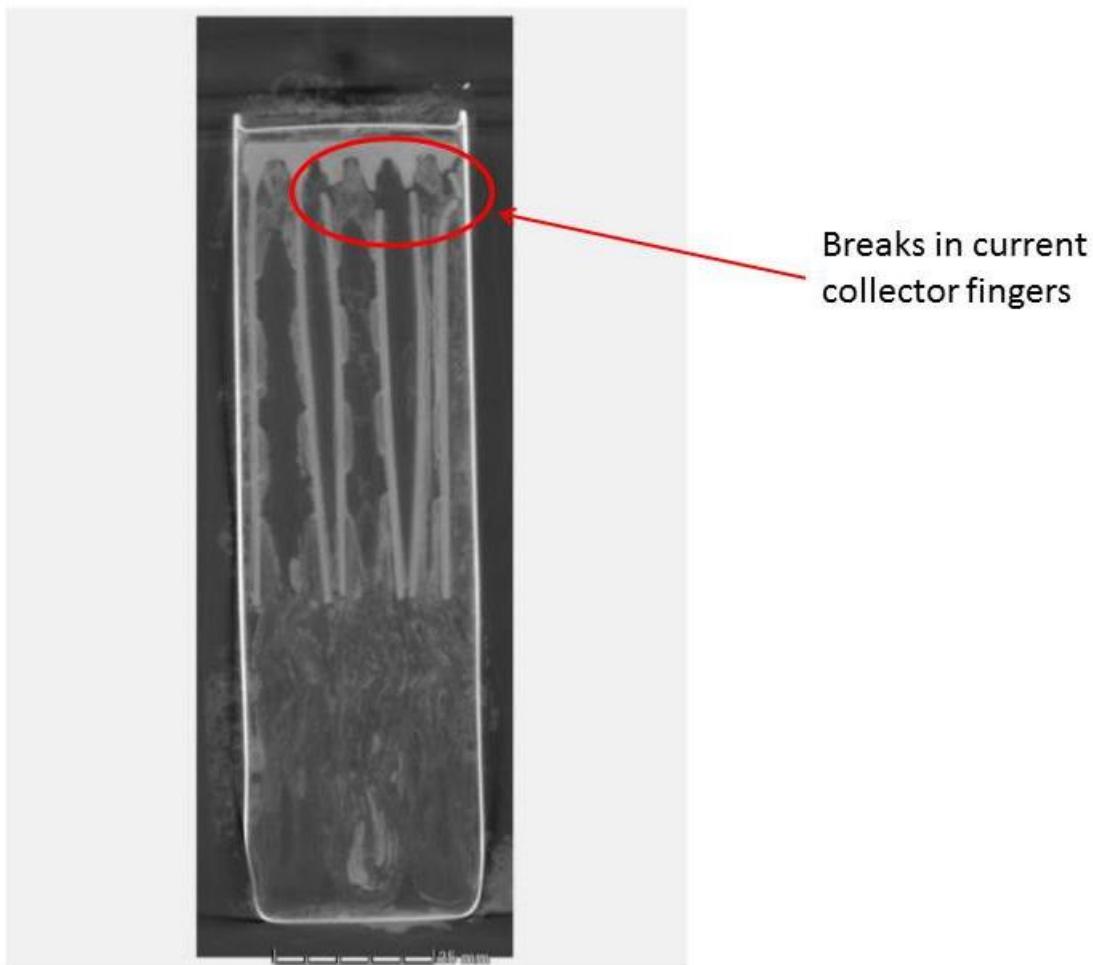
- Cell 6: Four of the six aluminum current collector fingers had breaks, as shown in figure 9, including one with breaks at multiple locations and another that was missing more material at the breakage location than the other current collector fingers with breaks. The current collector finger breaks occurred in the winding closest to cell 5 and the center winding. The other two aluminum current collectors and all of the copper current collectors were intact.
- Cell 7: Four of the six aluminum current collector fingers had breaks, including one with multiple breaks. All six current collector fingers appeared to be displaced from their original positions. The current collector finger breaks occurred in the winding closest to cell 6 and the center winding. The other two aluminum current collectors and all of the copper current collectors were intact.

Figure 9. Cross-sectional view of cell 6 aluminum current collectors.

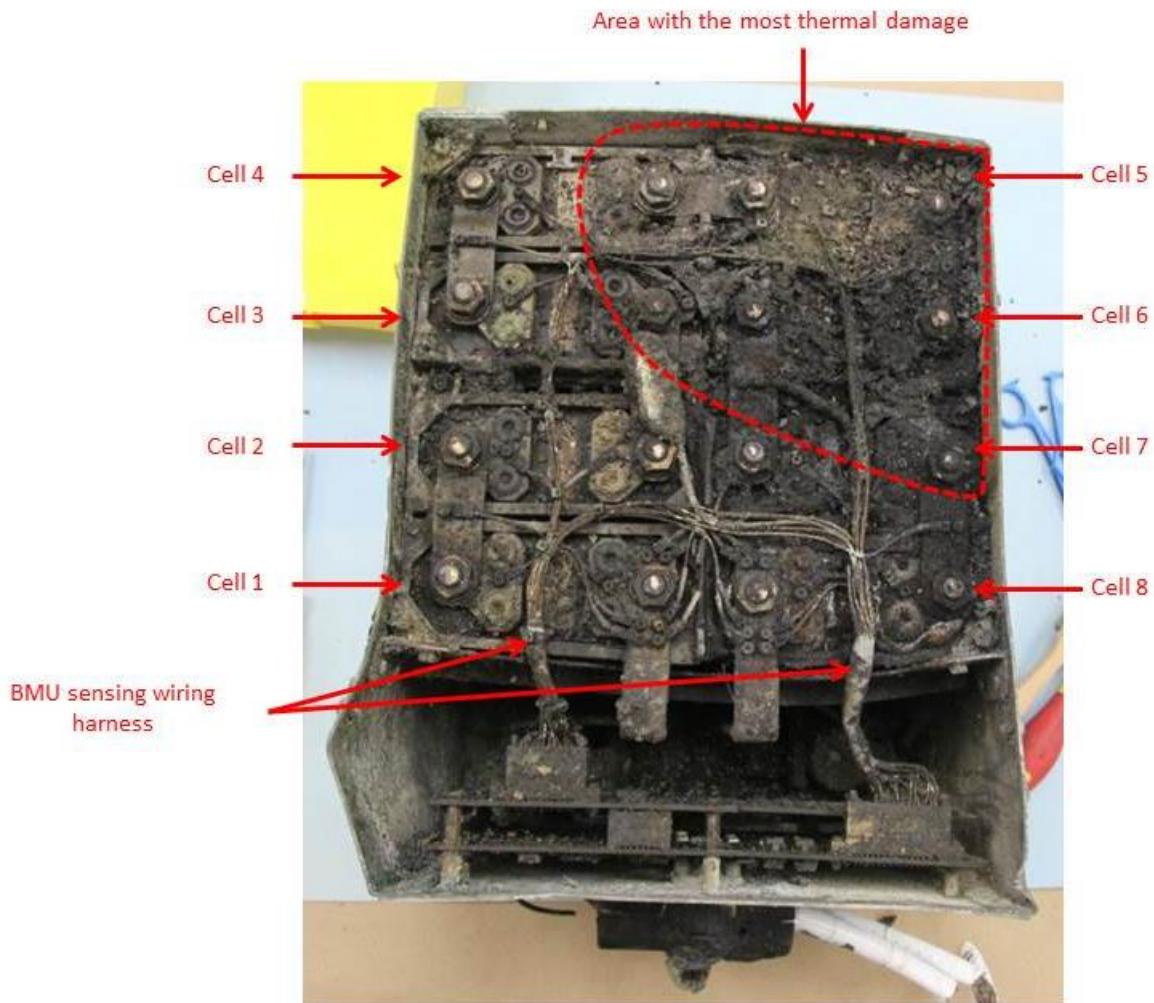
Figure 10. Thermal damage to battery.

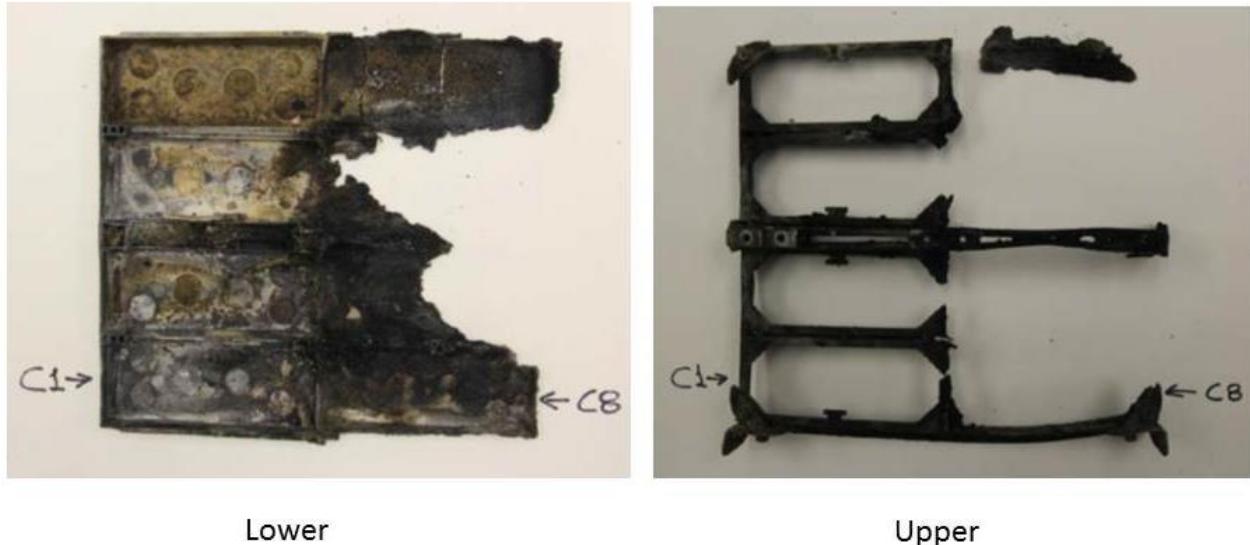
Debris and discoloration consistent with thermal damage were present on the cell 1 through 4 footprints on the lower fixation tray. The footprints of cells 5 through 8 were thermally decomposed, as shown in figure 11. Portions of the lower fixation tray under cells 5 and 6 could not be readily distinguished from other thermally damaged materials in the battery case. The portions of the upper fixation tray that contacted cells 1 through 4 sustained less damage than the portions that contacted cells 5 through 8. The cell 4 upper fixation tray imprint remained mostly intact, but the imprints for cells 1 through 3 showed progressively more damage. Minimal material remained from the portions of the upper fixation tray that contacted cells 5 through 8, which is also shown in figure 11.

Figure 11. Lower and upper fixation trays.

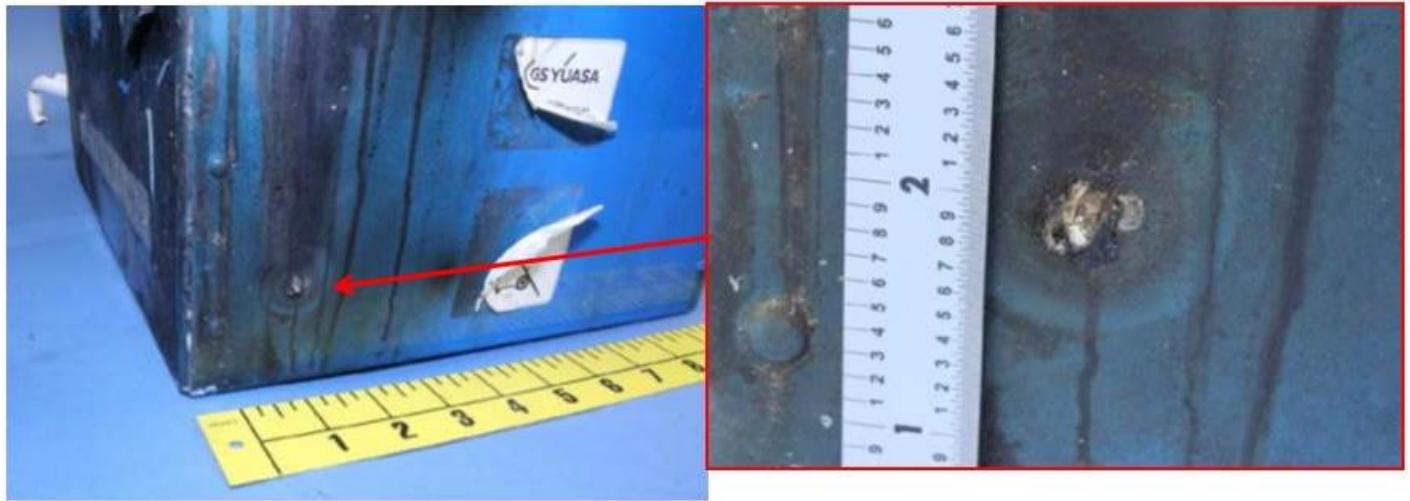
As stated in section 1.4.1, the battery case exhibited a 0.25-in-wide nodular protrusion on the lower left of side 3, as shown in figure 12. The protrusion extended about 0.12 in from the case. The protrusion appeared metallic and had no paint. Two concentric rings surrounding the protrusion corresponded with the discoloration of exterior paint. Deposits consistent with thermally degraded materials were observed on and near the protrusion. Three holes on the periphery of the protrusion were identified. The largest of these holes was elliptical in shape, with its longest dimension measuring 0.080 in. The two other holes, which were similar in size, measured about 0.004 in. Most of the interior side of the protrusion contained dull gray flaky material consistent with spatter, as well as shiny black material consistent with charred plastics and tars.

Figure 12. Protrusion on the lower left of battery case side 3.

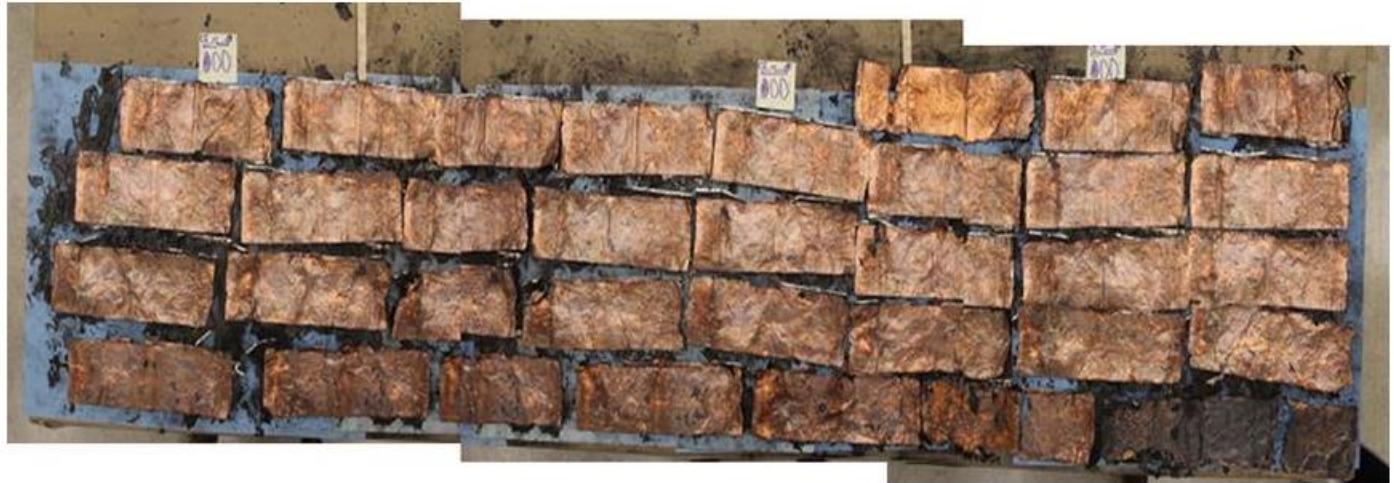
For the winding that was closest to battery case side 3, the copper foil was discolored at the header fold with small ripples. The copper foil also exhibited a band of darker color adjacent to the nodular protrusion, which was consistent with high heat exposure. This band of color propagated from the exterior to interior wraps of the winding. The center winding copper foil had ripples along the header fold. This winding appeared to have more overall damage than the other two windings. The winding closest to cell 6 showed the most fragmentation of the aluminum foil and the coated material. The first and second wraps of the winding had thermally adhered to the interior of the cell case, and portions of the first wrap had also thermally adhered to subsequent wraps of the winding. One of the innermost wraps showed folds in the copper foil on the side facing cell 6, which were present through several layers of the winding, as shown in figure 13. Other notable features found during the winding examination were the lack of any sizeable repeating rifts in the windings and the greater amount of damage to the exterior wraps of the windings compared with the interior wraps.

Figure 13. Cell 5 winding closest to cell 6.

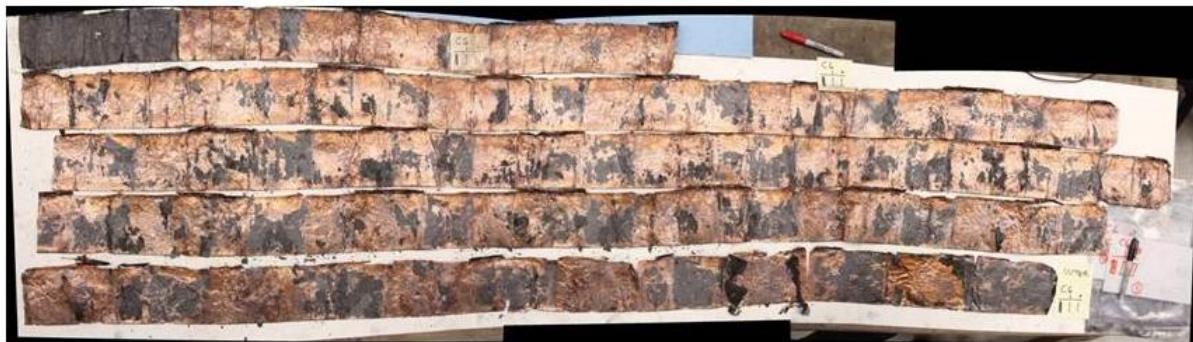
For all three windings, large portions of the active material coating for the copper foil had delaminated, exposing large areas of the foil. Pinholes and localized areas of thermal discoloration, which were consistent with localized hot spots, were observed near the edges of the copper foil. The winding closest to cell 5 showed areas of concentrated thermal discoloration that appeared in a repeating pattern on the copper foil, as shown in figure 14. One area of thermal discoloration began on multiple exterior wraps and became lighter toward the interior wraps. Another area of thermal discoloration began about midway through the wraps and continued all of the way to the interior wraps. This pattern of thermal discoloration, which was concentrated on the side of the foil closest to the copper current collectors, exhibited a radiating pattern of wrinkles. The center winding showed an area of thermal discoloration that began at one of the outermost wraps and continued into the winding. The winding closest to cell 7 showed a repeating area of thermal discoloration at one of the outermost wraps.

Figure 14. Cell 6 winding closest to cell 5.

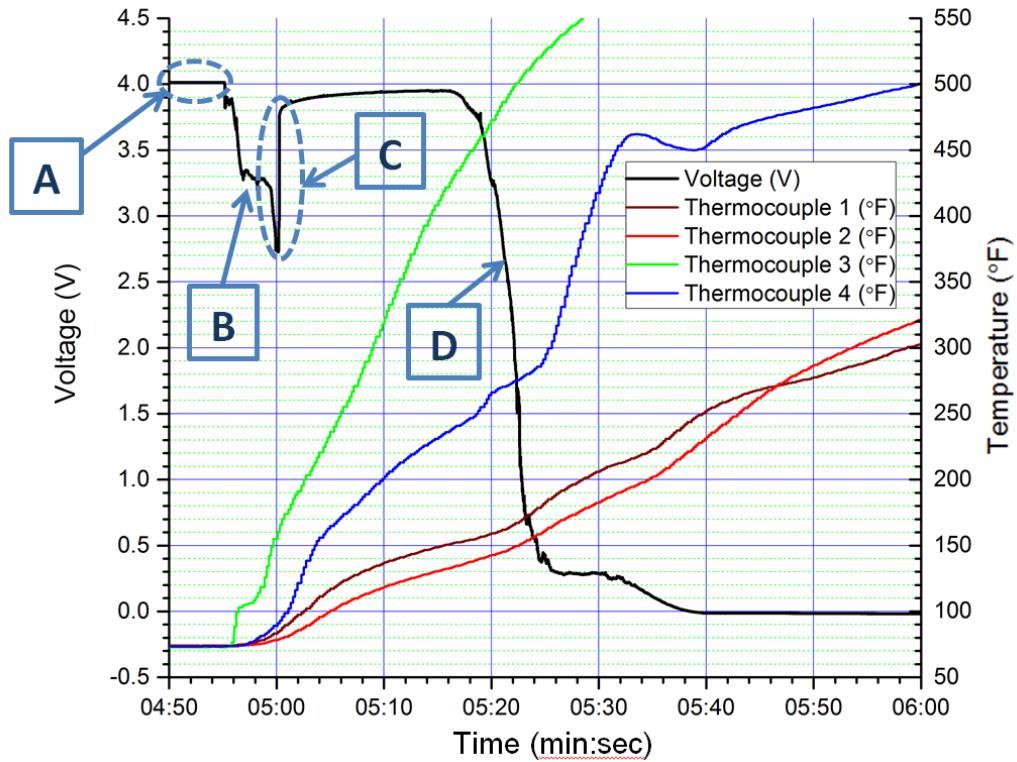
Figure 15. Results of cell-level internal short circuit abuse test.
