Aviation Investigation Report AIR-24-04

Collision with Powerlines and Terrain during Forced Landing

MARPAT Aviation

Bell Helicopter UH-1B, N98F

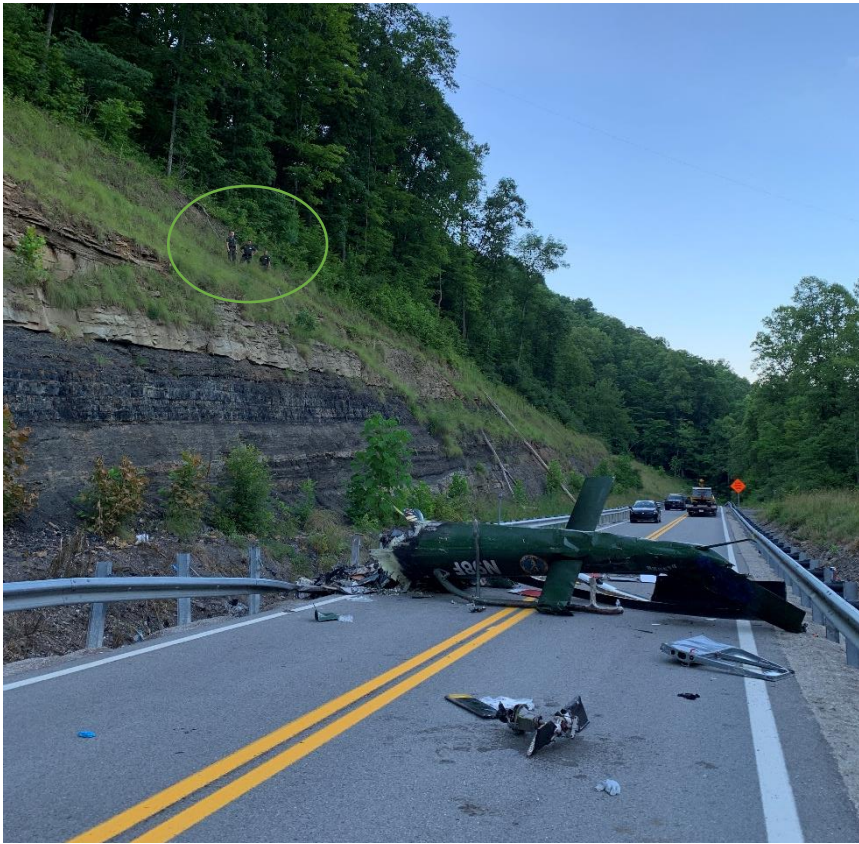
Figure 2. Accident scene.

The debris path spanned the 26-ft asphalt road and continued into a ditch at the base of the rock face. The main wreckage was located 542 ft beyond an intact utility cable, which was one of three cables that crossed the road at a height of 180 ft.¹⁵ The other two utility cables were located 220 and 397 ft from the intact utility cable, and both were found severed. All major components of the helicopter were located near the accident site.

Examination of the wreckage revealed that the cockpit and cabin had impacted the road and a guardrail and that the cockpit and cabin were consumed by the postcrash fire. The empennage, which comprised the tailboom, vertical fin, and horizontal stabilizer, remained attached to the aft fuselage. Additional wreckage, including pieces of plexiglass, the aft cap of the left skid, and a section of a tail rotor blade, was found about 40 ft above the main wreckage on a ledge of the rock face. A rock with green paint transfer was also located there. Figure 2 shows the accident scene.

Note: The circle denotes the area where the NTSB found pieces of plexiglass, the aft cap of the left skid, a tail rotor blade segment, and green paint transfer onto a rock.

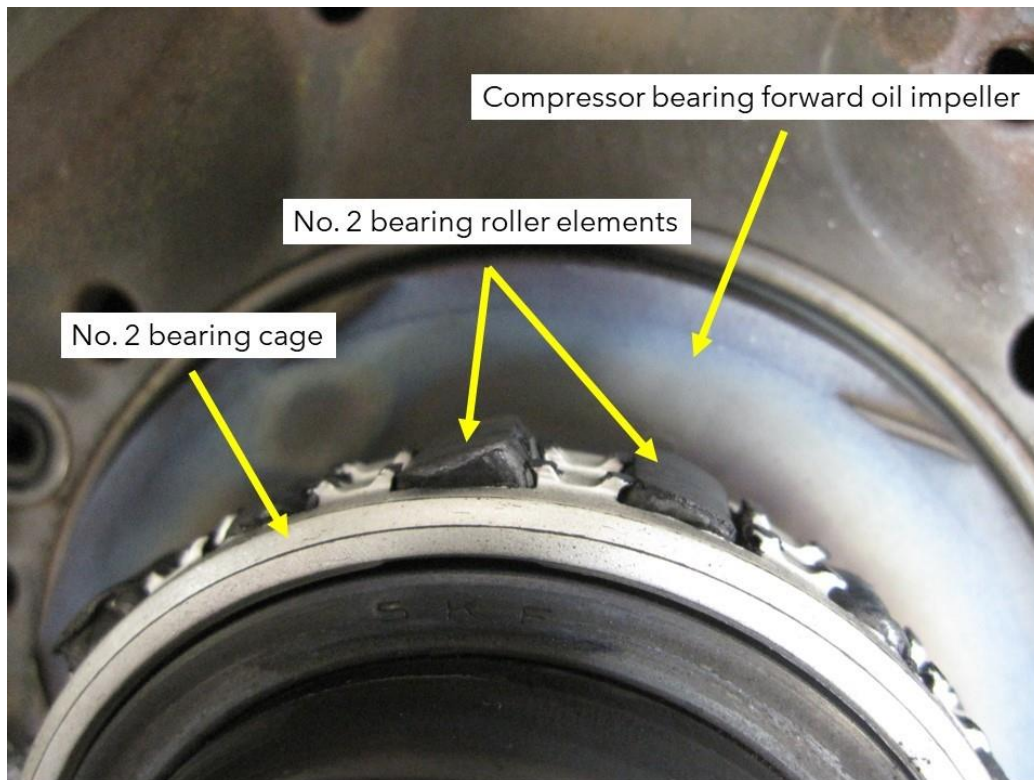
Figure 3. Close-up view of No. 2 bearing roller elements.

The No. 2 bearing, which supported (radially) the aft end of the compressor shaft of the gas-producer turbine, was found with its roller elements flattened and thermally distressed, as shown in figure 3. The outer race exhibited considerable material transfer, and the cage was in good condition with its silver plating still visible and no evidence of damage or thermal distress. Significant thermal distress and evidence of bulging and distortion were observed on the aft compressor shaft. Widespread thermal distress and material transfer were observed in the area of the No. 2 bearing. The NTSB Materials Laboratory analyzed the No. 2 bearing and determined that the observed heat damage and material transfer were consistent with skidding of the bearing rollers.

The No. 2 bearing compartment was dry with no evidence of oil; the oil jets on the No. 2 bearing retaining plate, which provided lubrication to the No. 2 bearing, were clear and unobstructed. The No. 2 bearing scavenge tube had black ferrous debris; the oil pressure supply tube was clear. Low-pressure brake cleaning fluid was used to test whether the oil supply and scavenge tubes were obstructed. The fluid flowed freely through the supply tube with no material debris collected, but no fluid flowed from the scavenge tube, indicating an obstruction. Material deposits from the scavenge tube were analyzed by the NTSB Materials Laboratory using energy dispersive x-ray spectroscopy. The analysis determined that the deposits were consistent with the material composition of the No. 2 bearing roller elements.

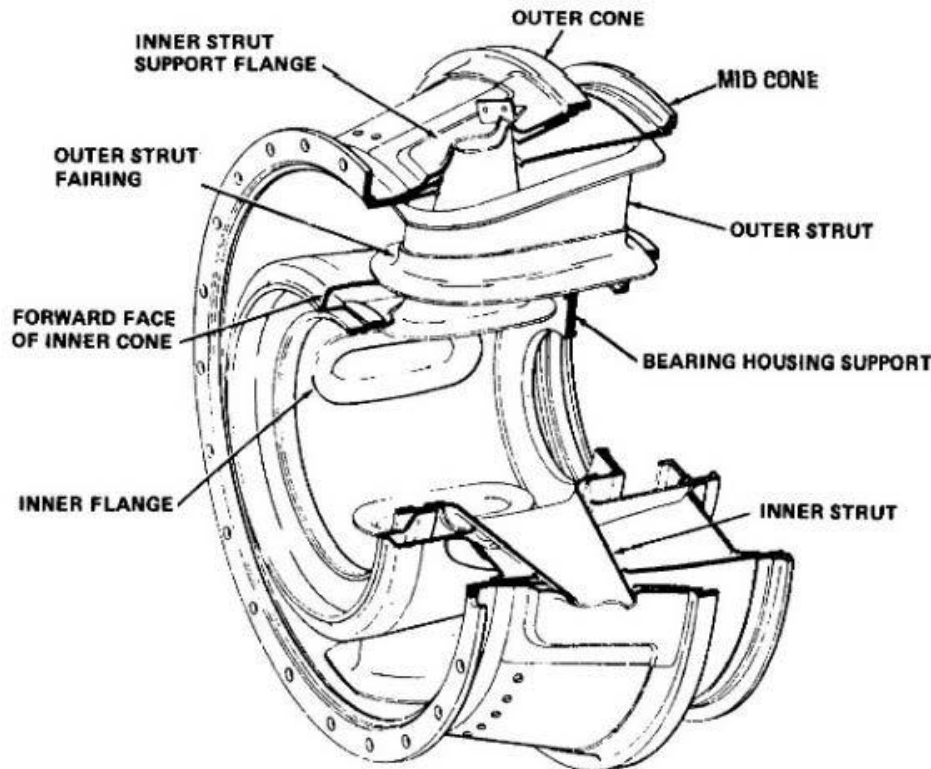
Figure 4. Exhaust diffuser diagram (Source: Ozark Aeroworks).

The power turbine exhibited circumferential rub marks on the blade roots and the wheel at the blade slots on the aft side of the turbine disk, which were consistent with rotational contact with the forward face on the inner cone of the exhaust diffuser assembly; a diagram of the assembly is shown in figure 4.

The exhaust diffuser exhibited multiple cracks around each outer cone inner strut support flange.¹⁶ The support flange for the inner strut at the 6:00 position was fractured around the perimeter of the strut, separating the inner strut from the outer cone. The inner strut at the 12:00 position had separated from the bearing housing support and exhibited extensive rubbing damage, which was consistent with the inner strut separating at some point before the accident and operating in that condition for a considerable amount of time.

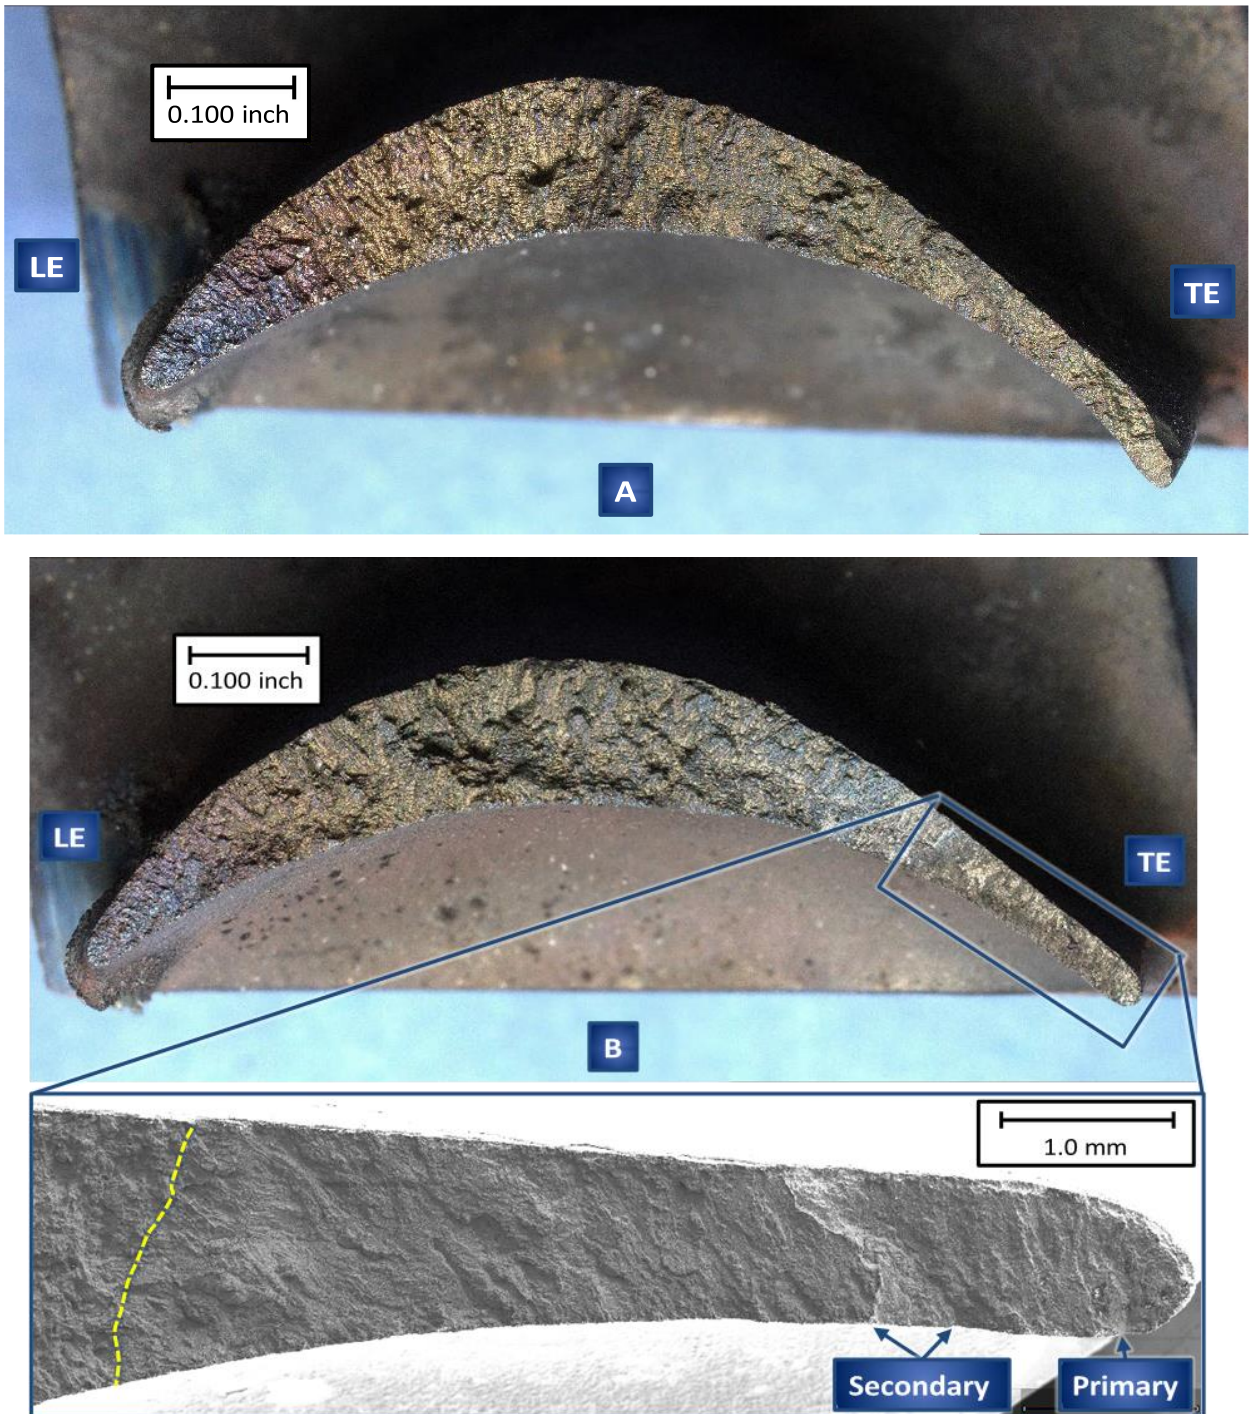
Figure 5. Power turbine blade fracture surfaces (top and center images) and blade trailing edge showing fatigue origin areas (bottom image).

The NTSB Materials Laboratory analyzed the two fractured power turbine blades, which are shown in figure 5, and determined that one blade exhibited heat tinting from rub damage at the leading edge and features consistent with overstress. The other blade exhibited similar heat tinting at the leading edge, similar fracture features across most of the fracture, and fatigue in a small area of the blade trailing edge. Examination of the fatigue origin area using a scanning electron microscope found no evidence of any anomalies or pre-existing damage associated with fatigue crack origins.

Note: The blades were arbitrarily labeled "A" (top image) and "B" (center image). The yellow dashed line (bottom image) shows the fatigue boundary. LE, leading edge; TE, trailing edge.

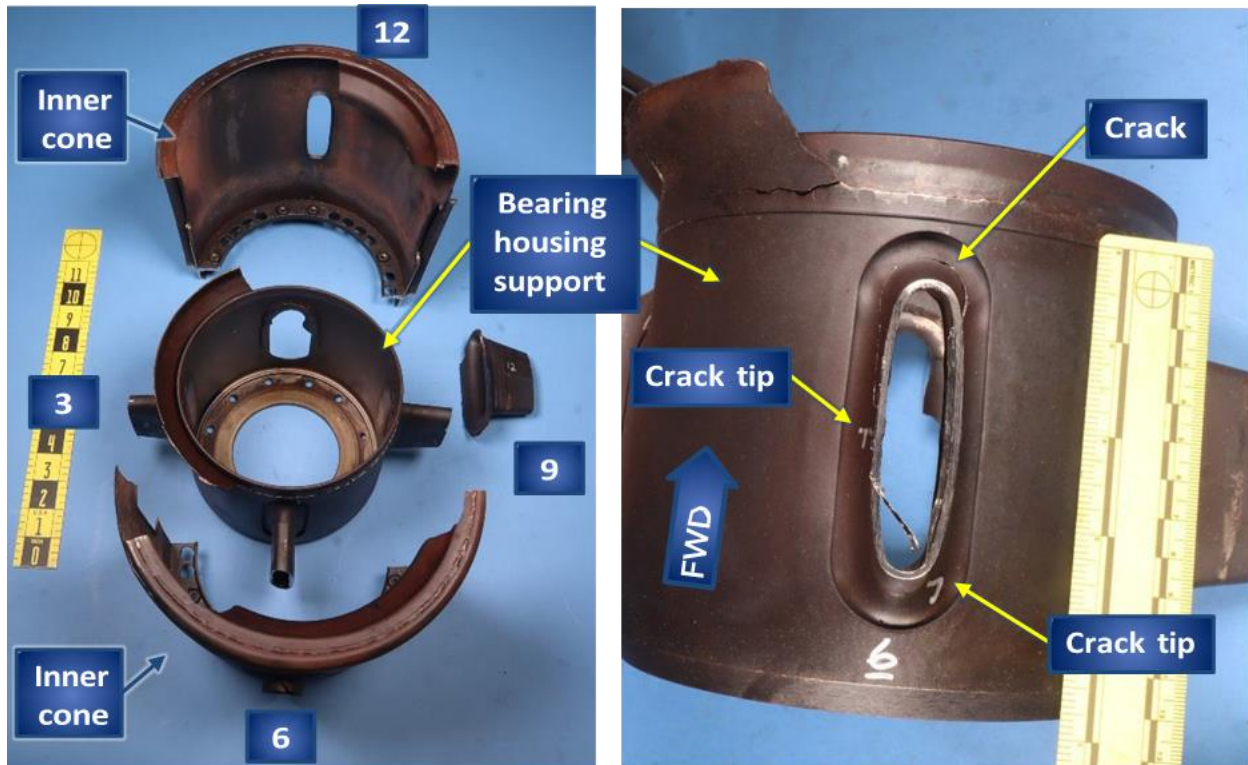
Figure 6. Bearing housing support and inner struts.

The NTSB Materials Laboratory's examination of the exhaust diffuser (after the inner cone was separated from the support) found that the four inner strut inner flanges that connected to the No. 3 and No. 4 bearing housing support were fractured or cracked in the radius where the inner flange transitioned to the inner strut, as shown in figure 6.

The cracks around the outer cone inner strut support flanges showed fatigue features from multiple origins; the cracks also had a relatively uniform straw-colored oxide tint, which was consistent with exposure to hot exhaust gases before the accident. The spot weld seam, which connected the forward face of the inner cone to the bearing housing support, was cracked and separated around two-thirds of its circumference. The fracture surface had relatively smooth fatigue features emanating from several individual spot welds, and the fatigue regions had oxides that were dark gray to black in color and extended nearly or completely through the inner cone wall thickness in multiple areas, which was consistent with relatively slower fatigue crack growth in these areas with exposure to hot exhaust gases before the accident.

We recommended that the FAA require operators of aircraft equipped with the accident engine model to perform recurrent inspections of the rear bearing cover and the exhaust diffuser inner cone and inner struts with the exhaust diffuser cover removed.

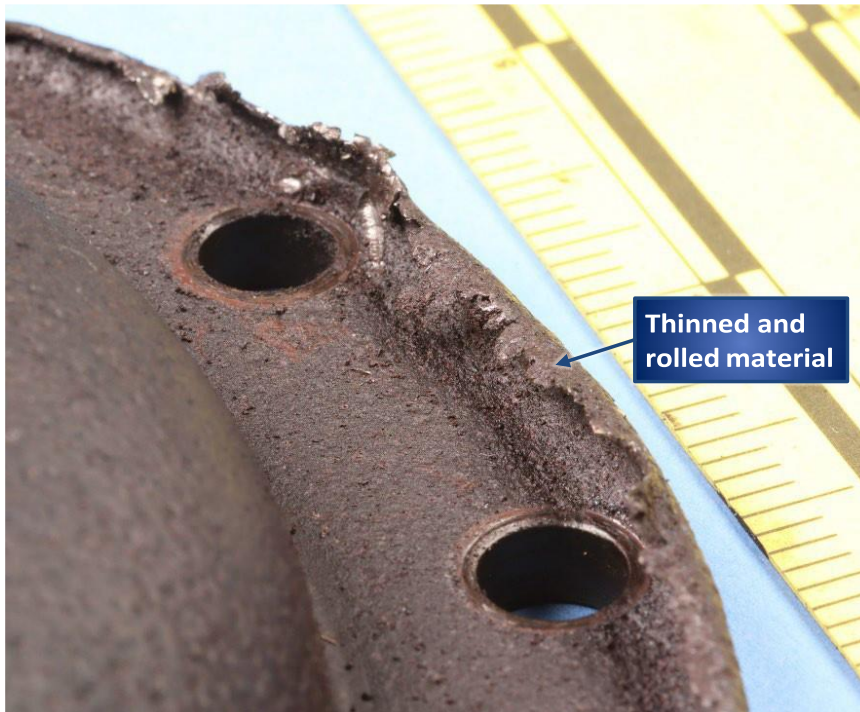
Figure 7. Outer flange separation surface at the outside diameter of the rear bearing cover.

Nos. 3 and 4. The bearing housing rear cover had separated circumferentially through the outer flange just aft of the front attachment plate. The separated outer flange piece was loose and resting in the bearing housing bore and against the exhaust diffuser cover, and the forward piece remained attached to the aft end of the bearing housing support on the exhaust diffuser. The interior surface of a rolled piece of outer flange material adjacent to the plane of separation was rough and oxidized due to corrosion. The Materials Laboratory found that the outer flange had separated due to wall thinning resulting from the corrosion, as shown in figure 7.
