Safety Recommendation Report

Preventing Windshield Arcing, Smoke, and Fire on Bombardier DHC-8 Airplanes

Accident Number:	ENG15IA024
Operator/Flight Number:	United Express flight 4776 (operated by CommutAir)
Aircraft and Registration:	Bombardier DHC-8-202, N363PH
Location:	Windsor Locks, Connecticut
Date:	June 5, 2015
Adopted:	March 11, 2016

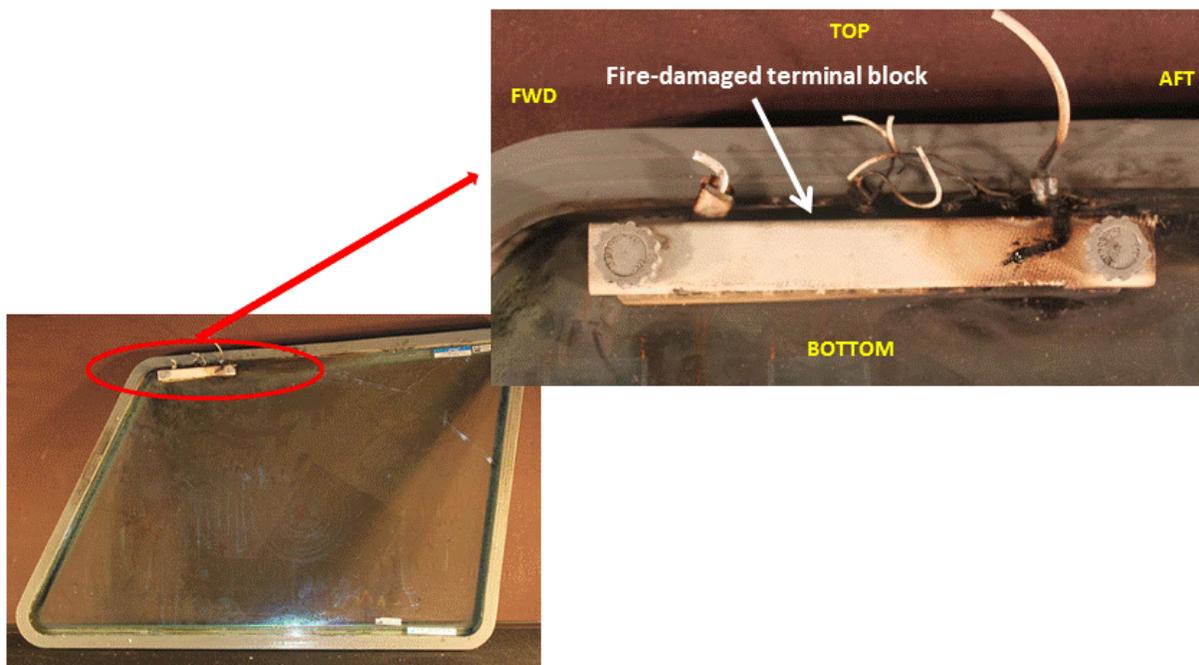
Although postincident examination of the windshield found typical signs of aging (described in more detail below) with evidence of moisture ingress into the laminate around the edges of the windshield, the discrepancies were within the manufacturer’s published limits and did not contribute to the failure.² The fire damage was concentrated in an area between the upper edge of the terminal block and the lower edge of the windshield gasket where the power wire was routed (see figure). The power wire was melted through in this area but remained soldered to the terminal block, indicating an arcing failure of the power wire. The damage to the power wire precluded investigators from determining whether it was damaged before the incident.

Figure. Photographs showing the damaged windshield and inset of the fire-damaged terminal block.

Postincident examination of the airplane found that the windshield heat switch was in the normal (NORM) position, which would continue to provide power to the windshield heating system. Switching the windshield heat selector to off would have cut power to the circuit, eliminating the arcing and fire. As discussed below, at the time of the incident, neither CommutAir nor Bombardier had flight crew checklists, guidance, or training addressing what to do in the event of windshield arcing, smoke, fire, or overheating. The NTSB determined that the probable cause of the fire was “the arcing failure of the windshield heat power wire on the right windshield due to unknown reasons. Contributing to the severity of the fire was the lack of

Redesign the windshield heat power connection for all Bombardier DHC-8 airplanes to provide a mechanically secure, low-resistance electrical connection. (A-16-3)

Add an emergency procedure checklist and revise training materials for all Bombardier DHC-8 airplanes that specifically instruct flight crews, as a memory item, to immediately turn off windshield heat in the event of windshield arcing, smoke, fire, or overheating. (A-16-4)
