National Transportation Safety Board
Washington, D.C. 20594

Safety Recommendation Report

**Preventing Incorrect Installation of the Beta Arm in
Pratt & Whitney Canada PT6A Engines**

Accident Number:	IAD01LA048 and ANC13WA057
Operator/Flight Number:	Multiple
Aircraft and Registration:	Multiple
Location:	Multiple
Date:	Multiple
Adopted:	December 5, 2016

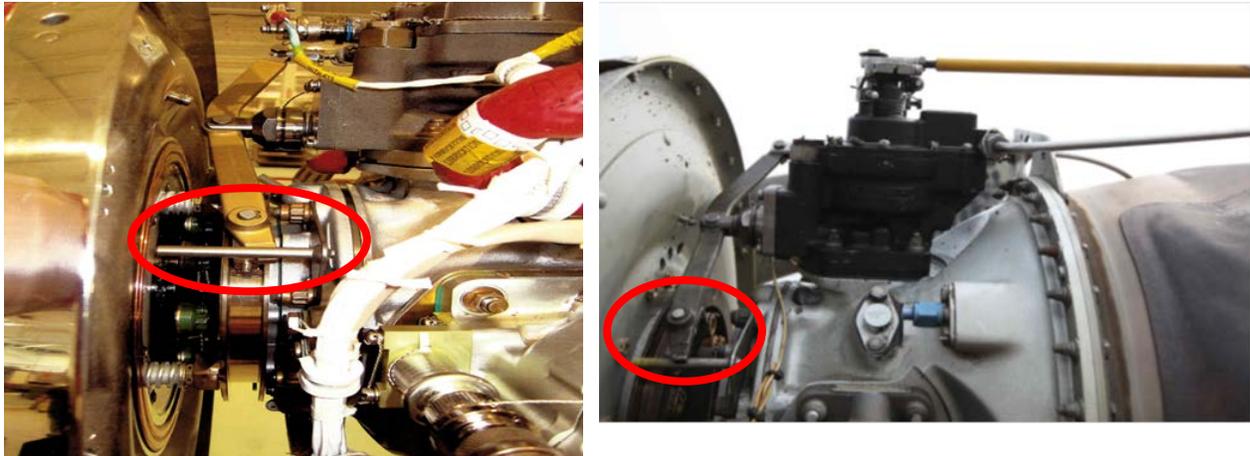
As a result of a previous NTSB investigation, we became aware of a safety issue concerning the possibility of the reversing lever (beta arm) and related components in PT6A engines being incorrectly positioned.² If the beta arm is not positioned such that it is secured under its guide pin, the unsecured linkage could release oil pressure in the beta valve and cause uncommanded travel of the propeller to the feather position (figure 1 shows exemplar engines with correctly and incorrectly positioned beta arms.)

Figure 1. Photographs of exemplar engines showing correct (left) and incorrect orientation (right) of the beta arm

Issue a special airworthiness information bulletin that directs maintenance personnel, during routine scheduled inspections of and after propeller installation on Pratt & Whitney model PT6A engines, to visually verify that the propeller reversing lever (beta arm) and guide pin are correctly installed and, if necessary, to fix any improper installations. (A-16-53)

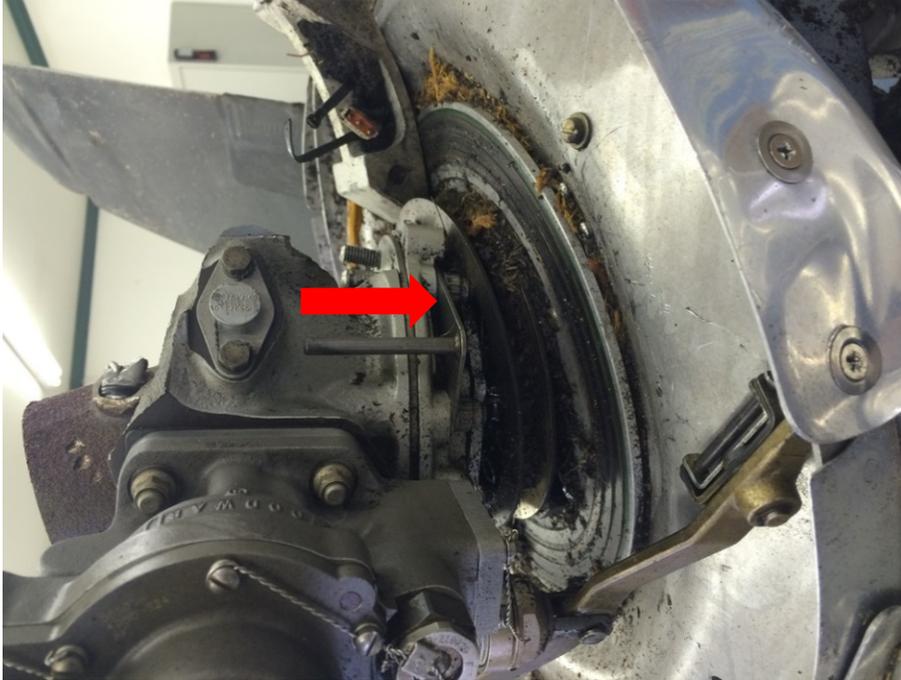
The NTSB's review found four events in which the incorrect position of the beta arm in a PT6A engine was noted and that occurred within 100 flight hours after maintenance of the beta arm or related components.³ In a fifth event (NTSB case number ERA15FA297), the investigation found that the guide pin had been installed backward, which allowed the beta arm to be free-floating, that is, neither above nor below the guide pin (figure 2 shows the installation on the engine involved in this accident).⁴ The NTSB is aware that one operator has welded a tab to the top of guide pins to make it physically impossible to incorrectly install the beta arm over the pin but notes that this fix would not prevent an intentional reversal of the guide pin if, for example, a mechanic chose to do so to provide clearance for maintenance work.

Figure 2. A photograph showing a beta arm guide pin installed incorrectly in the aft direction (the red arrow points forward, indicating the pin's correct orientation).

As soon as practicable, complete the development and implementation of a redesigned guide pin assembly for PT6A engines to prevent the possibility of the reversing lever (beta arm) and guide pin being incorrectly installed. (A-16-54)
