Safety Recommendation Report

**Unsafe Wiring Conditions in Piper Model PA-31T-Series Airplane
Floor-Mounted Circuit Breaker Panels**

Accident Number:	WPR16FA153
Operator/Flight Number:	Cal-Ore Life Flight
Aircraft and Registration:	Piper PA-31T, N661TC
Location:	McKinleyville, CA
Date:	July 29, 2016
Adopted:	January 5, 2017

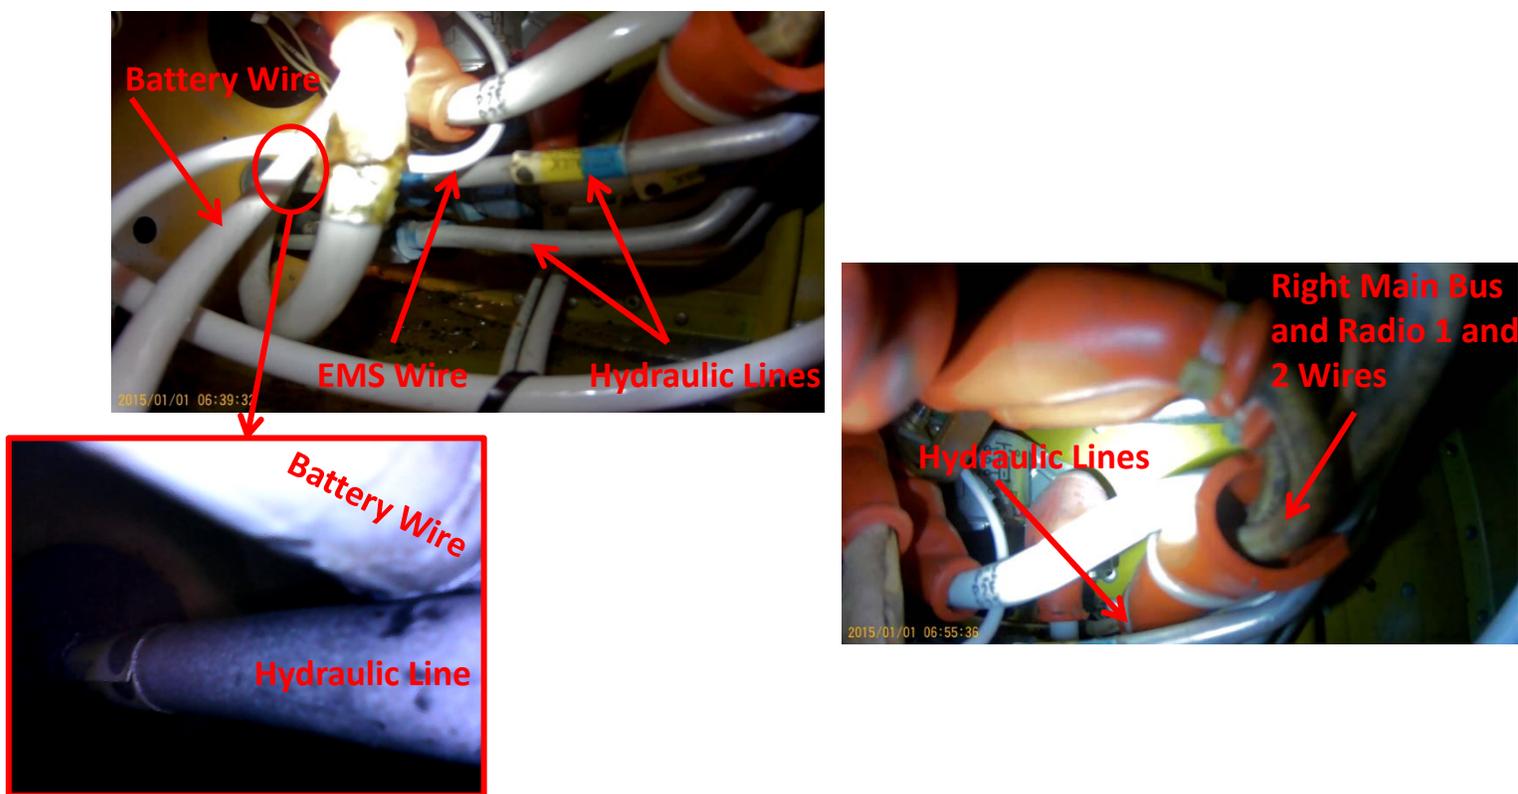
Advisory Circular (AC) 43.13-1B, “Acceptable Methods, Techniques, and Practices— Aircraft Inspection and Repair,” advises against wires and fluid lines being in contact due to the risk of chafing, which can lead to thermal stress and arcing in an area where flammable liquids are routed.² This guidance material specifies a minimum 1/2-inch clearance between the wires and the fluid-carrying lines. During this investigation, the NTSB and the FAA examined the same area in six exemplar Piper model PA-31T-series airplanes and found instances on all six exemplar aircraft of unsafe conditions in which electrical lines and hydraulic lines were in direct contact (see figure).³ Some of the wires in the exemplar aircraft showed chafing between the hydraulic line and the electrical wires, which, if left uncorrected, could have led to electrical arcing and subsequent fire.

Figure. Photographs showing contact between wires and hydraulic lines in exemplar Piper PA-31T-series airplanes.

The NTSB notes that, currently, about 317 Piper PA-31T-series airplanes are registered with the FAA. During annual inspections, the area below the circuit breaker panel is only accessible through a panel in the belly of the airplane. As shown in the figure, the number of

electrical wires and hydraulic lines that are routed through the area further obscure an already confined space where visual sight lines are limited. Current maintenance procedures in AC 43.13-1B only specify a general visual inspection of the area to check “electrical wiring for security.” The difficulty of detecting this unsafe condition through visual means alone likely explains why it was not previously identified on all six of the exemplar airplanes examined during our investigation using a borescope and camera. We are concerned that current maintenance procedures do not provide adequate guidance for inspection in these areas, thereby allowing contact between electrical wires and hydraulic fluid lines to persist undetected.

On December 16, 2016, the FAA issued Special Airworthiness Information Bulletin (SAIB) CE-17-05 to alert owners and operators of these airplanes about this safety issue. The SAIB recommends that the condition of all wiring in the floor-mounted circuit breaker panel be inspected at the next scheduled maintenance visit using “a mirror, a suitable light source or other equipment (small cameras, borescopes, magnification, etc.) capable of providing equal or better resolution.” It also recommends that owners and operators repair or replace any damaged wires and ensure that proper clearance between wires and hydraulic lines is maintained.

Issue an emergency airworthiness directive (AD) that requires owners and operators of Piper PA-31T-series airplanes to take the actions recommended in Special Airworthiness Information Bulletin CE-17-05 immediately after the AD is issued. (A-17-1) Urgent
