National Transportation Safety Board

Safety Recommendation Report

Uncommanded Nosewheel Steering Anomalies During Landing in Embraer EMB-145 Regional Jets

Accident/Incident Numbers:	DCA13WA123, ENG13IA020, ENG11IA047, CEN11IA234
Operators:	ExpressJet Airlines, China Eastern Airlines
Aircraft:	Embraer EMB-145 Regional Jets
Locations:	Multiple
Dates:	2011 through 2013
Adopted:	January 26, 2017

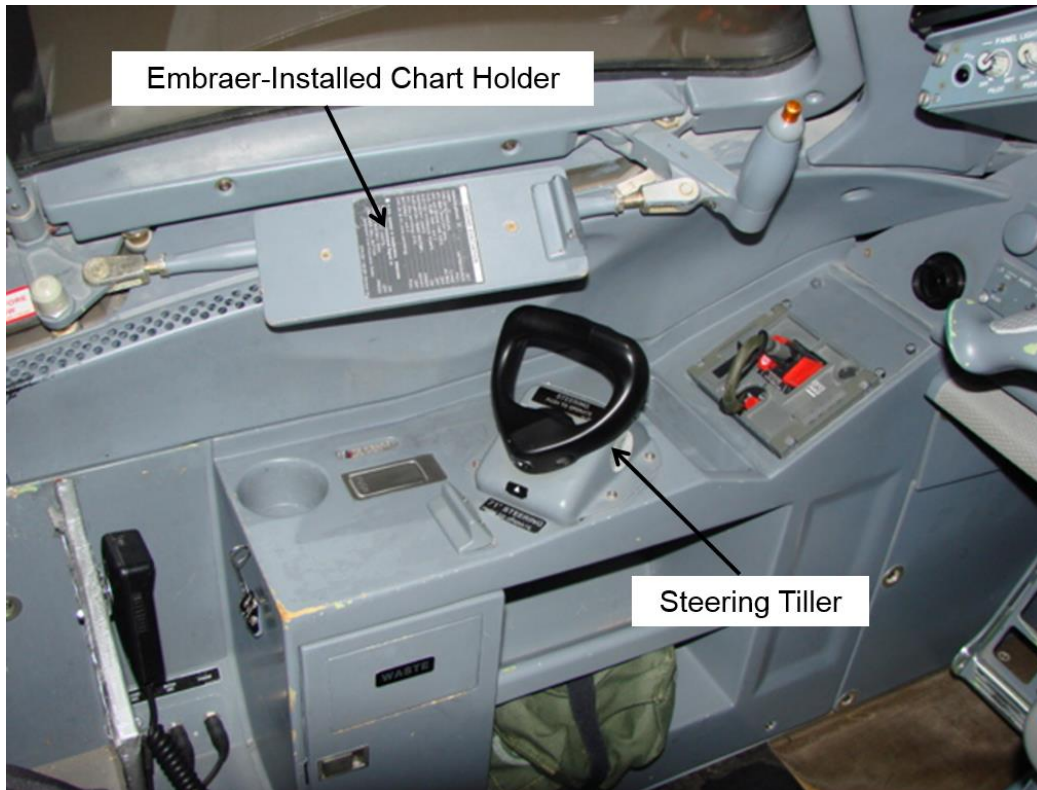
the Embraer-installed and -authorized chart holder.⁹ The binder bracket clips to the chart holder and holds a chart binder open in view of the pilot, eliminating the need, as occurs with use of the Embraer-installed chart holders, to open the binder and remove the individual charts needed for the approach. The brackets can be removed after each flight. One binder bracket attach point, next to the left (captain's) side window, is located directly above and close to the nosewheel steering tiller (also called a steering handle). These binder brackets are not approved by Embraer, and the EMB-135, EMB-140, and EMB-145 *Airplane Operations Manuals* do not reference their use.

Figure 1. Embraer-installed chart holder and steering tiller locations.

The NTSB is concerned that a binder being held by an unapproved bracket may become dislodged, fall, and strike the tiller, engaging the nosewheel steering system and possibly providing a nosewheel steering input. If this happens during the landing roll, the nosewheel steering input could cause a runway excursion.¹⁰ The NTSB concludes that the use of binder brackets on EMB-135, EMB-140, and EMB-145 airplanes could result in an inadvertent engagement of the nosewheel steering system and a possible runway excursion if a chart binder becomes dislodged from the binder bracket during landing and strikes the tiller. Therefore, the NTSB recommends

that Embraer issue an operations bulletin informing its operators that the use of binder brackets to hold chart binders is not approved by Embraer and could cause a hazardous condition if a binder becomes dislodged from the bracket. The NTSB further recommends that, after Embraer issues the operations bulletin as recommended in Safety Recommendation A-17-3, the FAA notify operators of Embraer aircraft that the use of binder brackets to hold chart binders could cause a hazardous condition if a binder becomes dislodged from the bracket and encourage operators to comply with the Embraer operations bulletin.

Issue an operations bulletin informing your operators that the use of binder brackets to hold chart binders is not approved by Embraer and could cause a hazardous condition if a binder becomes dislodged from the bracket. (A-17-3)

After Embraer issues the operations bulletin as recommended in Safety Recommendation A-17-3, notify operators of Embraer aircraft that the use of binder brackets to hold chart binders could cause a hazardous condition if a binder becomes dislodged from the bracket and encourage operators to comply with the Embraer operations bulletin. (A-17-5)

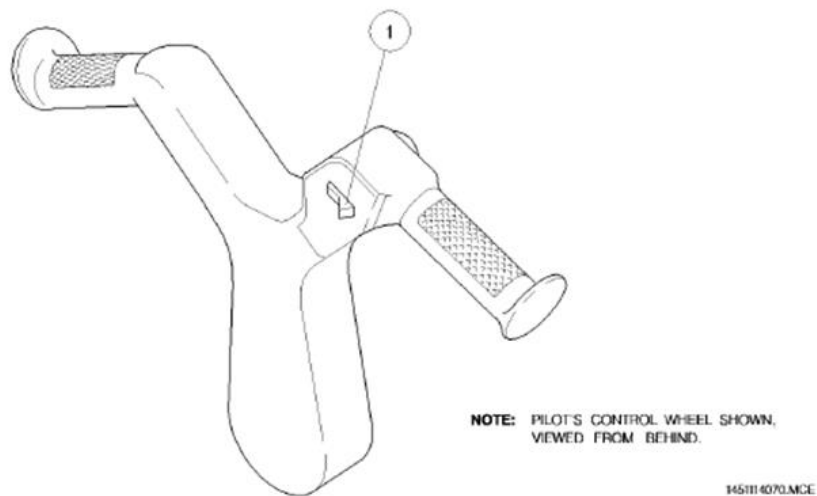
The NTSB reviewed the procedures that US operators of EMB-145 airplanes use for uncommanded nosewheel steering anomalies, with an emphasis on landing roll.¹¹ The procedures recommend that operators disengage the nosewheel steering system by pressing a button on the control wheel if the airplane veers off its intended path (figure 2 shows the control wheel and steering disengage button). However, the NTSB's review revealed that not all operators provide simulator training for such events and that several operators only demonstrate (using Embraer-provided materials) nosewheel steering anomalies during taxi or the low-speed regime of a takeoff, rather than during landing.

Figure 2. Pilot control wheel (and steering disengage button) on Embraer regional jets.

The NTSB concludes that the simulator training that ExpressJet Airlines provides to flight crews to disengage the nosewheel steering system if the airplane veers off its intended path during landing could decrease possible loss of directional control and runway excursions. While ExpressJet Airlines currently offers this training, not all other US operators of EMB-135, EMB-140, and EMB-145 airplanes may offer comparable simulator training for uncommanded swerving on landing. The NTSB believes that all US operators of EMB-135, EMB-140, and EMB-145 airplanes would benefit from this simulator training. Therefore, the NTSB recommends that the FAA require operators of Embraer EMB-135, EMB-140, and EMB-145 airplanes to incorporate training for uncommanded swerving on landing in their initial and recurrent simulator training programs.

Require operators of Embraer EMB-135, EMB-140, and EMB-145 airplanes to incorporate training for uncommanded swerving on landing in their initial and recurrent simulator training programs. (A-17-6)
