PRELIMINARY REPORT

RAILROAD

DCA15MR006

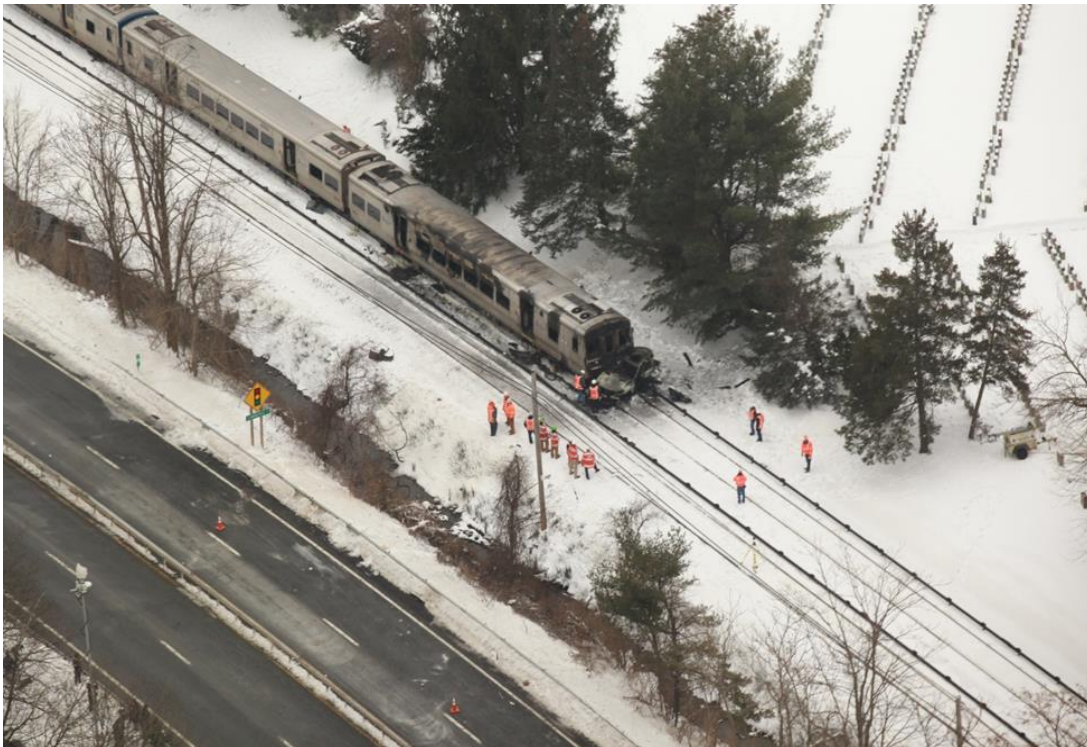
Figure 1. Train and SUV at point of rest following collision.

This highway-rail grade crossing was comprised of gates and warning lights that activate to warn motorists of an oncoming train. Train no. 659 consisted of eight electrically powered M-7 railcars. The collision resulted in a fire which consumed the SUV and lead railcar, MN 4333.

The train and the SUV continued northbound resulting in the damage of the electrified third rail on the west side of the track. The third rail detached, pierced the SUV, and then entered the railcar in two locations from the underside at the aft end of the left side passenger doorway. The train and SUV came to rest about 650 feet from the point of collision. An estimated 480 feet of third rail was damaged. Twelve sections of the third rail, each 39 feet long, were found inside the first passenger railcar.
