PRELIMINARY REPORT RAILROAD

Collision of BNSF Eastbound Train S-LACLPC1-26K and BNSF Westbound Train Q-CHISBD6-27L

Panhandle, Texas

DCA16FR008

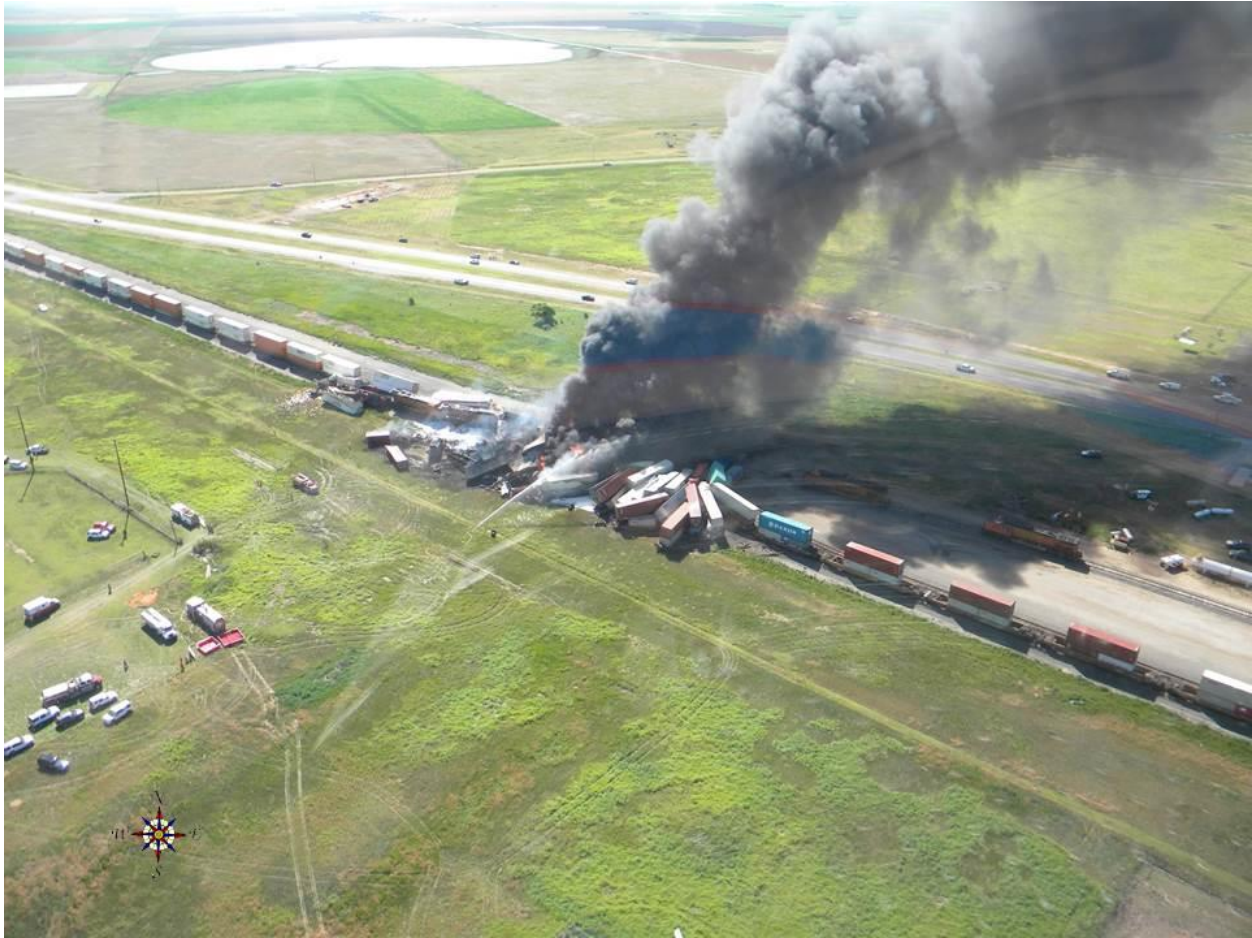
On Tuesday, June 28, 2016, at 8:21 a.m. central daylight time, two BNSF Railway (BNSF) trains collided at milepost 525.4 on the BNSF's Panhandle Subdivision. (See figure 1.) Each train was crewed by a locomotive engineer and a conductor. Eastbound train S-LACLPC1-26K consisted of 3 head-end locomotives, 2 distributive power units, and 56 loaded cars, and westbound train Q-CHISBD6-27L consisted of 5 head-end locomotives and 54 loaded cars. The signal system was lined to route the westbound train into the Panhandle control point siding at milepost 526.1 while holding the eastbound train on the main track before the east end of the siding. The collision, which caused the derailment of the locomotives and several cars from both trains, occurred about one-half mile east of the east switch (east end) of the Panhandle siding. The weather at the time of the accident was clear and 74°F. The collision and derailment resulted in a significant fire. Three crew members died in the accident—the engineer and conductor on the eastbound train and the conductor on the westbound train. The engineer of the westbound train jumped from the train before impact and survived with injuries. The BNSF estimated damages of \$16 million.

Figure 1. Derailment site.
