# PRELIMINARY REPORT

## RAILROAD

### DCA16MR011

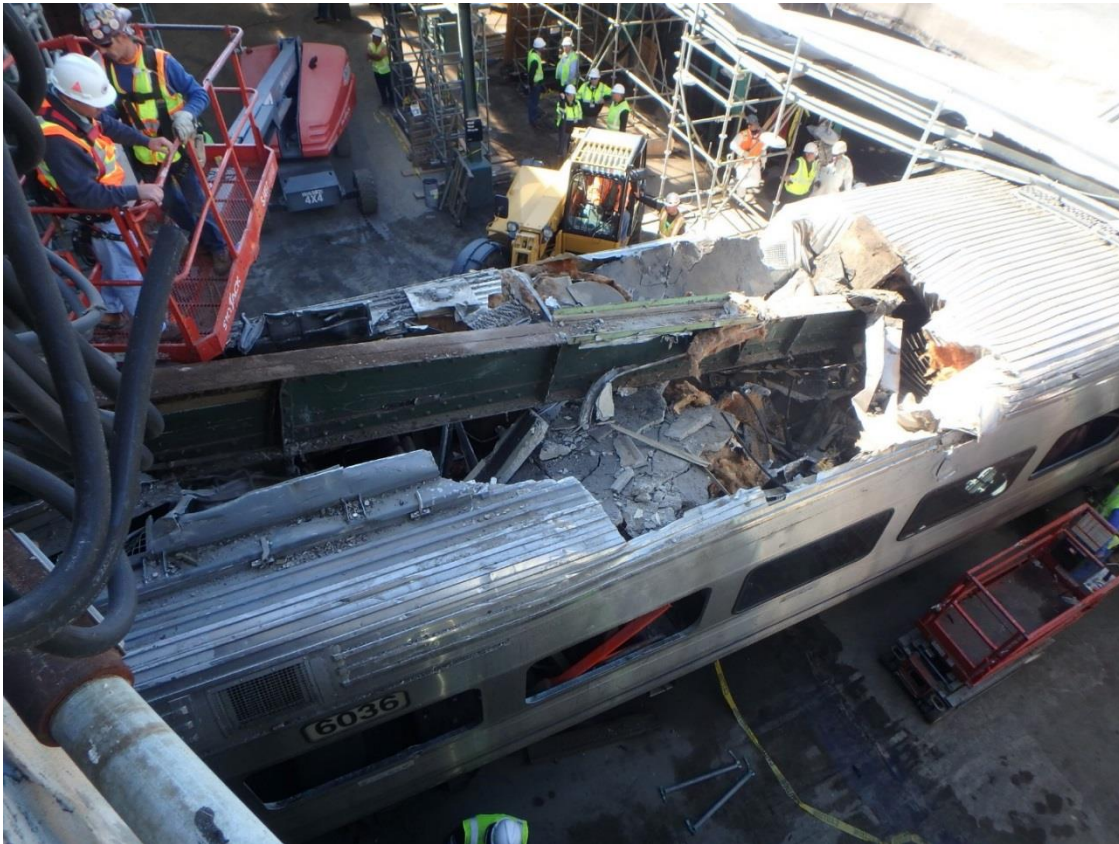
**Figure 1.** Damaged controlling cab car.

Investigators completed an examination of the controlling cab car to determine if the brake control system, throttle, and other systems could be repaired to complete testing. They found that the cab car's electrical communication network necessary for brake, signal, and propulsion control was destroyed in the accident, and that functional testing of key controlling components would be necessary to assess the mechanical condition of the train prior to the accident. Accident damage to the cab car's air brake system was minor and repaired for testing. A friction brake test was
