PRELIMINARY REPORT

RAILROAD

CSX Transportation, Train Derailment with Hazardous Materials Release

**Hyndman, PA
August 2, 2017
DCA17FR011**

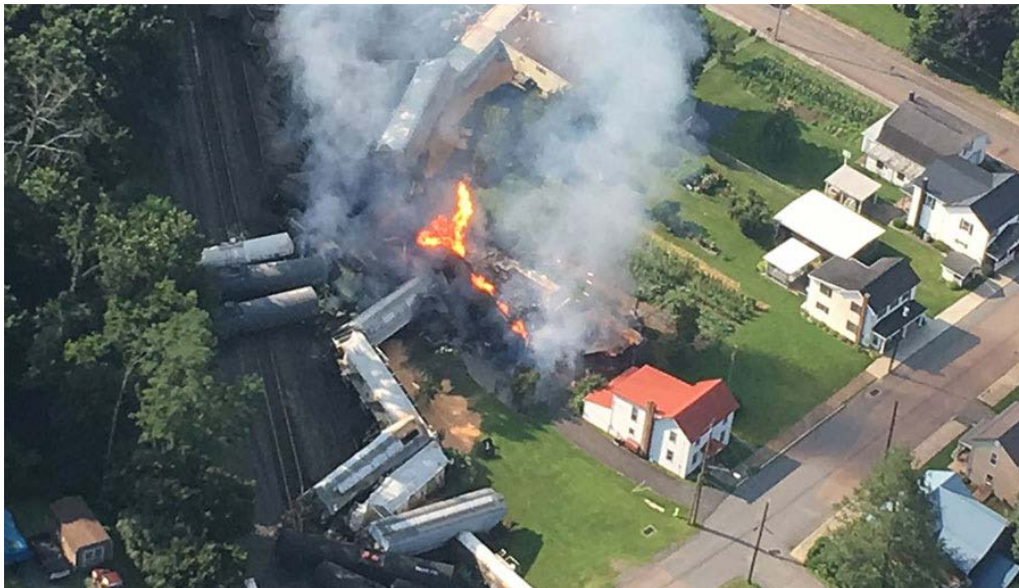
On August 2, 2017, about 4:54 a.m. eastern daylight time, CSX Transportation (CSX) train Q38831, with 5 locomotives and 178 railcars (128 loaded and 50 empty), derailed railcars 33 through 65 in Hyndman Borough, Bedford County, Pennsylvania. Three hazardous material tank cars were breached and released material: one containing propane, one containing asphalt, and one containing molten sulfur. Both the propane tank car and the molten sulfur tank released caught fire. (See figure 1.) About 1,000 residents within a 1-mile radius were evacuated and several highway-railroad grade crossings were closed. There were no injuries or fatalities. On August 5, about 12:00 p.m., the evacuation was lifted. At the time of the accident, the sky was clear, visibility was 10 miles, and the temperature was 64°F.

Figure 1: Accident scene. (Photograph courtesy of Pennsylvania State Police.)

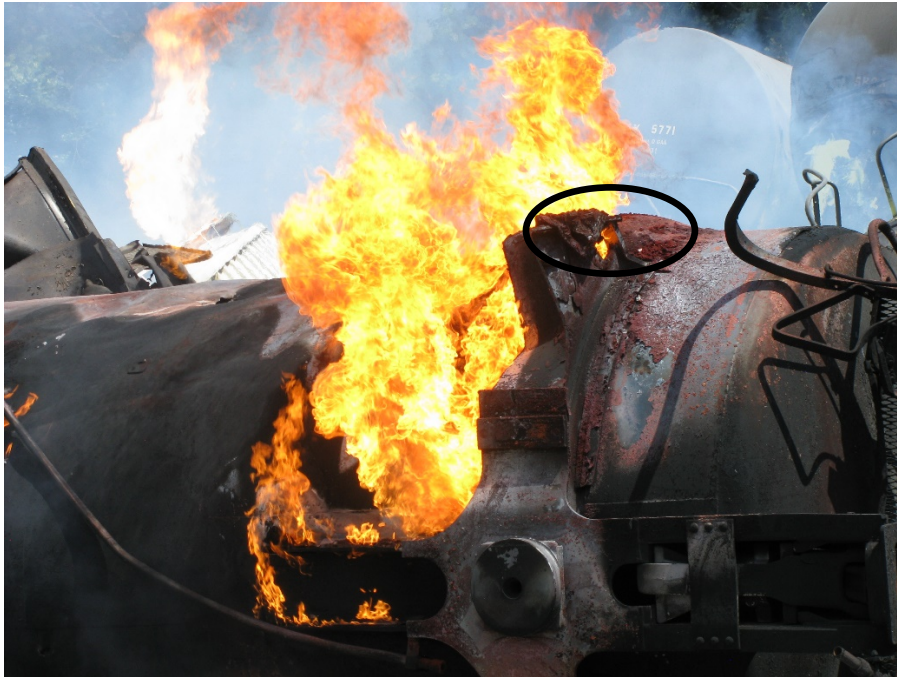
The 53rd car, a 33,710-gallon specification DOT-112 pressure tank car, released its load of odorized propane from a punctured tank shell.² The puncture measured about 3 1/4-inch in length and about 1/4-inch wide. Released propane gas escaped through the void space between the jacket and tank shell and emerged burning vigorously at several locations on the tank car for more than 48 hours. A 6-inch-high bulge, measuring 27 inches longitudinally and 56 inches

circumferentially, formed in the tank shell above the body bolster near one point of fire exposure (See figure 2).

Figure 2: Bulge in the tank shell of the burning tank car. (Photograph courtesy of CSX.)
