# PRELIMINARY REPORT

### Union Pacific Railroad Employee Fatality in Remote-Control Locomotive Operation

**Arlington, Texas**  
**September 22, 2017**  
**DCA17FR013**

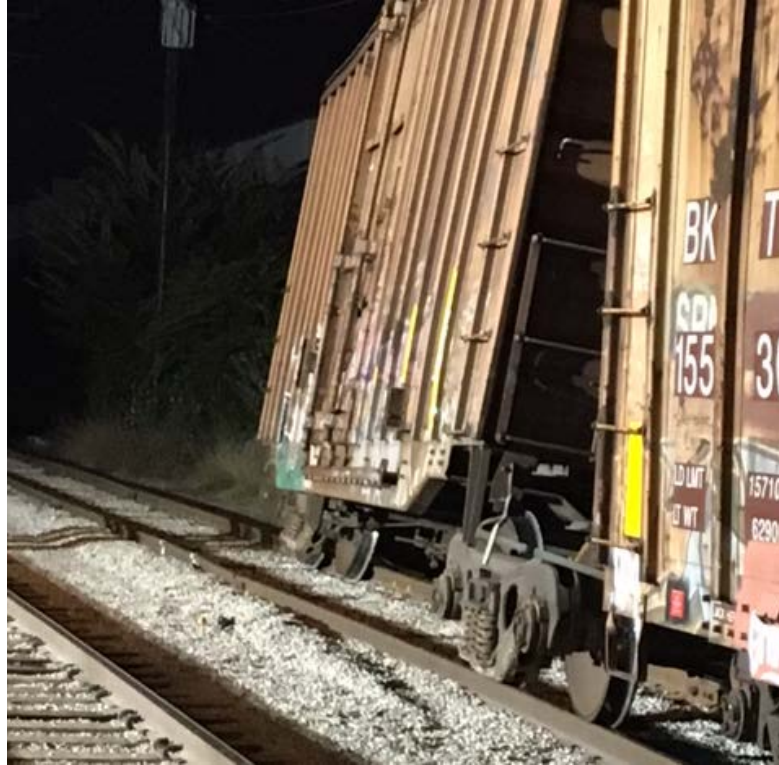
**Figure 1.** Photo of derailed boxcar.
