PRELIMINARY REPORT

RAILROAD

DCA17MR007

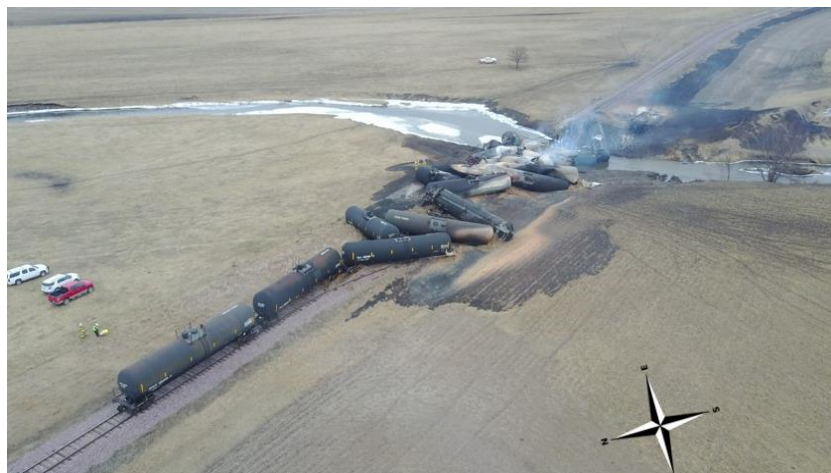
Figure 1. Aerial view of accident (NTSB UAS).
