# PRELIMINARY REPORT

## RAILROAD

### Employee Fatalities – CSX/Amtrak

DCA17MR010

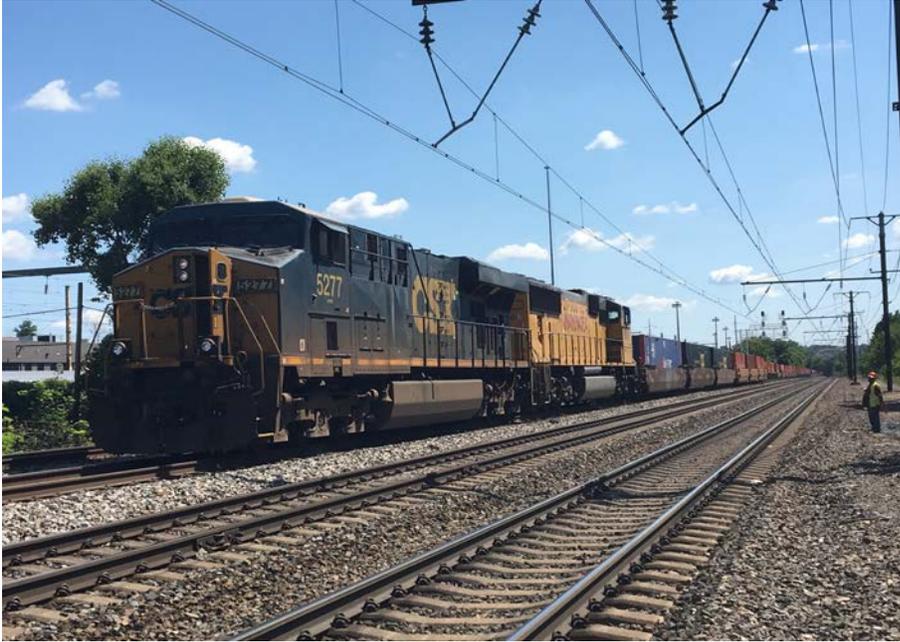
There were four parallel tracks (two CSX and two Amtrak) where the employees were struck. CSX freight train Q13727 was stopped on CSX track 2. The middle track was Amtrak track 3 where Amtrak train 175 was traveling in the same direction as the freight train. The track on the far right was Amtrak track 2 where Amtrak train 66 was traveling in the opposite direction of the freight train at the time the employees were struck. According to each Amtrak engineer, they started sounding their horns when they observed the employees on the track.<sup>2</sup> (See figure.)

**Figure.** CSX train Q13727 that was stopped on CSX track 2.
