# National Transportation Safety Board

## Highway Accident Brief

Accident No.: HWY-00-F-H028  
Accident Type: Single vehicle rollover  
Location: Texas State Highway 43, 1.5 miles north of Karnack, Texas  
Date and Time: February 10, 2000, about 6:50 p.m.  
Vehicle Involved: 1999 Ford E-350 XLT 15-passenger bus (van)  
Owner: Enterprise Rent-A-Car Company  
Operator: Prairie View A&M University student athlete  
Operation: Athletic field trip  
Vehicle Damage: Roof structure displaced about 19 inches to left and moderately compressed downward at left front  
People on Board: Ten—track coach, athletic trainer, and eight student track athletes  
Injuries: Four fatal and six serious

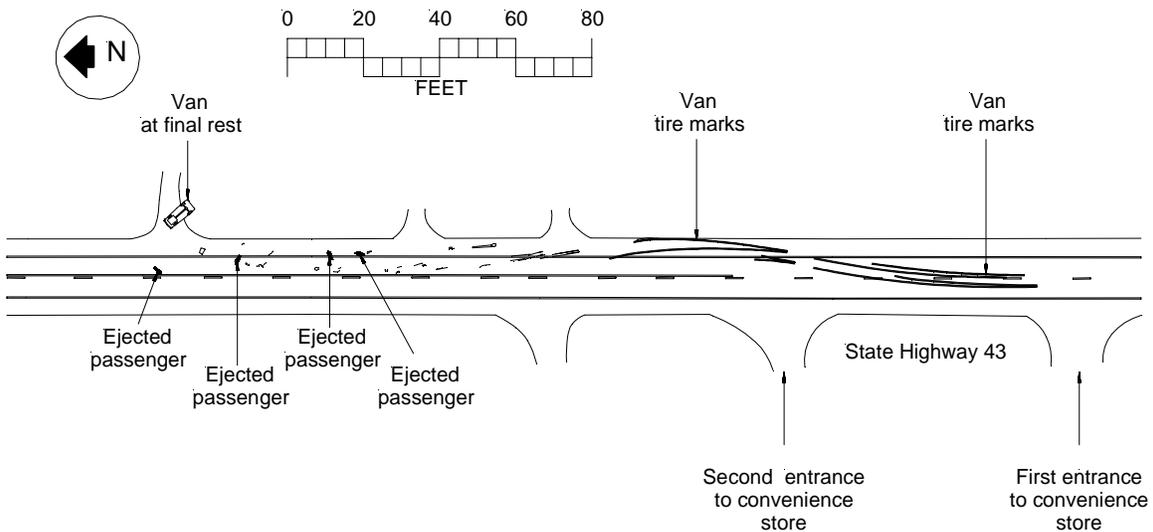
**Figure 1.** Accident diagram.

A Texas Highway Patrol reconstruction team determined that the van yawed<sup>2</sup> right, then left, dropped off the northbound pavement edge, and began overturning (see figure 1).<sup>3</sup> The van traveled approximately 490 feet from where it began its yaw to where it came to its final position and about 265 feet from where it hit the pavement edge to where it came to rest. Evidence on the roadway indicated that the van flipped three full turns before coming to rest inverted.
