National Transportation Safety Board

Highway Accident Brief

Accident No.: HWY-01-FH006
Accident Type: School bus run-off-the-road and rollover
Location: U.S. Route 191 at milepost 428
18 miles north of Ganado, Arizona
Date and Time November 3, 2000, about 10:00 a.m.
Vehicle: 1997 Blue Bird model type D school-activity bus
Certified to carry 52 high school to 75 elementary school passengers
Owner/Operator: Chinle Unified School District No. 24, Chinle, Arizona
School band competition trip
People on Board: Thirty-eight—driver and 37 passengers
Injuries: One fatal
Two serious and 35 minor

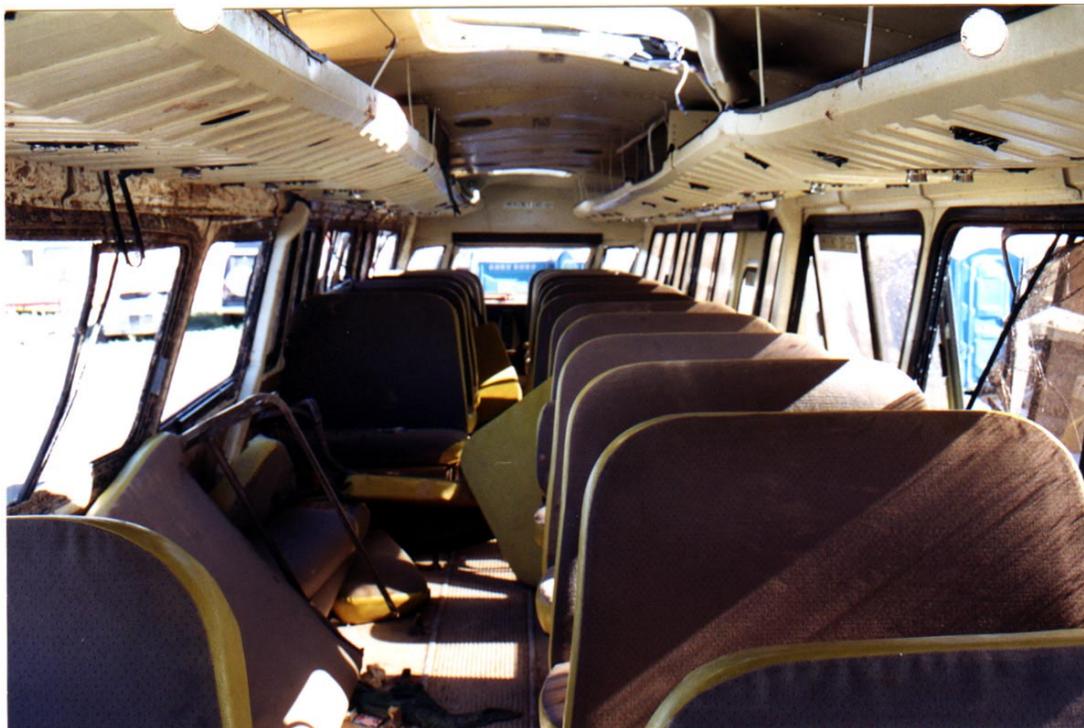
Deformation of the bus interior was primarily confined to the roof and right side. (See figure 1.) The roof was compressed down about 7 inches on the right side, and the occupant compartment was compressed inward about 8 inches vertically above the window bottoms. The windshield and back emergency exit window were broken.

Figure 1. View of interior damage looking aft.

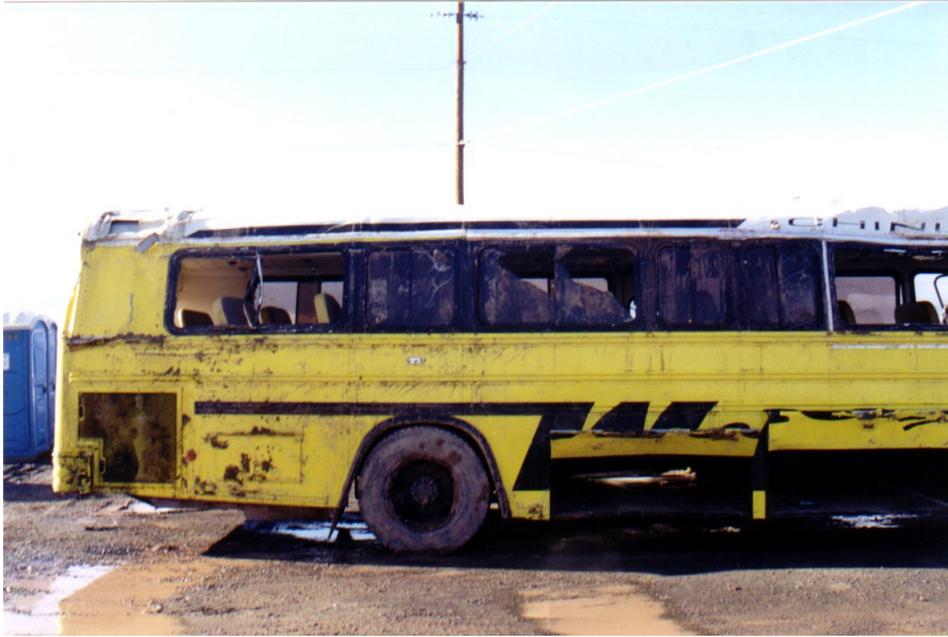
The bus exterior sustained impact damage on the right side and the adjacent roof. The bus's right side was deformed inward about 8 inches along the roofline. The deformation began along the bottom of the window frames. Five of the 10 right-side windows and the boarding door were broken during the rollover sequence. (See figures 2 and 3.) On the left side, the most significant damage was below the floor area adjacent to the left-side emergency exit door. In addition, the first 3 of the 11 left-side windows were broken. The left-side emergency exit door was functional.

Figure 2. Right side view showing damage above bottom of window frames and along roofline.

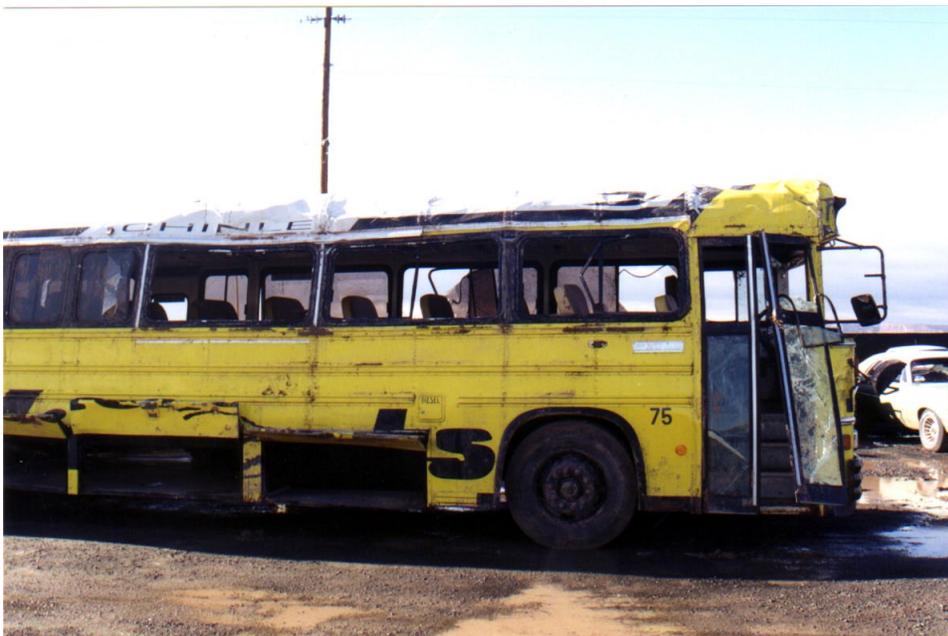
Figure 3. Right side damage view showing boarding door and driver area.
