National Transportation Safety Board
Washington, DC 20594

Highway Accident Brief

Accident No.: HWY-02-FH-012
Accident Type: Multiple-vehicle collision and fire
Location: Interstate Highway 40, eastbound at milepost 290.7
Cuervo, New Mexico
Date and Time March 8, 2002, 1:18 p.m.
Vehicles: 3 truck tractor-semitrailers
2 straight trucks
1 pickup truck
4 passenger vehicles
1 school bus
1 motor home
Owners/Operators: U.S. Express LSG, Inc.
Kurtz Trucking Ltd.
Zimmerman Truck Lines, Inc.
Atlanta Peach Movers, Inc.
Fatalities/Injuries: 7 fatalities
3 serious and 13 minor injuries

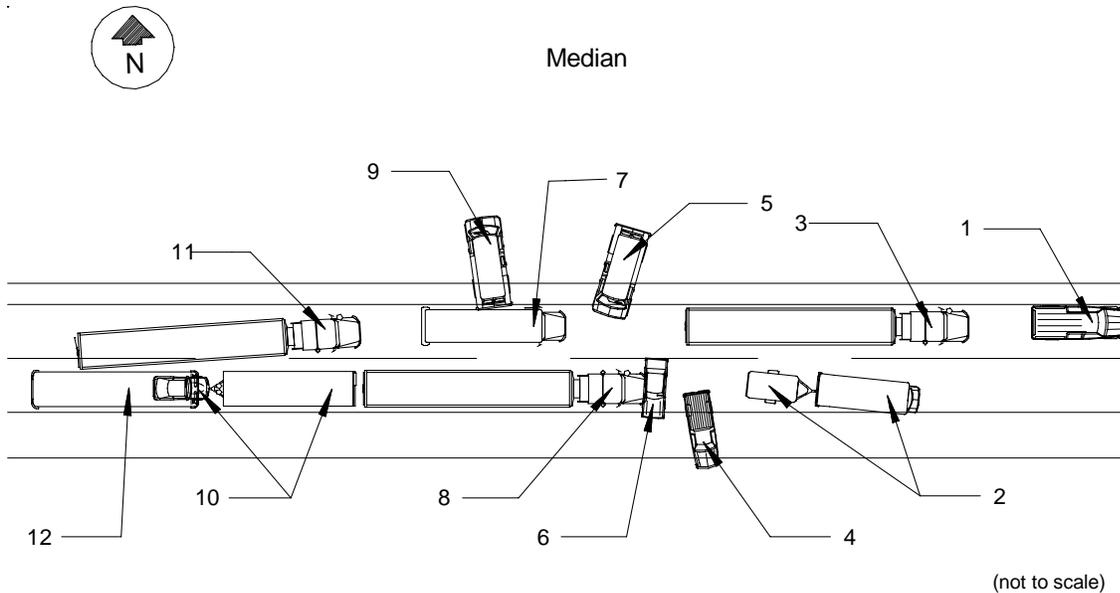
Key:	
1. 1999 Jeep	7. 1999 International straight truck (Atlanta Peach)
2. 1989 U-Haul straight truck towing car	8. 2001 Freightliner truck tractor-semi-trailer (U.S. Express)
3. 1999 Kenworth truck tractor-semi-trailer (Kurtz)	9. 1988 Plymouth van
4. 1992 GMC pickup truck	10. 1994 motor home towing 1990 Suzuki
5. 2001 GMC van	11. 1999 International truck tractor-semi-trailer (Zimmerman)
6. 1999 Buick sedan	12. 1989 Blue Bird school bus

Figure 1. Accident scene eastbound.
