National Transportation Safety Board

Highway Accident Brief

This brief discusses two rear-end, chain-reaction collisions that occurred at the same location near North Hudson, New York. The first accident took place on February 22, 2004, and will be referred to as North Hudson I. The second accident, which will be referred to as North Hudson II, occurred on September 19, 2004.

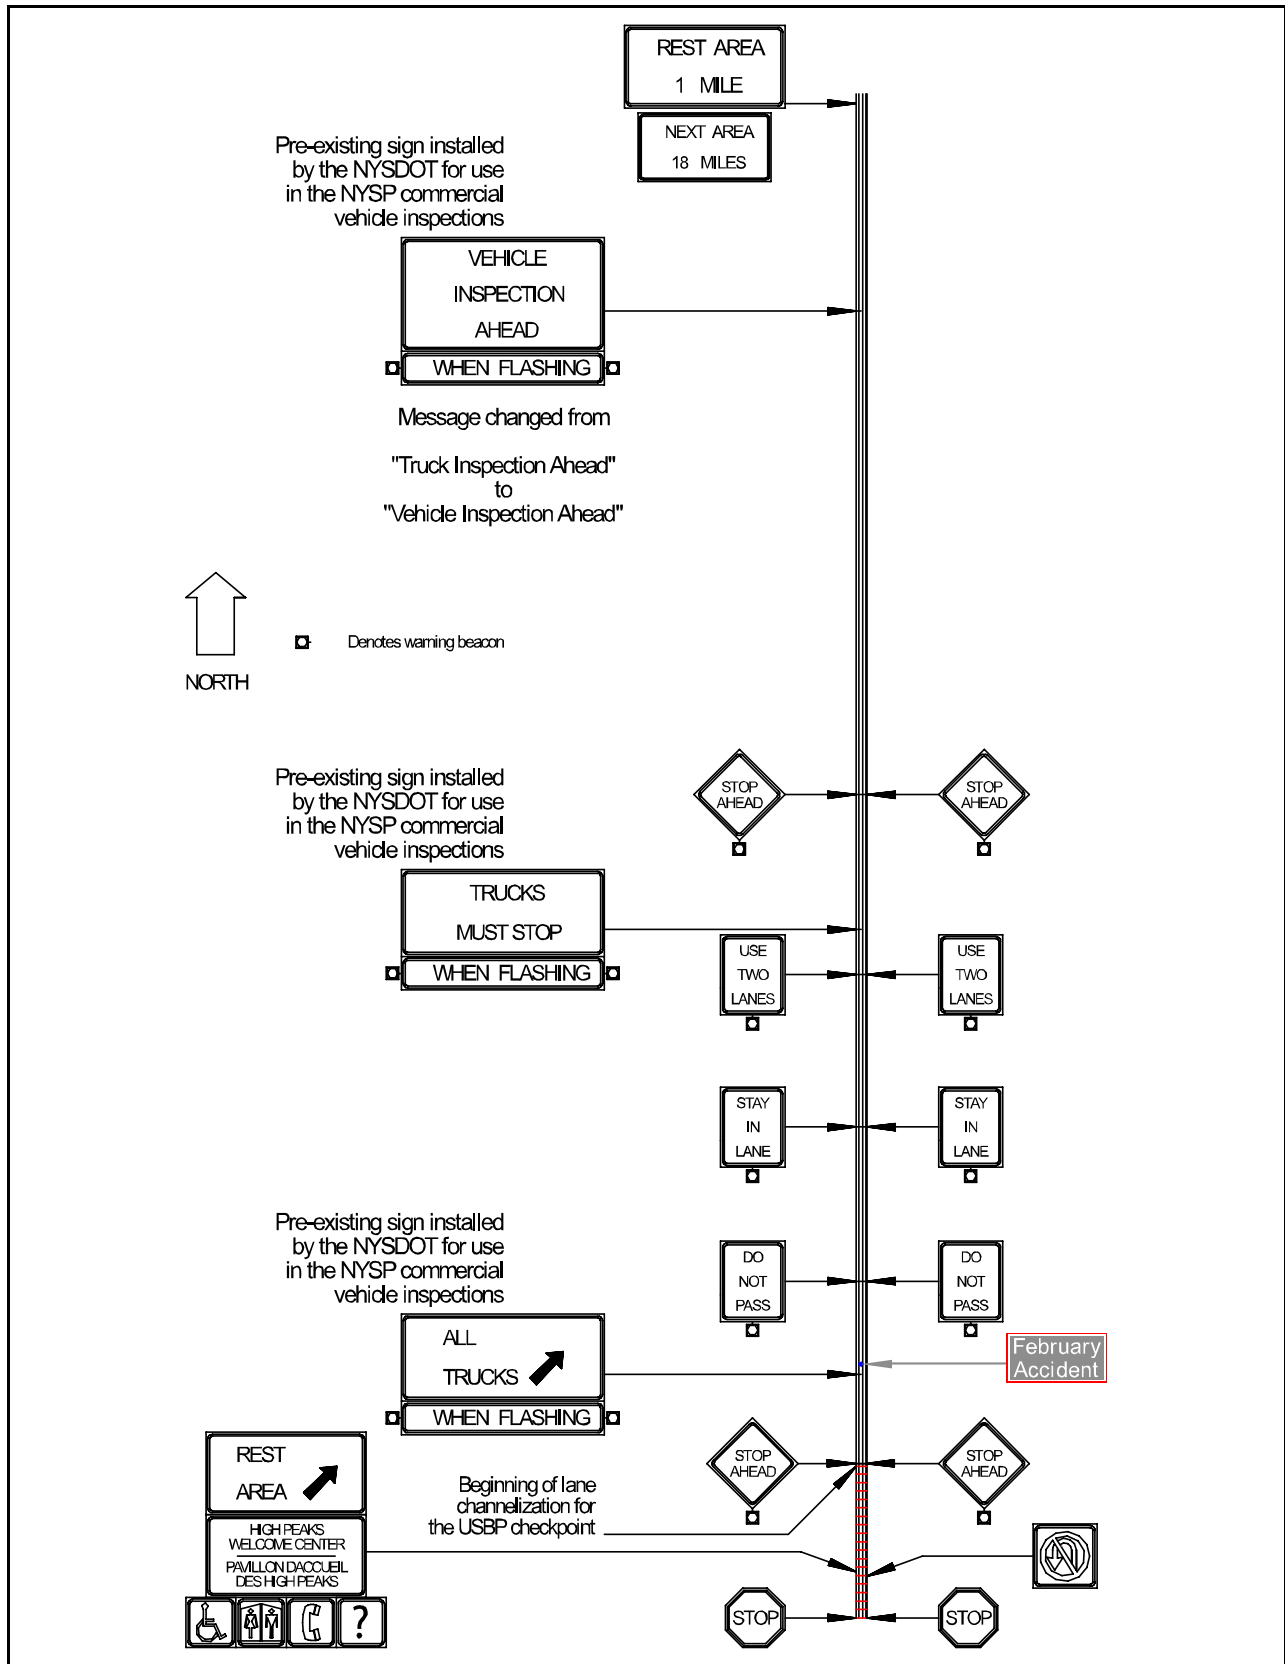
Besides the USBP checkpoint, the New York State Police (NYSP) also used the High Peaks rest area for commercial vehicle inspection and enforcement activities. The various uses of this facility resulted in a mixture of signs and flashing beacons being posted along the southbound interstate approaching the rest area. These signs included: 1) service signs notifying motorists of the rest area; 2) regulatory signs for vehicle speed, lane usage, and prohibited turning movements; and 3) warning signs regarding vehicle inspections and the requirement for vehicles to stop. (See figure 1.) Of the 12 signs posted in the 4 miles preceding the accident location, none gave specific notice of the USBP checkpoint.

Approximately 0.9 mile before the checkpoint, a sign displayed the message “Vehicle Inspection Ahead When Flashing.” This sign was used in combination with a flashing beacon, which was not flashing at the time of the North Hudson I accident but was at the time of the North Hudson II accident. Following this sign, 0.6 mile before the checkpoint, were a pair of “Stop Ahead” warning signs; slightly less than 0.1 mile later, approximately 0.5 mile from the checkpoint, motorists encountered a sign with the message “Trucks Must Stop When Flashing.” Unlike the first sign, the flashing beacon for this sign was working when the North Hudson I accident occurred. With the exception of the “All Trucks When Flashing” sign and another pair of “Stop Ahead” signs, all signs incorporating flashing beacons were located on the approach to the checkpoint *before* the collision site; the remaining signage was used to regulate vehicle lane position.

Figure 1. Signage at approach to USBP checkpoint on February 22, 2004.

After the February accident, the USBP and the New York State Department of Transportation (NYSDOT) added signage along the approach to the checkpoint as follows:

- Changeable message sign that alternated between “Reduce Speed” and “Stop Ahead” (in median 4,780 feet before the checkpoint).
- “Traffic Stopped Ahead” sign (on right side of road and median 3,770 feet before the checkpoint).
- “Reduce Speed” sign (on right side of road and median 2,330 feet before the checkpoint).
- “Be Prepared to Stop” sign (on right side of road and median 913 feet before the checkpoint).

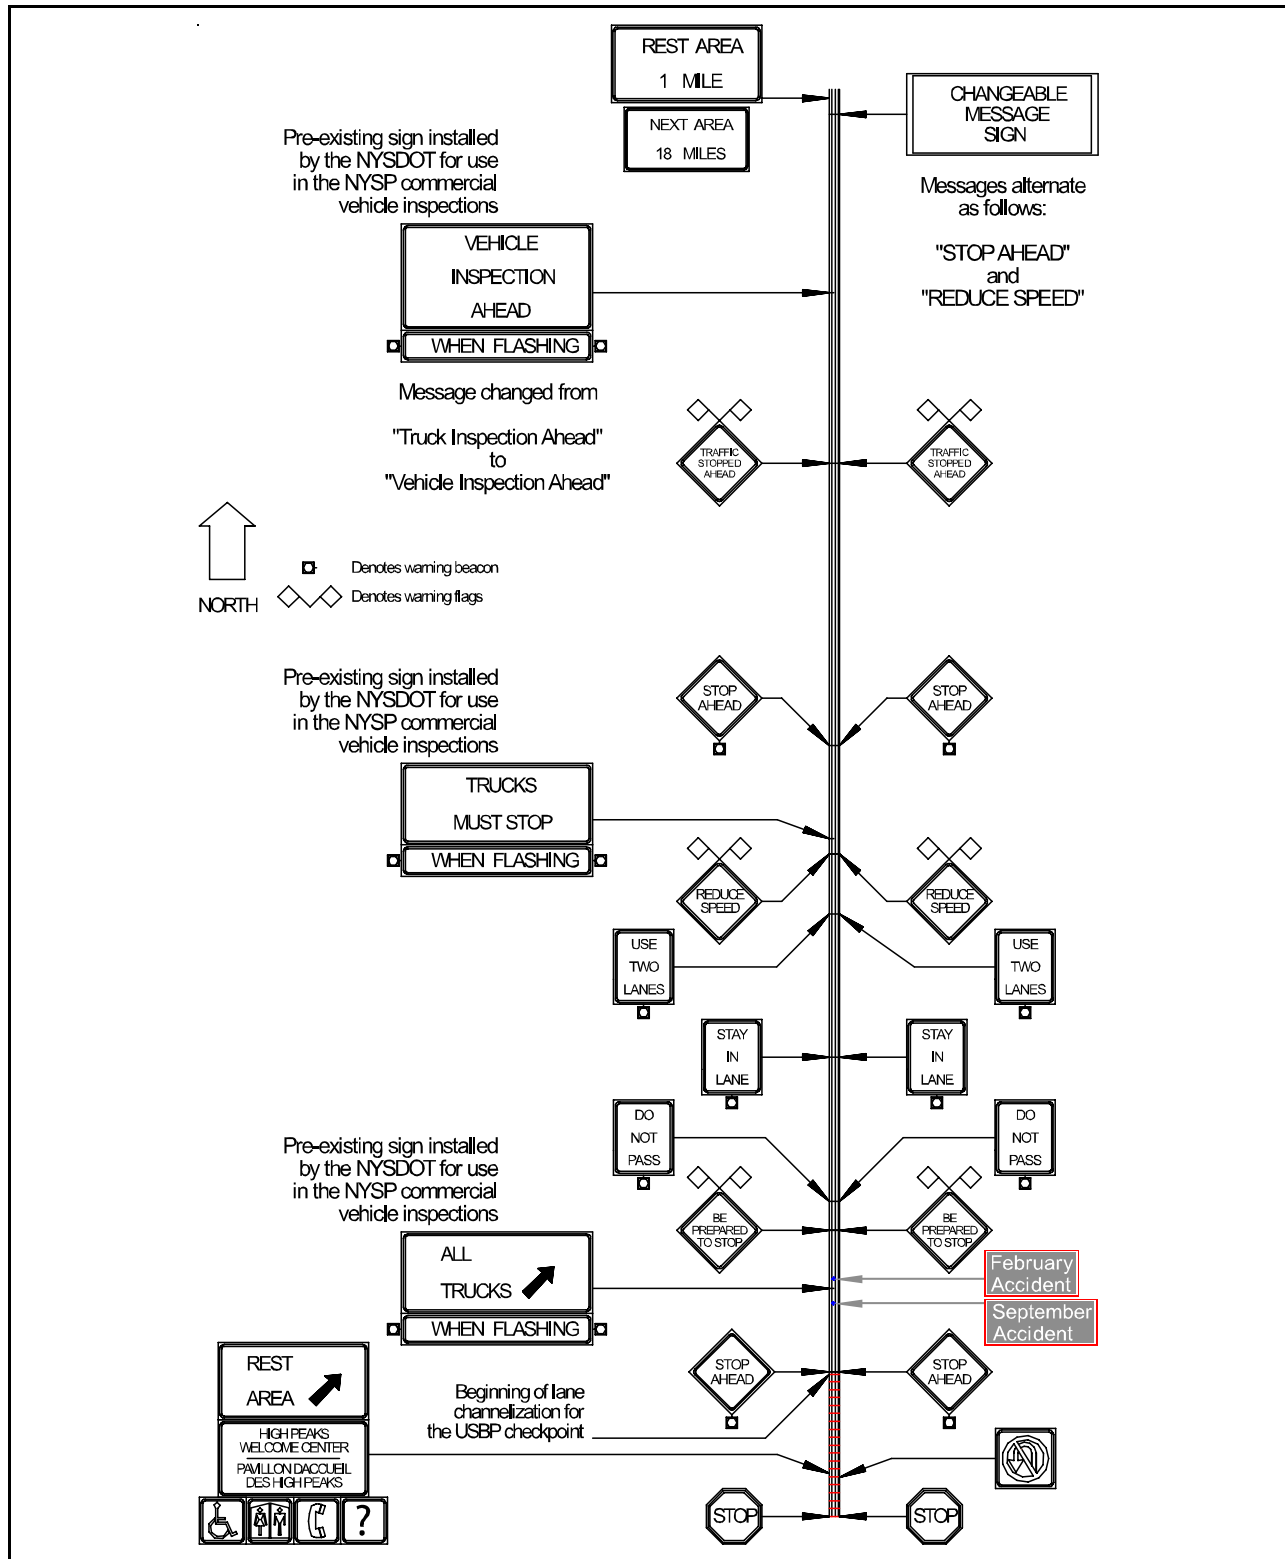
The additional signage increased the number of signs to at least 25, none of which gave specific notice of the USBP checkpoint. (See figure 2.)

Figure 2. Signage at approach to USBP checkpoint on September 19, 2004.

Although “Stop Ahead,” “Reduce Speed,” and speed limit signs were added to the TTC after the February and September 2004 accidents, motorists approaching the checkpoint had no clear advance warning that all vehicles, not just trucks, would be required to stop.

Following the September accident, the USBP and the NYSDOT again added signage, bringing the total number of signs on the approach to the checkpoint to 29. The additional signage included the following:

- Changeable message sign that alternates between “Be Prepared to Stop” and “Stopped Traffic Ahead” (in median 2.6 miles prior to checkpoint).
- “Speed Zone Ahead” sign (on right side of road and median 2.2 miles prior to checkpoint).
- “Speed Limit 45” sign (on right side of road and median 2.0 miles, 1.8 miles, and 1.2 miles prior to checkpoint).
- Changeable message sign that alternates between “Speed Limit 45 MPH” and “Your Speed ___ MPH” (in median 1.1 miles prior to checkpoint).
- “Speed Limit 30” sign (on right side of road and median 3,300 feet and 2,138 feet prior to checkpoint).
- Symbol sign for stop ahead (on right side of road and median 3,036 feet prior to checkpoint).
