National Transportation Safety Board
Washington, DC 20594

Highway Accident Brief

Accident No.:	HWY-04-MH-023
Accident Type:	Passenger vehicle collision with a fallen overhead girder
Location:	Eastbound on Interstate 70 at the Colorado State Route 470 overpass, Golden, Colorado
Date and Time:	May 15, 2004; 10:04 a.m., mountain daylight time
Vehicle:	2002 Dodge Durango
Injuries:	3 fatal

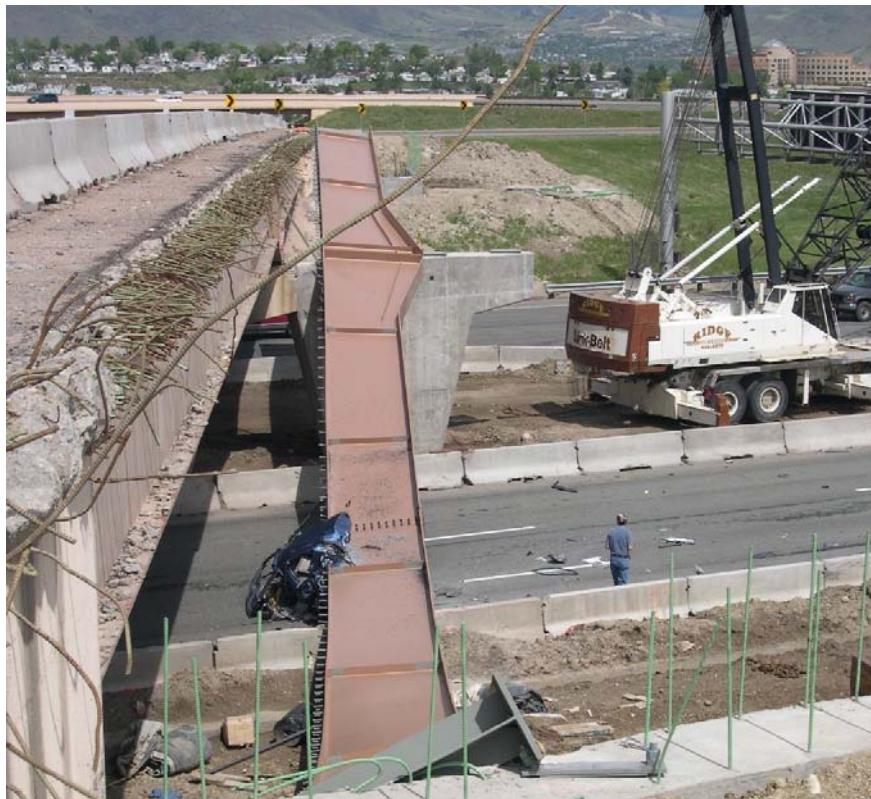
As the SUV approached the overpass, a fabricated steel girder line composed of two joined sections, which had been erected during the evening of May 11 through the early morning hours of May 12, 2004, parallel to the existing overpass, as a part of the bridge-widening project, rotated toward the overpass and sagged into the I-70 eastbound lanes. The girder struck the SUV about half the distance between the vehicle's front end and its windshield and sheared off the vehicle's top. The lower portion of the SUV continued east for 818 feet, coming to rest in the grassy median of I-70. All three vehicle occupants were killed. (See figures 1 and 2.)

Figure 1. Fallen girder and top portion of the accident vehicle on I-70 (looking north). The C-470 bridge/overpass being widened is to the left of the fallen girder in this photograph.

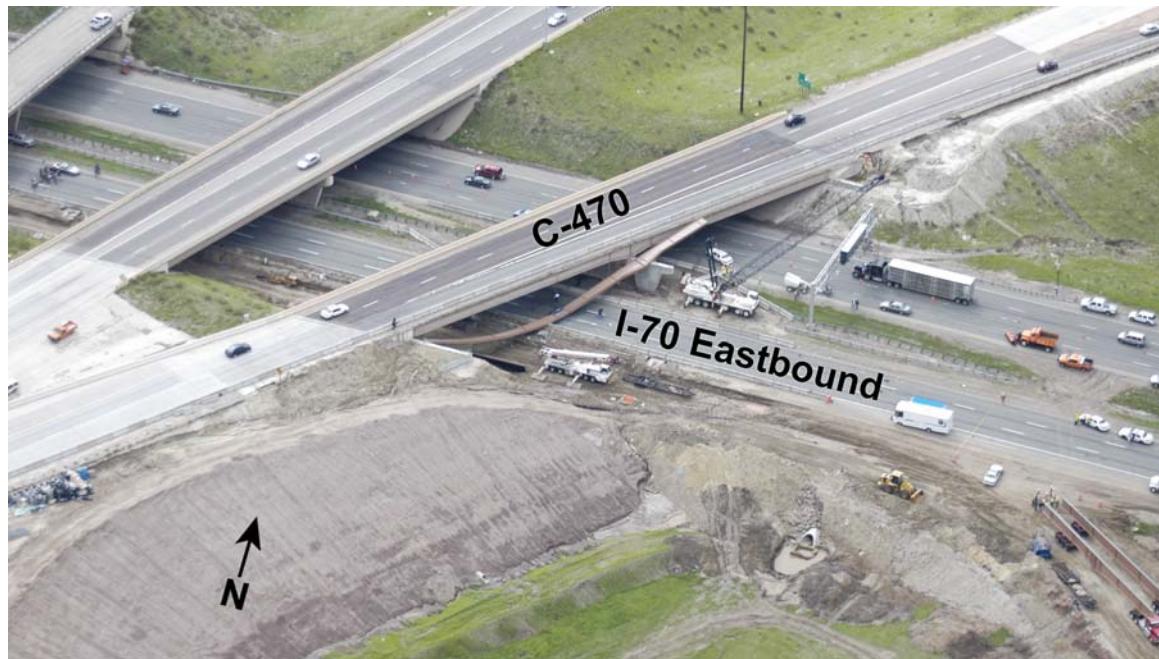
Figure 2. Overhead view of the accident scene, showing the C-470 bridge and fallen girder. (Photo source: Jefferson County Sheriff's Office)

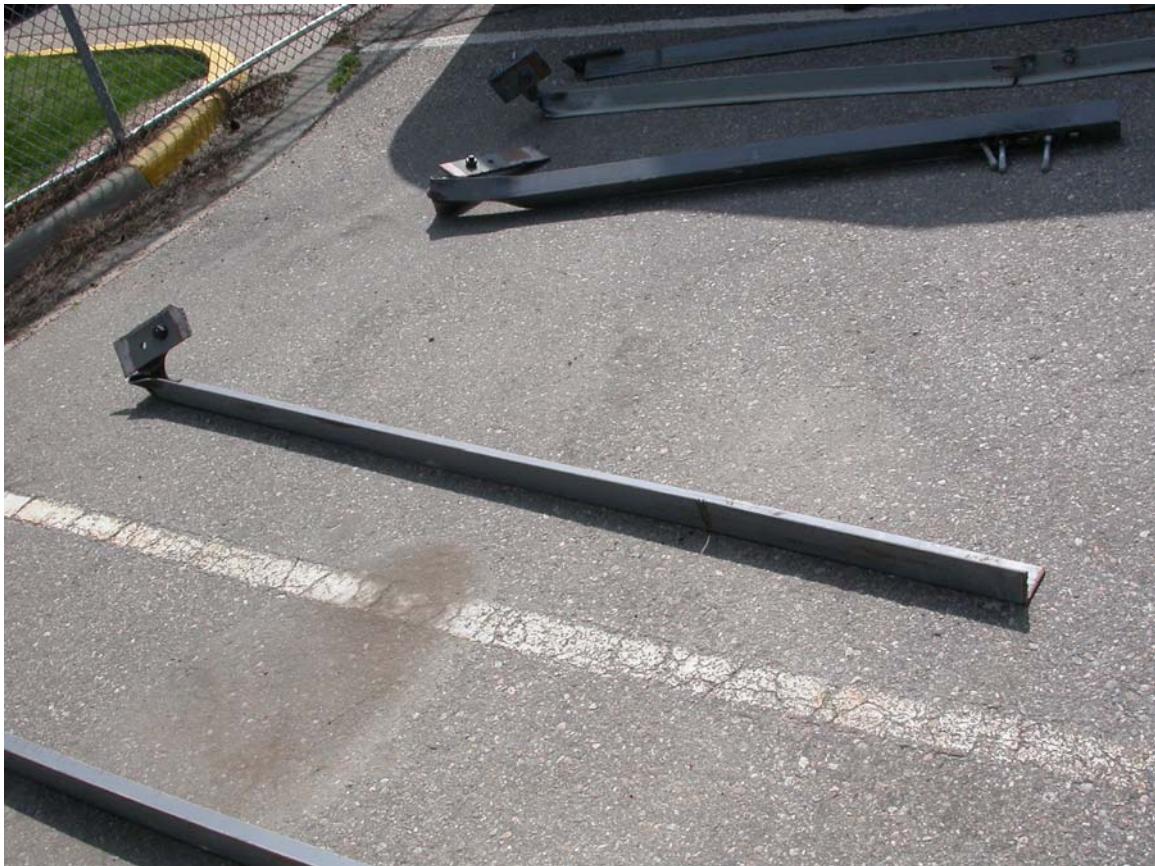
Figure 3. Postaccident photograph of one of the angle-shaped steel braces used to brace the accident girder.

About 3:45 a.m. to 4:00 a.m., Ridge workers began installing bracing to temporarily stabilize the single girder. They intended to install five angle-shaped steel braces to connect the single girder with the edge of the deck on the existing C-470 bridge. (See figure 4.) The braces were fabricated on site. To bend the braces, workers used a cutting torch to cut one leg of each brace (except the third brace, which was not cut). They also used torches to cut circular holes in the braces for the expansion bolts that would connect them to the bridge deck. Postaccident examination showed that these cutting procedures reduced the cross section of the braces by about half.

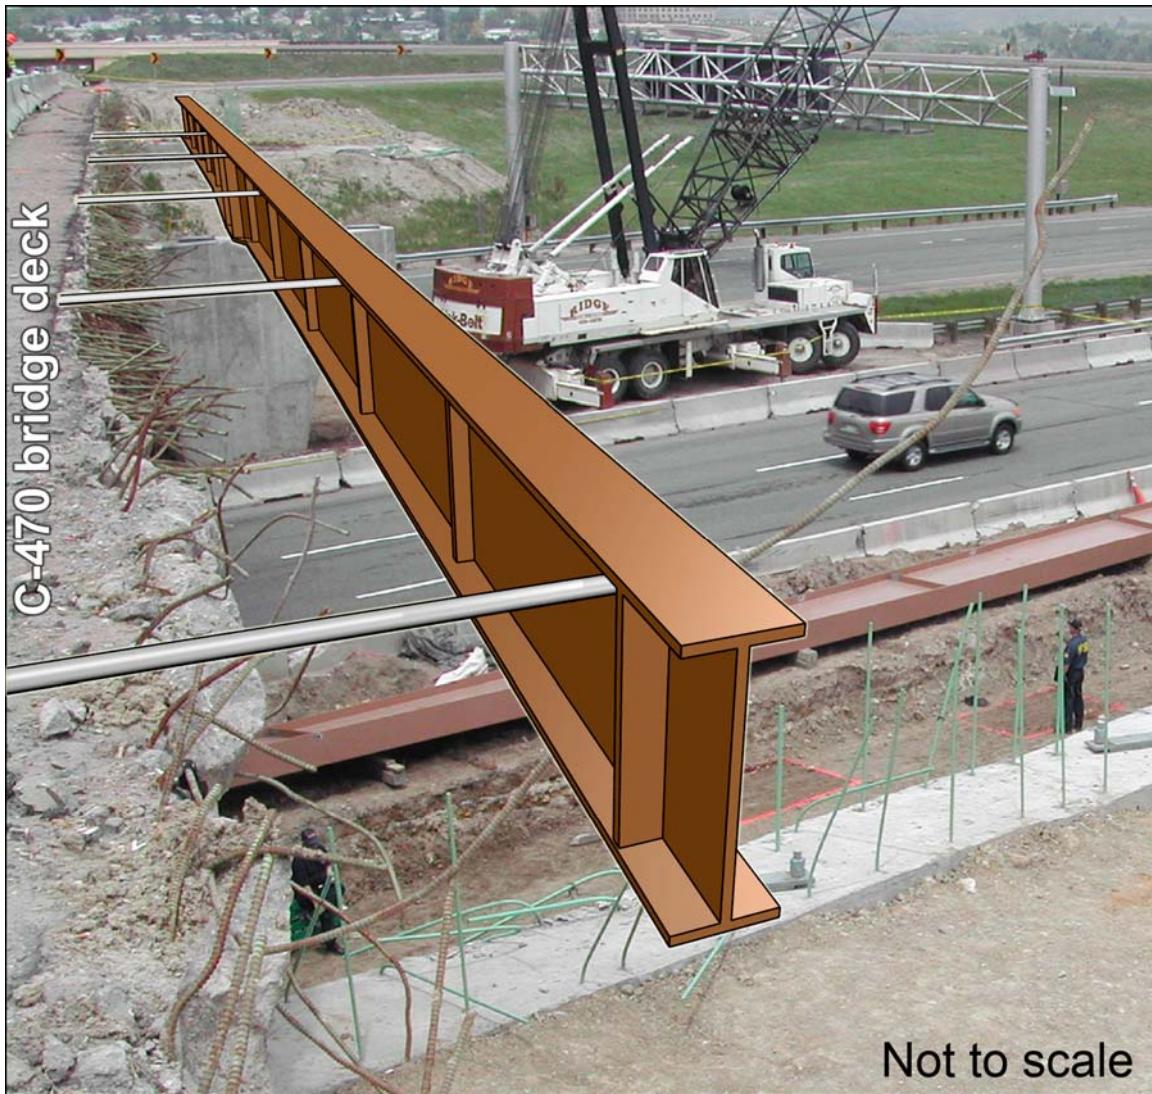
Figure 4. Diagram overlaid on photograph to show the accident girder and five braces in relation to the existing C-470 bridge deck. Note that this graphic is representative only of the approximate relative positions of the girder, bracing, and deck.

Bolts were to be used to connect the girder to the braces, and expansion bolts were to be used to connect the braces to the bridge deck. When Ridge's workers bored holes in the bridge deck and attempted to install expansion bolts in them, they found that the bolts they had on hand were too long for the bridge deck holes.¹⁷

The bracing's failure occurred at the bridge deck, when the lateral force from the girder's distortion placed loads on the expansion-bolted connections, separating the expansion bolts from the bridge. Postaccident examination indicated that the expansion bolts used to connect the braces to the bridge deck were, in various ways, not installed in accordance with manufacturers' requirements. In particular, the Safety Board Materials Laboratory found that the bolt hole diameters in the existing bridge deck measured

0.90 inch while the diameters of the expansion bolts were only 0.75 inch. A 0.75-inch-diameter expansion bolt set in a 0.90-inch-diameter hole required the presence of a horizontal load to maintain some pullout resistance. The horizontal loads at the time of the girder erection levered (or cocked) the bolts in the holes. Once the horizontal load decreased in magnitude or changed direction, the pullout resistance was immediately lost. Over time, the varying cyclical loads on the bolts caused by lateral vibrations, thermal expansion and contraction loads, and wind loads would have resulted in variations to the horizontal loads on the bolts, which eventually would have led to the bolts pulling out of the holes.

9. Based on the cases investigated in this study, the most likely cause of final collapse was the failure of brace 2. Failure of other braces changes the lateral deflected shape of the girder but would not be expected to cause collapse.

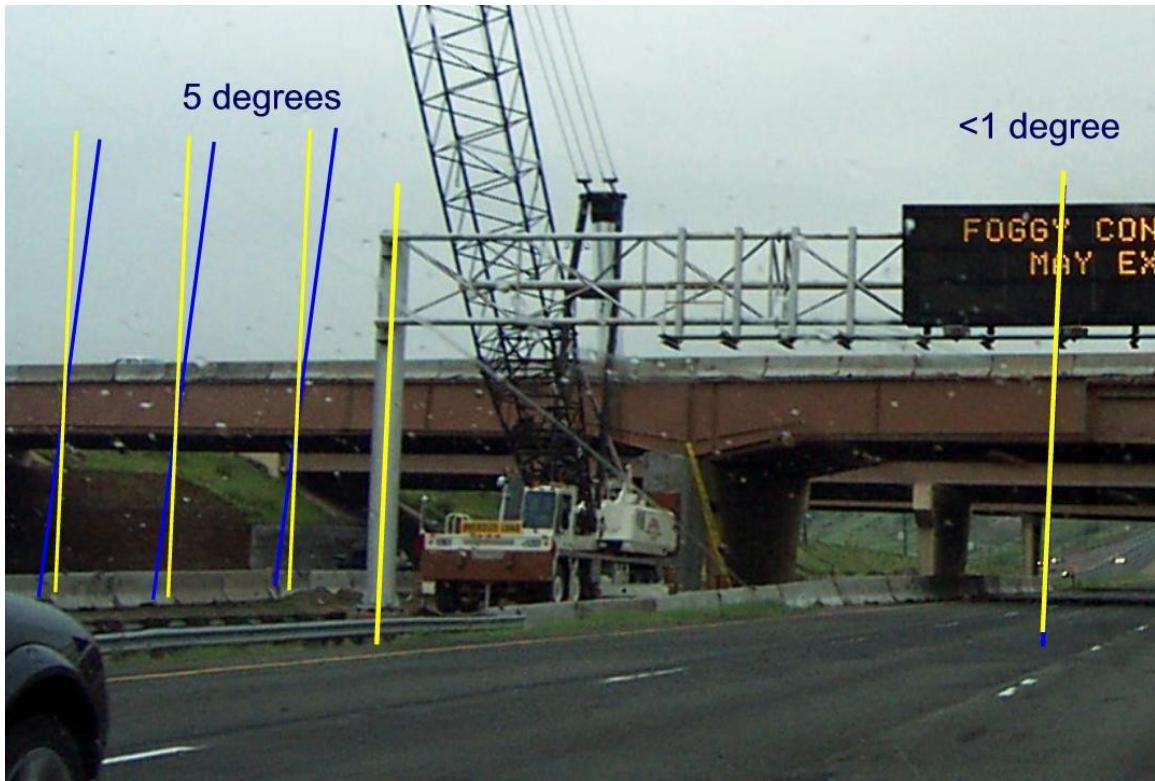
On May 13, a traveler driving westbound on I-70 incidentally made a digital image of the accident girder through the car's windshield. After the accident, Safety Board investigators examined this image and found that it indicated that at this time the accident girder appeared to be leaning toward the existing bridge deck by about 5 degrees between the south abutment and the center bridge pier for the extension and by about 1 degree beyond the center bridge pier. (See figure 5.)

Figure 5. Portion of photograph taken by driver on May 13, 2004, while accident girder was in place over I-70. Photo has been cropped and enlarged to show area of interest; guidelines indicating vertical alignment (yellow) and estimated angle of lean of girder (blue) have been added.

4. The out-of-plumb girder model was more susceptible to instability compared to the plumb girder model. This indicates that erection of the girder in an out-of-plumb condition could be a significant factor in the girder failure.
