National Transportation Safety Board

Highway Accident Brief

Accident Number: HWY-05-MH-006
Accident Type: Motorcoach run-off-the-road and rollover
Location: Interstate 55, near Turrell, Arkansas
Date and Time: October 9, 2004, 5:02 a.m. central standard time
Vehicles: 1988 Motor Coach Industries, Inc., 47-passenger motorcoach
Owners/Operators: Walters Bus Service, Inc.
Fatalities/Injuries: 15 fatalities
13 serious injuries
2 minor injuries

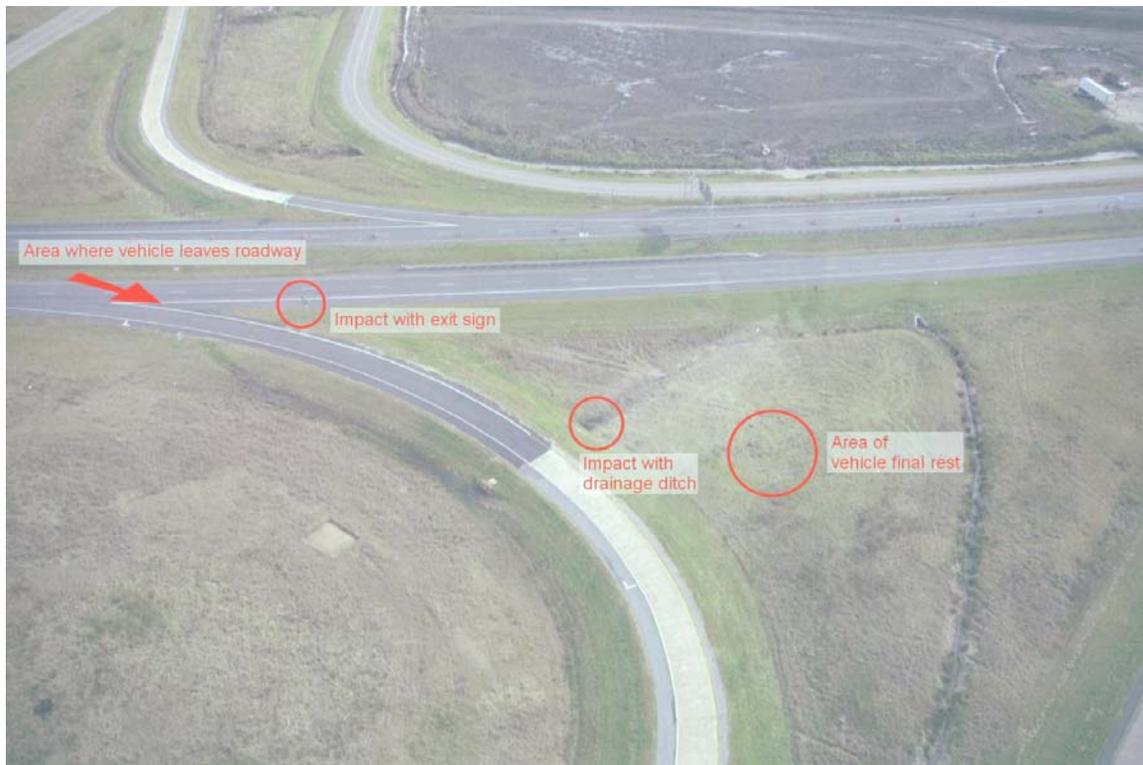
Figure 1. Path of motorcoach from I-55. (Courtesy of Arkansas Highway Police)

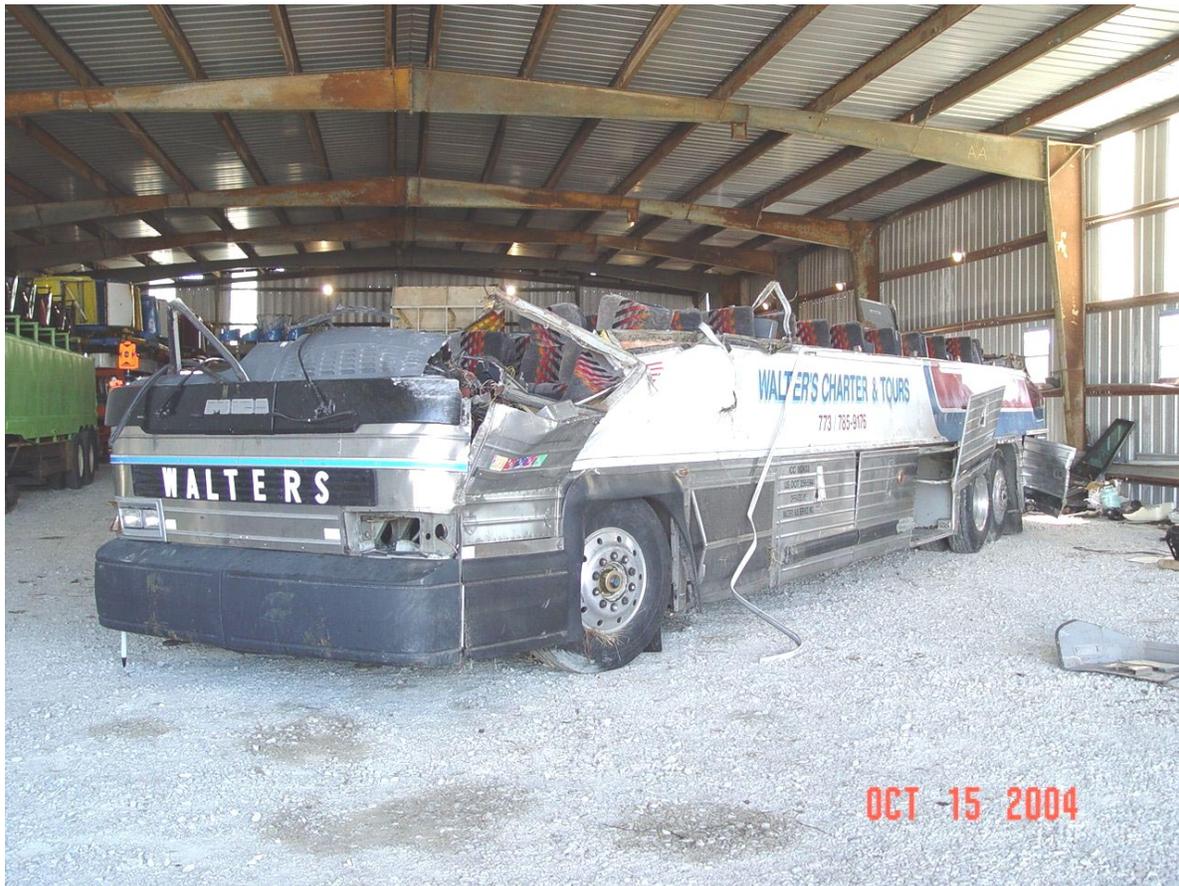
The motorcoach body sustained damage to the upper front driver's side corner, right-passenger-side rear corner near the lavatory, and roof. (See figure 2.) During the rollover, the entire left side of the roof, including the front and rear upper structures, became separated from the motorcoach sidewall at the sash rail (lower window sill level). At final rest, the motorcoach was upside down with the roof adjacent to the body (top side up) and still partially attached

along the right side by several vertical posts.³ The motorcoach sustained significant interior damage as a result of the rollover.

Figure 2. Motorcoach postaccident, with roof detached.

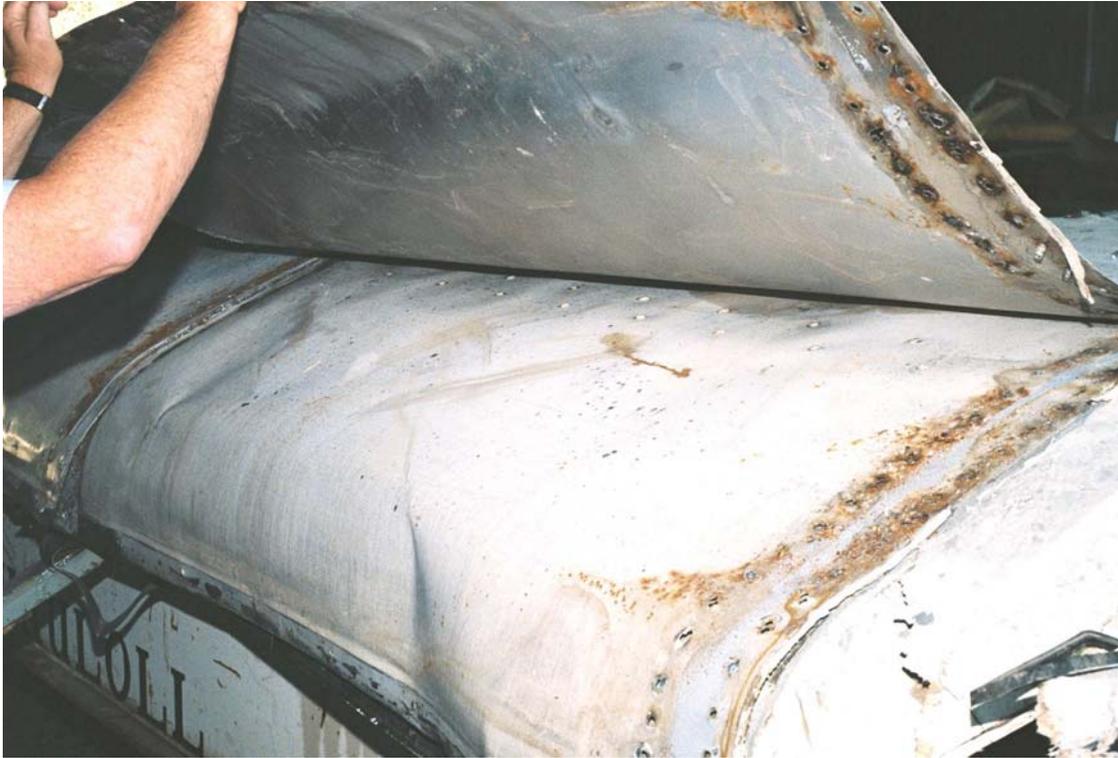
During the investigation, it was discovered that—2 years prior to the accident—the motorcoach had sustained fire damage to its roof and interior as a result of a fire in a facility in which it was parked. Postcrash inspection revealed 14 additional panels of sheet metal attached on top of the original 14 panels on both sides of the roof along its curvature.⁴ (See figure 3.) The new roof panels were 35 by 60 inches. The panels were glued and riveted using Magna-Lock rivets on top of the original roof panels, which ran horizontally from window line to window line and measured 106.25 inches in length and 62 inches in width. Rivet holes drilled to attach the new roof panels were misaligned with the original rivet holes. The investigation also revealed corrosion of several roof vertical posts, roof rails, roof bows, and sash rails along both sides of the motorcoach. Stick welding (oxyacetylene) found in the right-rear upper structure of the roof was also indicative of previous repairs.

Figure 3. Roof of motorcoach, postaccident.

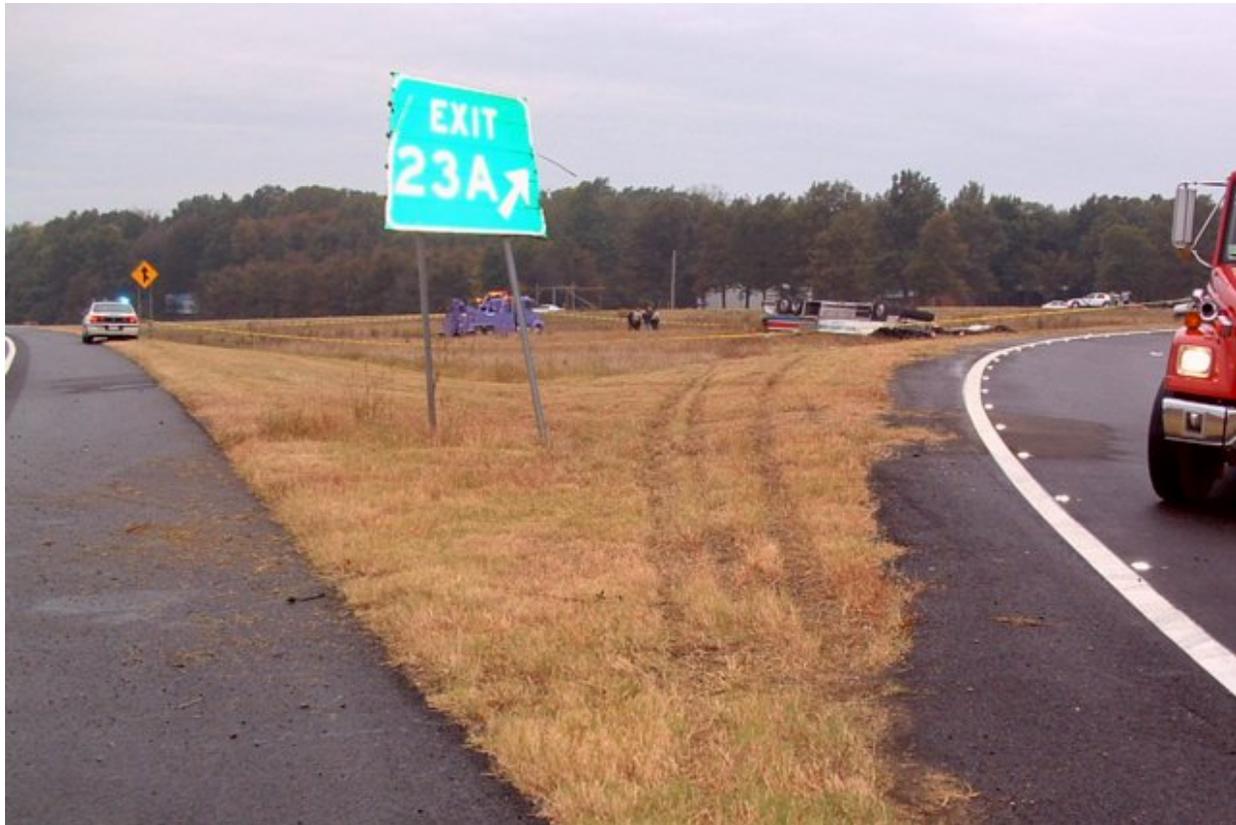
Four tire marks about 71 feet long were located along the southbound shoulder adjacent to the right traffic lane. These marks ended at the edge of the pavement, where furrow marks continued for a distance of 55 feet to the exit 23A sign. Contact damage was observed along the right edge of the exit sign panel, 9 feet above the ground. (See figure 5.) Another tire mark—beginning about 41 feet south of the origin of the four tire marks—was observed along the left side of the exit ramp.

Figure 5. Gore area with furrow marks.

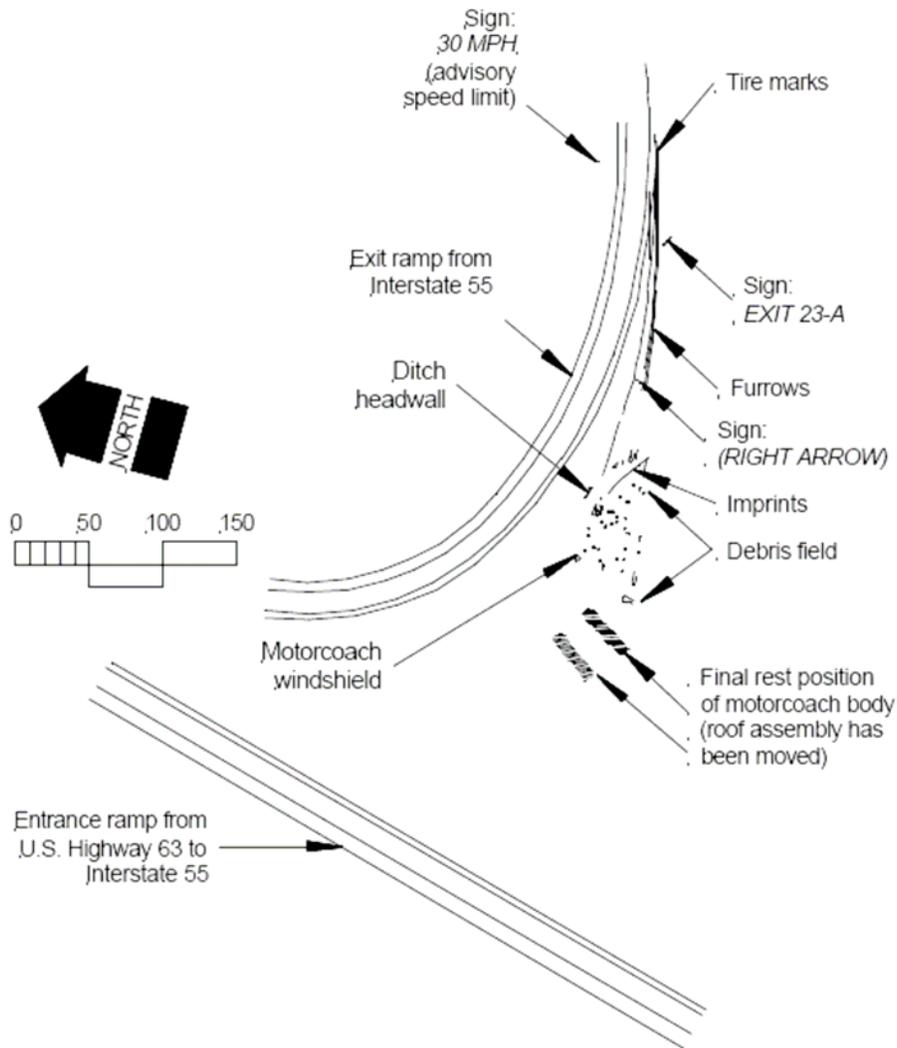
The furrow marks continued for an additional 97 feet until they went across a pair of posts supporting a right arrow sign. The accident motorcoach had overrun the sign, bent the posts forward until they became detached, and then traversed a drainage ditch, leaving a 6- by 8-foot scar. A debris field extended across both sides of the drainage ditch. The motorcoach came to rest about 65 feet south of the ditch. (See figure 6.)

Figure 6. Accident scene diagram.
