National Transportation Safety Board

Highway Accident Brief

Accident No.: HWY-07-MH-007
Accident Type: School bus bridge override following collision with passenger vehicle
Location: Interstate Highway 565 transition exit ramp 19A, Huntsville, Alabama
Date and Time: November 20, 2006; 10:10 a.m., central standard time

HIGHWAY ACCIDENT BRIEF
NTSB/HAB-09/02

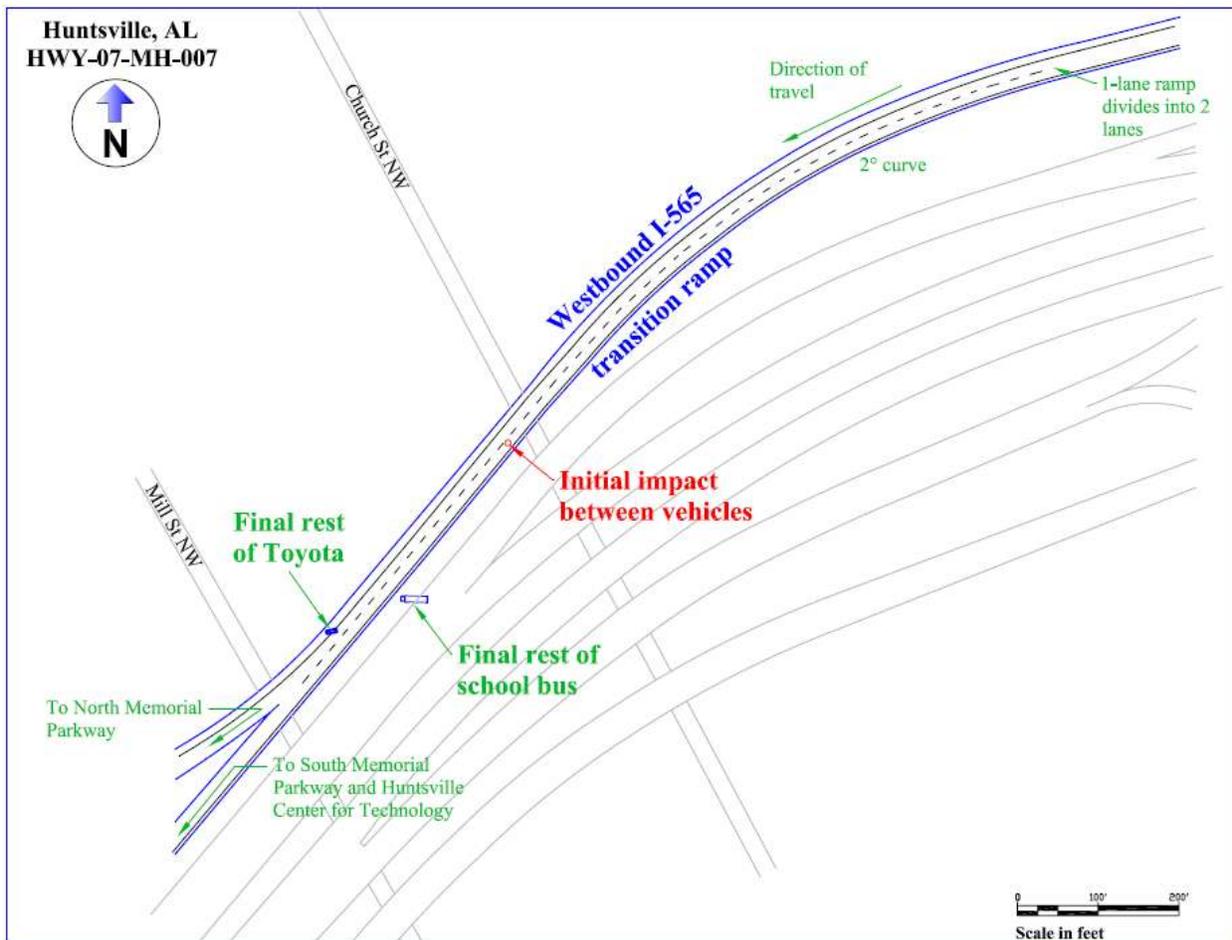
Figure 1. Diagram of westbound I-565 transition ramp, showing point of initial impact between the two accident vehicles, as well as their final rest locations.

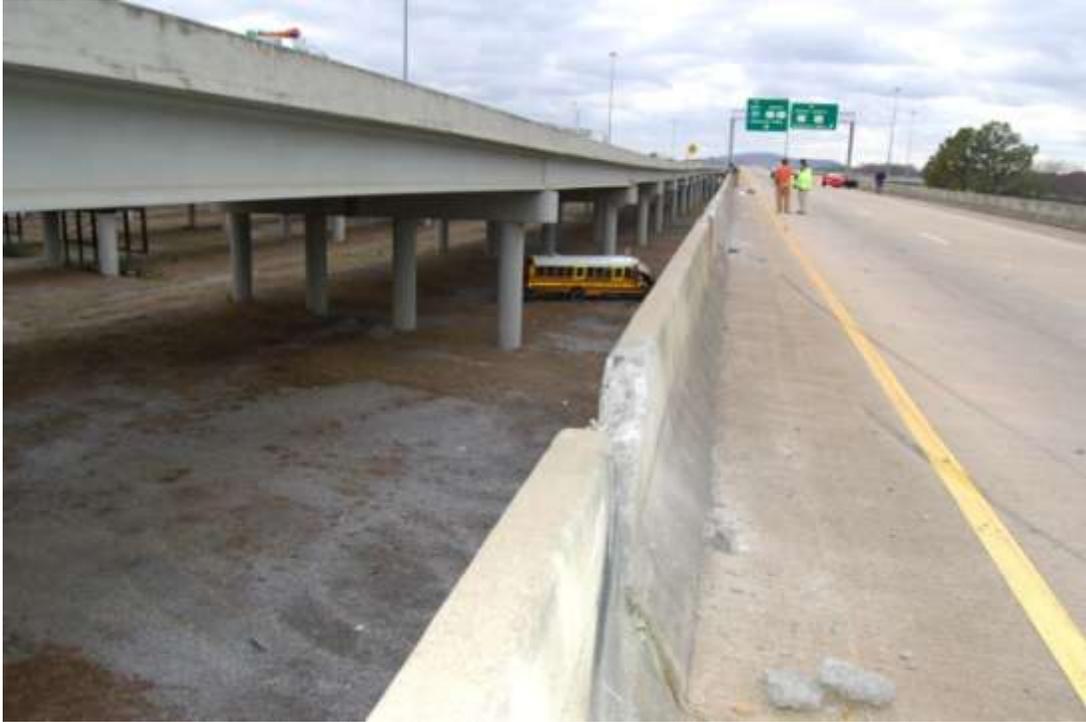
Physical evidence indicated that the school bus climbed and overrode the bridge rail. The school bus driver, who was not wearing his seat belt, was ejected from the bus onto the roadway. The bus continued along the top of the bridge rail for about 117 feet before rolling and falling

Figure 2. Impact damage caused by school bus, westbound I-565 transition ramp bridge rail.

There are some similarities between the impact of the school bus with the bridge rail and the NCHRP TL-4 parameters: the bus had a gross empty weight of 17,700 pounds, it was traveling no more than 55 mph, and it struck the bridge rail at a 9- to 10-degree angle. However, NCHRP test vehicles are provided with unrestricted trajectory before and after impact with a barrier. By contrast, the trajectory of the Huntsville school bus away from the bridge rail was restricted by the presence of the Toyota, which resulted in the school bus mounting and rolling over the bridge rail.

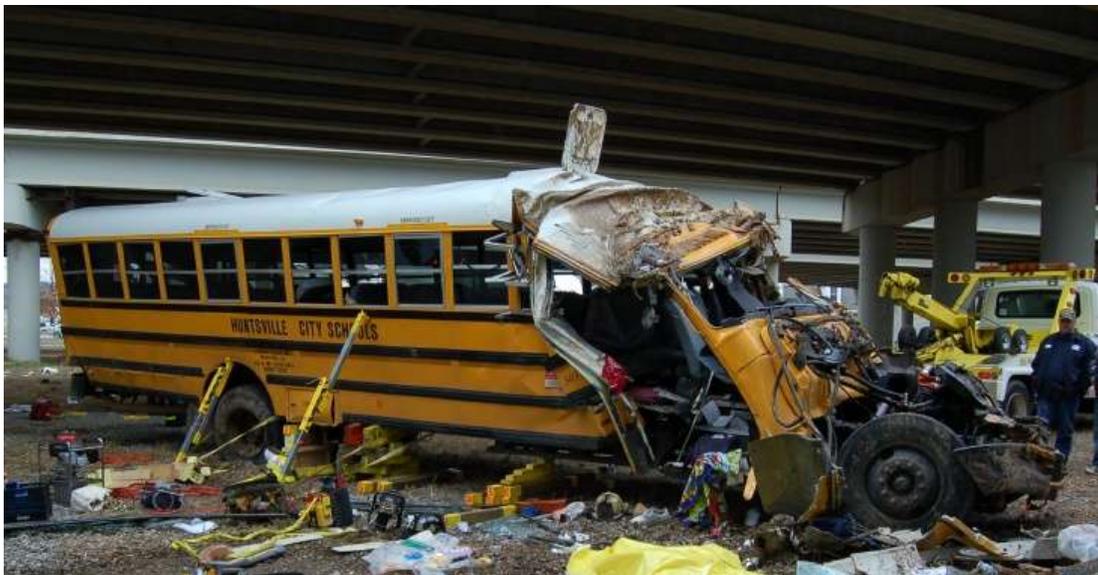
30 feet to a dirt and grass area beneath the ramp. The school bus landed on its front end, rotated clockwise, and came to rest upright on its wheels. (See figures 2 and 3.) Four students in the school bus were killed. The bus driver was seriously injured, and 33 students received minor-to-serious injuries. Three students were not injured.

Figure 3. School bus at final rest position.

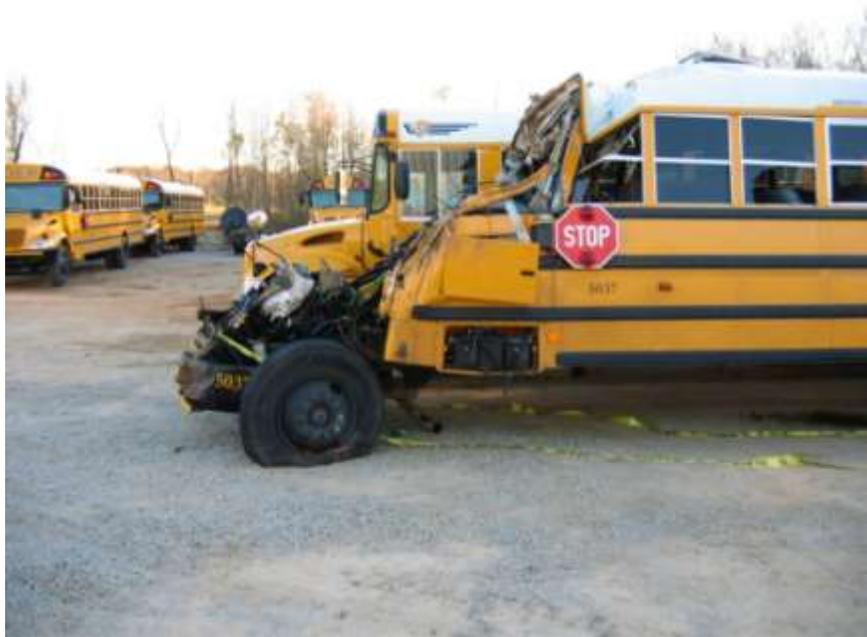
The school bus sustained significant exterior damage to its front end, undercarriage, and roof during its collisions with the Toyota, the bridge rail, and the ground. The damage due to impact with the Toyota extended from the front right corner of the school bus bumper to the right front wheel rim. The damage from the bridge rail ran along the undercarriage and extended almost the entire length of the school bus. The ground impact crushed the front end of the school bus, as well as the front portion of its roof. (See figure 4.) The impact twisted the frame and chassis and caused wrinkled body panels extending to the rear roof area. The twisting of the frame around the rear emergency exit door caused the lower half of the doorframe to be torn away from the body of the bus and caused the top of the rear exit door to bend, allowing the door to spring open. (See figure 5.) The door was bowed inward, and the bottom hinge pin was bowed outward; the top hinge pin was sheared off.

The damage to the interior of the school bus was primarily to the driver seating area and the front loading door. The steering wheel and steering column were crushed downward into the driver seat cushion. The roof crush extended approximately 36 inches into the driver seating area and loading door. The roof also intruded into the first row passenger seating area, though the maximum extent of intrusion could not be determined due to the extensive use of extrication tools and other lifesaving devices within the school bus after the accident.

Figure 4. Extent of damage to front of accident school bus, compared with exemplar school bus.

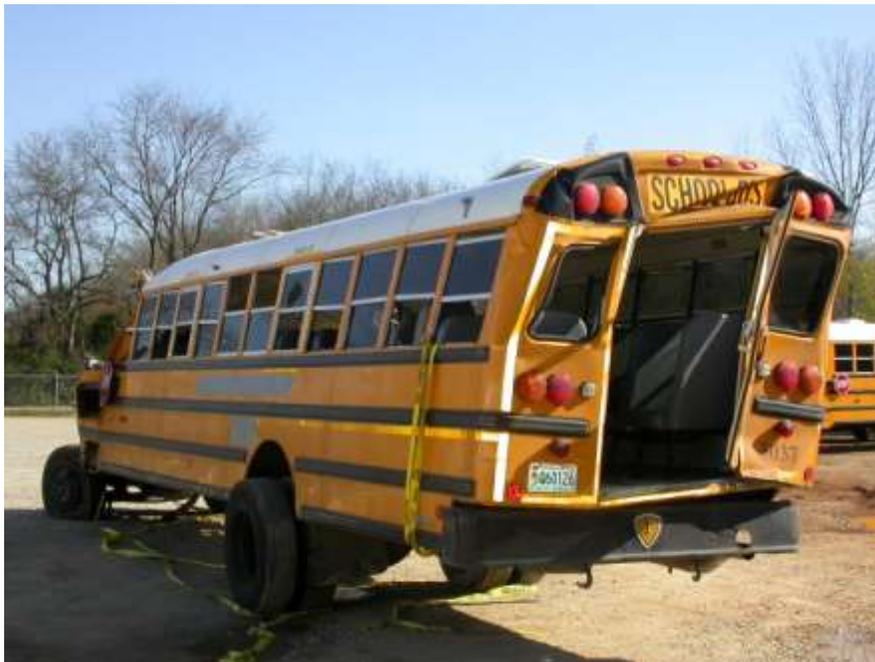
Figure 5. Twisted bus frame and open rear emergency exit door resulting from impact with ground.

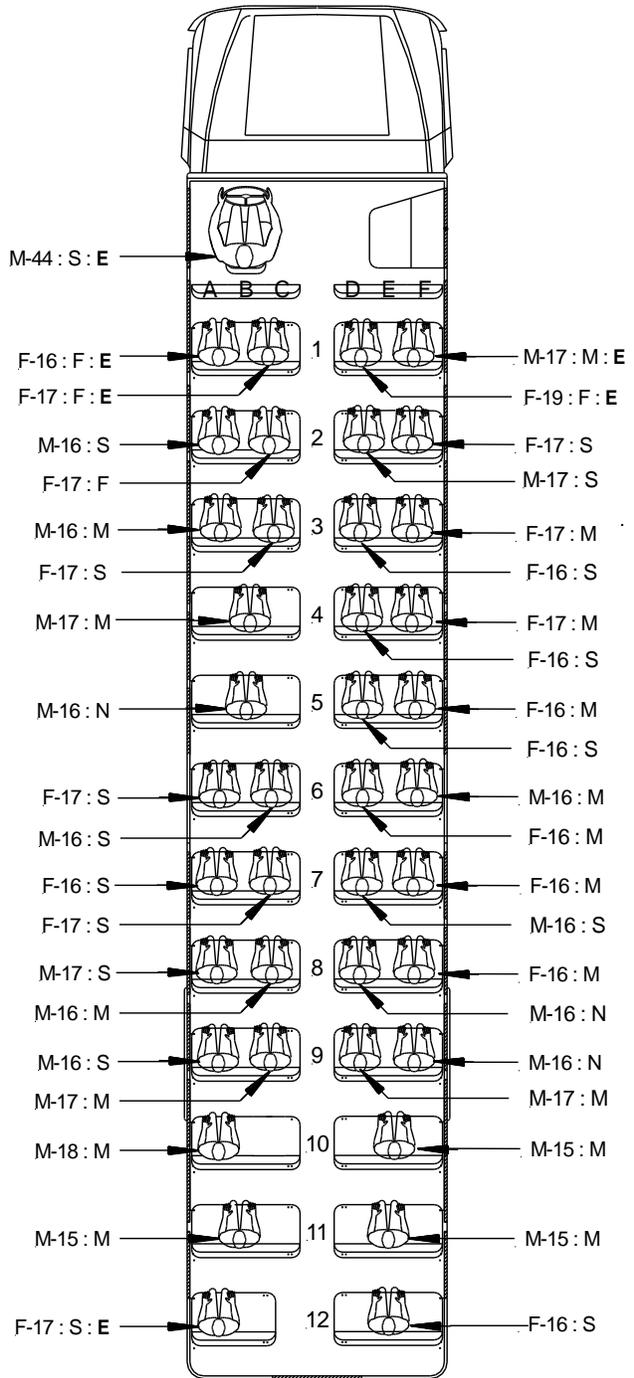
Table 1 summarizes the injuries resulting from the accident, and figure 6 shows the seating positions, ejection status, and injury severity of the school bus passengers. Three of the four fatalities occurred among the front row passengers, and one fatality occurred among the second row passengers. Had the school bus been equipped with lap/shoulder belts, some serious injuries might have been mitigated among occupants seated away from the area of intrusion, such as the fatally injured passenger in the second row and the seriously injured passengers in the rear of the bus, because the belts would have kept these students within their seating compartments during the accident sequence.² However, because it could not be determined whether—at its point of maximum penetration—the school bus roof impinged upon the survivable space of the first row passengers, uncertainty exists as to whether lap/shoulder belts might have prevented the fatalities among the first row passengers.

Figure 6. Seating chart listing gender, age, and injury severity of each bus occupant. Occupants further identified with an "E" were fully or partially ejected from the bus during the accident sequence.

On page 7, figure 6, seating chart, the following corrections are made: (1) the age of the student passenger in row 7, right side, window seat, is corrected to “16,” and the injury code is corrected to “M” for “minor”; and (2) the injury code for the student passenger in row 7, right side, aisle seat, is corrected to “S” for “serious.”
