National Transportation Safety Board

Highway Accident Brief

Accident No.: HWY-04-FH-039
Accident Type: Median crossover, collision, and fire
Location: U.S. Highway 75, Sherman, Texas
Date and Time: September 20, 2004; 4:29 p.m. central daylight time

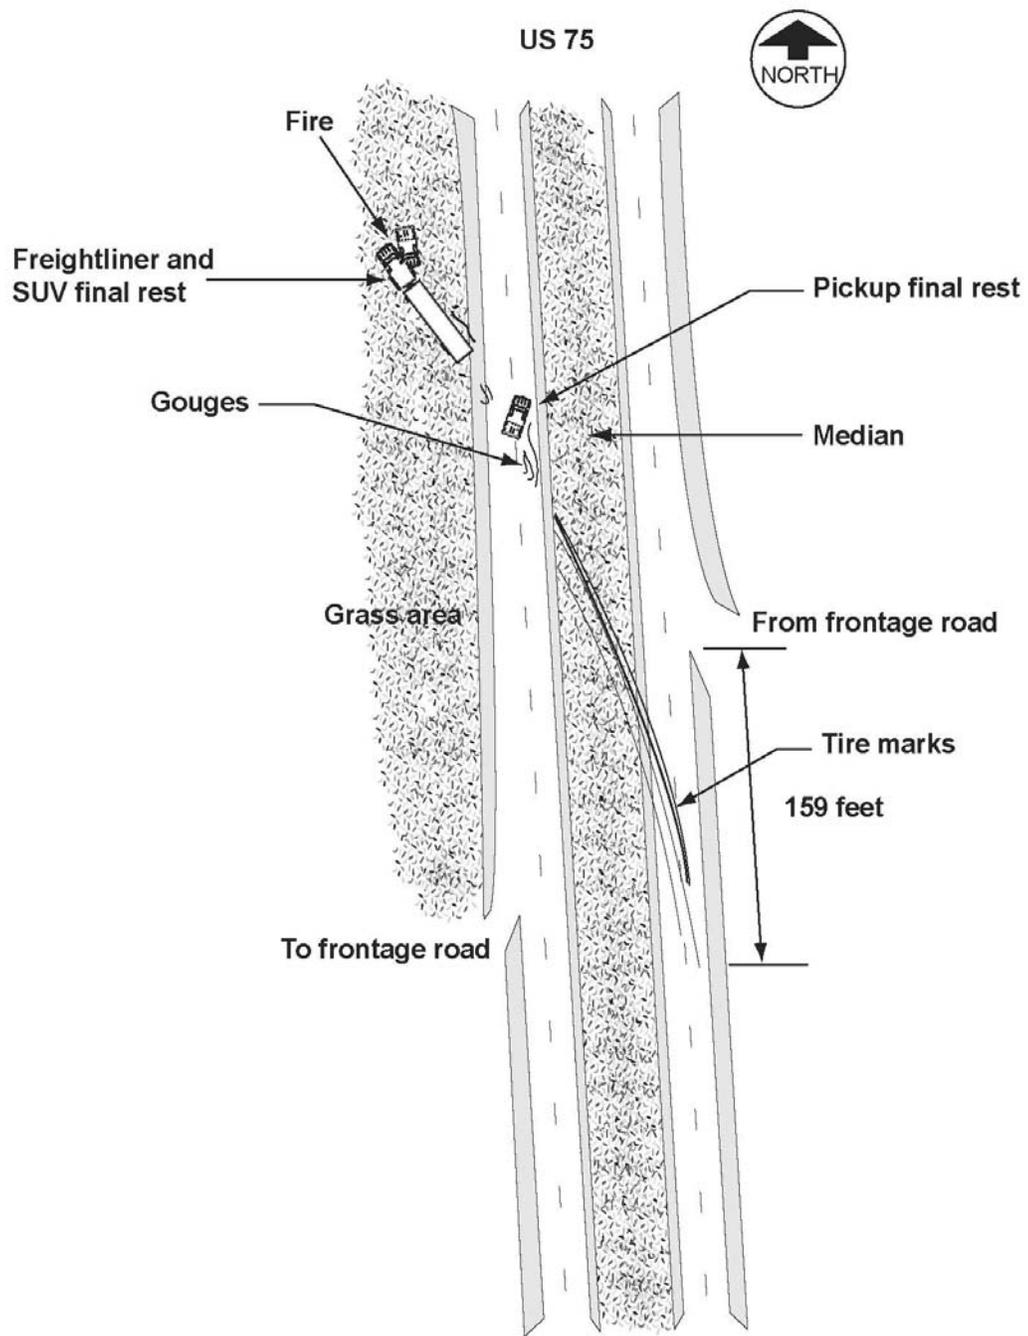
Tire marks from the accident scene, consistent with scuff marks,¹ indicate that as the Freightliner tractor-semitrailer approached the Farm-to-Market 1417 overpass bridge at a speed of 65–70 mph, it veered leftward from the right lane, crossed the left lane, and entered the

earthen median at an angle of approximately 20°. The tractor-semitrailer continued across the median and entered the southbound lanes, where it collided with the SUV and the pickup truck. The Freightliner and the SUV came to rest partially in the grass, just west of the southbound travel lanes; the ensuing fire engulfed both vehicles. The pickup truck came to rest in the southbound travel lanes.

At the accident scene, US 75 is a controlled-access divided road running north–south. The depressed earthen median that separates the two northbound and two southbound travel lanes varies in width from 34–43 feet. The posted speed limit is 70 mph. In the immediate vicinity of the accident, the northbound lanes included an entrance ramp from a frontage road running parallel to the highway. As shown in the accident scene figure, the tire marks produced by the Freightliner began approximately 159 feet prior to the entrance ramp.

Figure. Accident scene diagram, adapted from Sherman Police Department sketch.

Immediately before the accident, the Freightliner driver was traveling in the right lane. The tire marks created as the tractor-semitrailer abruptly moved to the left were consistent with those caused by an evasive steering maneuver. The accident scene diagram (see figure) shows that the tire marks began about 159 feet prior to where an entrance ramp joined the main northbound travel lanes of US 75. Based on the Freightliner's overall length of approximately 50 feet, the front of the tractor would have been only 109 feet from the ramp at the inception of the tire marks. Witnesses reported the Freightliner to be traveling 65–70 mph, which would have placed it less than 1.15 seconds from the ramp. At least two witness statements place other vehicles in the vicinity of the entrance ramp. One vehicle was changing from the right lane to the left lane in front of the tractor-semitrailer, and the other vehicle was preparing to enter the highway at the entrance ramp. Although none of the statements suggested that these vehicles were a hazard, the Freightliner's tire marks show that the driver made an evasive steering maneuver in response to possibly perceiving the vehicles as being hazardous.
