National Transportation Safety Board

Highway Accident Brief

Accident No.: HWY-06-MH-026
Accident Type: Run off roadway and rollover
Location: Westport, New York
Date and Time: August 28, 2006; 6:40 p.m.
Vehicle: 2000 MCI 102DL3 55-passenger motorcoach
Owner/Operator: Greyhound Lines, Inc.
Occupants: Driver and 52 passengers
Fatalities: 5, including driver
Injuries: 48 (20 serious and 28 minor)

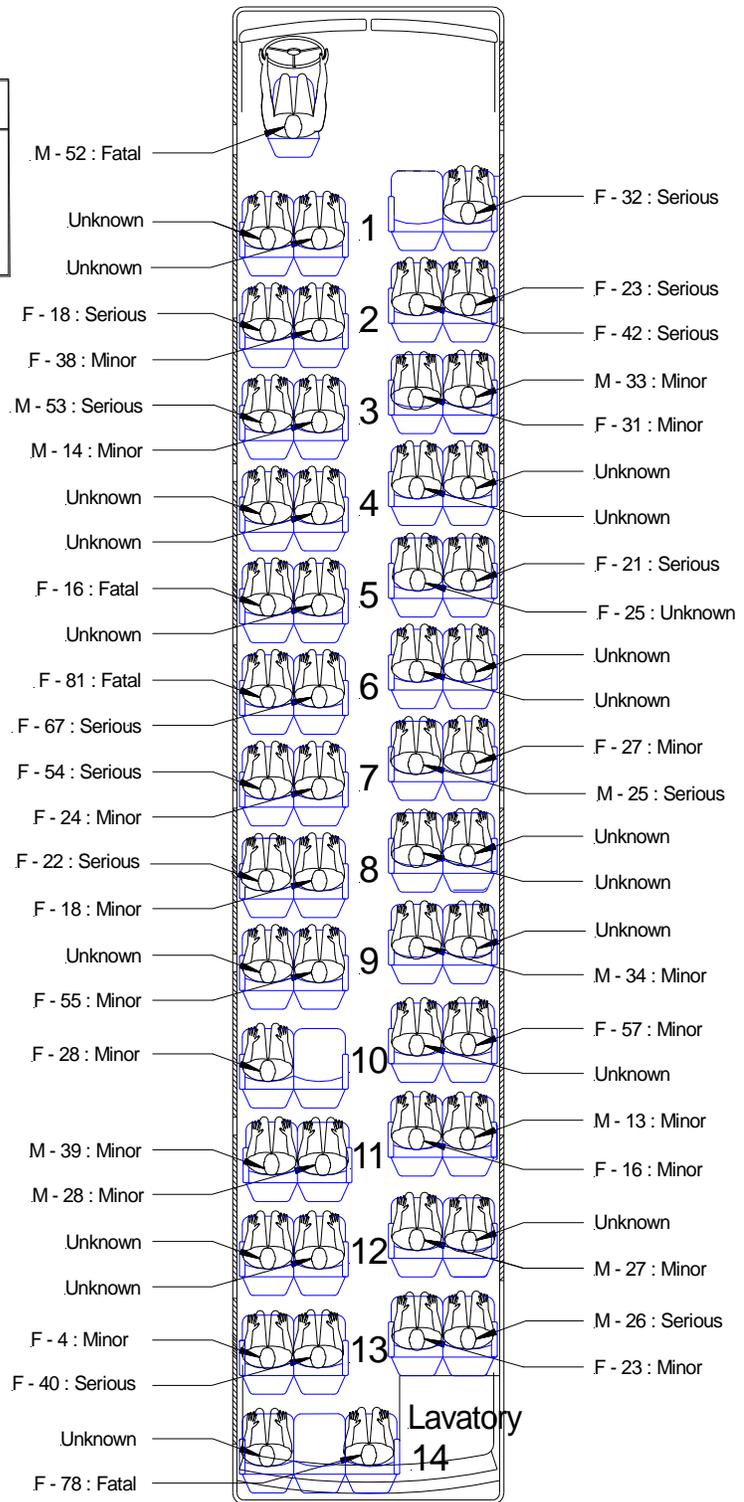
Figure 1. Seating chart.

There were 53 occupants aboard the accident motorcoach (see figure 1). The driver and four passengers sustained fatal injuries (see table 1). The passengers who died were seated in seats 5 (left-side¹⁶ window), 6 (left-side window), and 14 (right-side aisle)¹⁷; the location of the fourth passenger could not be determined. For seating locations marked “unknown” in figure 1, investigators were unable to determine specific seating locations.¹⁸ The driver was wearing a lap belt restraint; the passenger seats did not have restraints.

Seating chart is based on interviews and depicts persons in known seating positions.

Chart does not include fourth fatally injured passenger, whose location could not be determined.
