National Transportation Safety Board

Highway Accident Brief

Accident Number: HWY-13-FH-018
Accident Type: Multivehicle collision and subsequent vehicle fall from bridge
Location: US Route 50/301, eastbound span of William Preston Lane, Jr., Memorial Bridge (Chesapeake Bay Bridge) near Annapolis, Maryland
Date and Time: Friday, July 19, 2013, 8:24 p.m. eastern daylight time
Vehicles: 2010 International truck-tractor semitrailer combination unit
2007 Chrysler Sebring passenger vehicle
2014 Mazda CX-5 passenger vehicle
Fatalities: None
Injuries: 1 minor, 3 uninjured

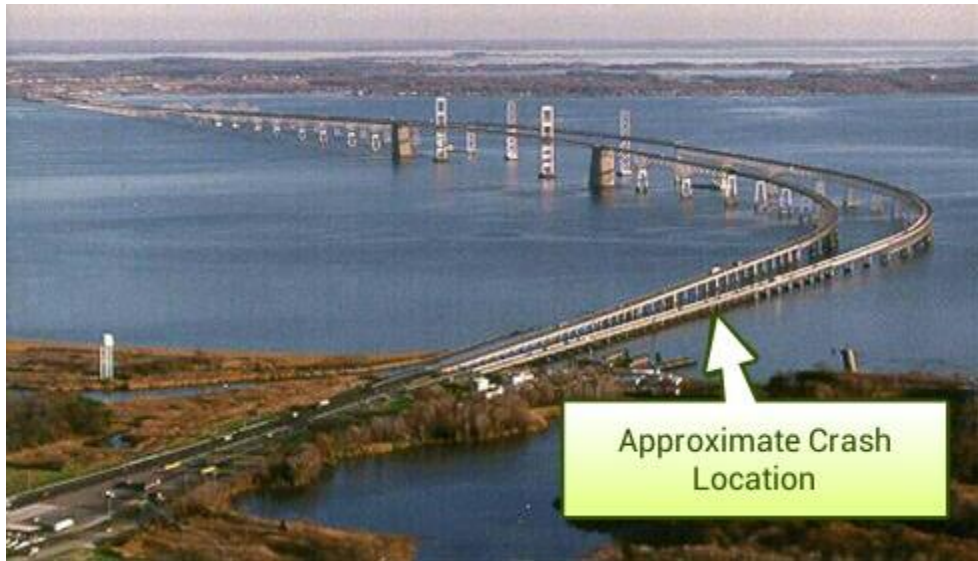
The Chrysler was in the right lane and had reduced speed to 4 mph due to the traffic queue ahead when it was struck from behind by a 2010 International truck-tractor and refrigerated semitrailer combination unit traveling 47 mph.¹ The truck-tractor, operated by a 29-year-old male driver, collided with the left rear corner of the Chrysler, pushing it into the concrete barrier adjacent to the right lane. As the truck-tractor and the Chrysler continued forward, the front of the Chrysler collided with a 2014 Mazda CX-5 occupied by a 65-year-old male driver and his wife. During the collision sequence, the Chrysler was pushed up onto the barrier wall and then rode along the top of it, before falling approximately 27 feet into the Chesapeake Bay. The Chrysler came to rest between two bridge piers to the south of the eastbound span, in approximately 7 feet of water. The Mazda rotated counter-clockwise and came to rest near the left front corner of the truck-tractor in the middle of the two travel lanes. (See figure 1 for the approximate location of the crash and figure 2 for the final rest of vehicles.)

Figure 1. View of Chesapeake Bay Bridge looking east, showing crash location. (Courtesy of Maryland Transportation Authority)

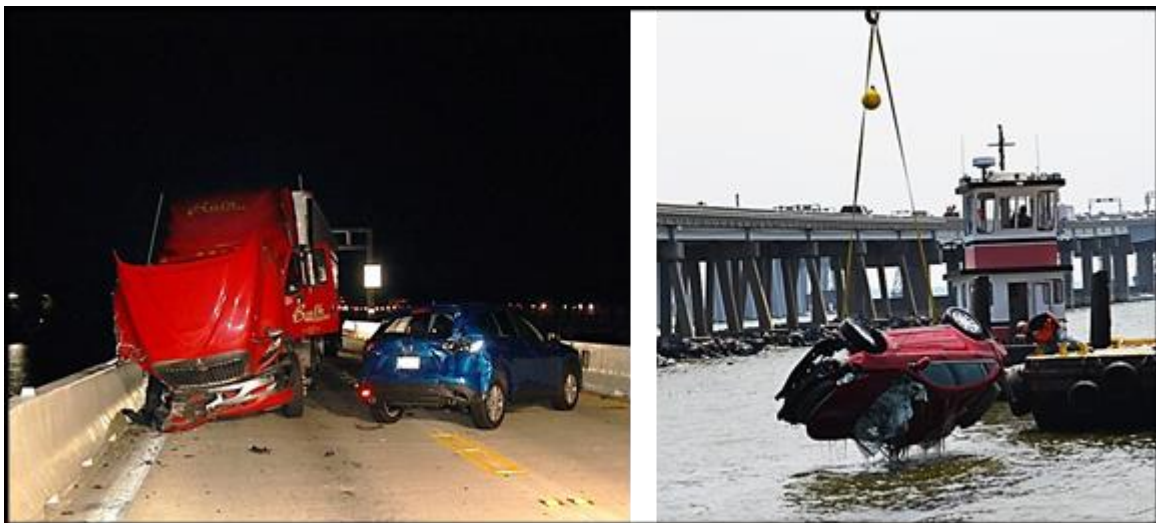
Figure 2. At left, collision scene view of 2010 International truck-tractor and 2014 Mazda CX-5 at final rest. At right, 2007 Chrysler Sebring being recovered from Chesapeake Bay. (Courtesy of Maryland Transportation Authority)

Both the 2010 International truck-tractor and the 2007 Chrysler Sebring were significantly damaged as a result of the crash, though the 2006 Great Dane refrigerated semitrailer was not damaged. The 2014 Mazda CX-5 sustained relatively minor damage to the rear end. All vehicles were removed from the scene and transported to North Country Recovery in Odenton, Maryland, for further inspection.

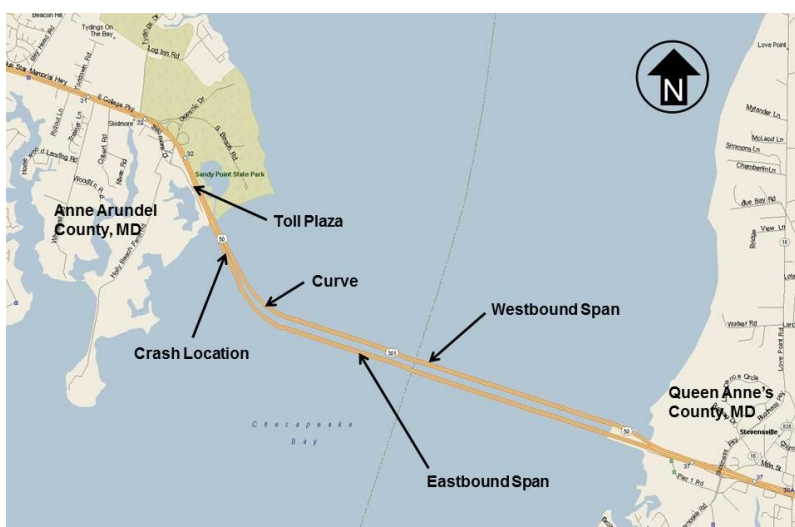
An 11-lane-wide toll plaza is located on the west end of the eastbound span at mile marker 32. The crash occurred about 0.5 mile past the toll plaza, near mile marker 32.5, after traffic had merged into two travel lanes. Just past this location, near mile marker 33, the bridge begins to curve to the left as it ascends farther above the Chesapeake Bay. (See figure 3 for a map showing the crash location.)

Figure 3. Map of Chesapeake Bay Bridge, showing eastbound and westbound spans, eastbound toll plaza, crash location, and roadway curve.

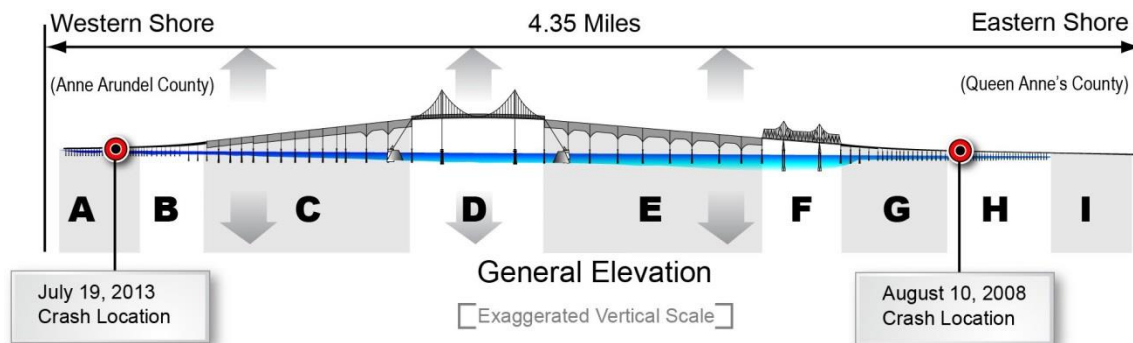
Figure 4. General elevation diagram of Chesapeake Bay Bridge eastbound span, noting locations of July 19, 2013, and August 10, 2008, crashes. Sections A and H are both beam span construction. Other construction types within the eastbound span include girder spans, deck truss spans, suspension spans, deck cantilever truss spans, and through cantilever truss spans.

Following the August 10, 2008, crash, the MDTA upgraded the concrete barrier lining the outside travel lanes in the beam span portions of the eastbound span (sections A and H in figure 4). Prior to the upgrade, however, the concrete barrier on these portions of the bridge satisfied height and strength requirements equivalent to test level 2 (TL-2)⁷ traffic railings.

continuity. The upgrade brought the previously TL-2 concrete barrier located in the beam span portions of the eastbound span of the bridge to an equivalent TL-4 high-performance barrier.⁸ The concrete barrier itself remained 34 inches high.

Because of this upgrade, the 34-inch-high barrier in place at the time of the July 19, 2013, crash was equivalent to a TL-4 high-performance barrier. Following the collision, the barrier remained intact and in place on the bridge deck.

The upgrade consisted of adding 1-inch-diameter high-strength anchoring bolts extending down through the traffic side face of the barrier, securing it through the bridge deck. In addition, W-beam guardrail was installed on the outside face of the barrier to provide longitudinal

The MDTA has investigated various rehabilitation options to increase the height of the concrete barrier. It has determined that substantial reconstruction would be required on the bridge deck, and that the most suitable course of action is deck replacement.

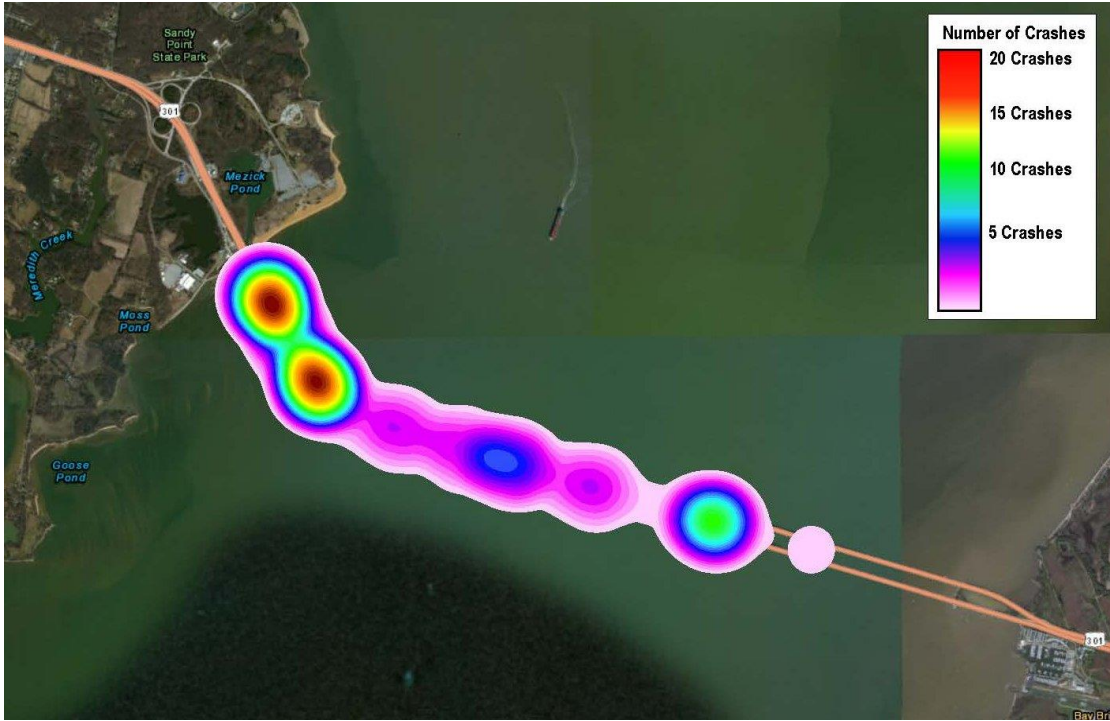
Based on the accident history for the years 2008–2010, figures 5 and 6 present hotspot maps showing the location of crashes on the eastbound and westbound spans of the bridge. The data show a greater concentration of crashes between the toll plaza and the leftward curve in the bridge on the eastbound span, with smaller concentrations near the center peaks of the bridge. During this 3-year period, 79 crashes occurred on the eastbound span and 54 on the westbound span, though the data show that the westbound span had a greater concentration of crashes in the center of the bridge.

Figure 5. Hotspot map showing location of crashes on eastbound span from 2008 through 2010. (Courtesy of Maryland Transportation Authority)

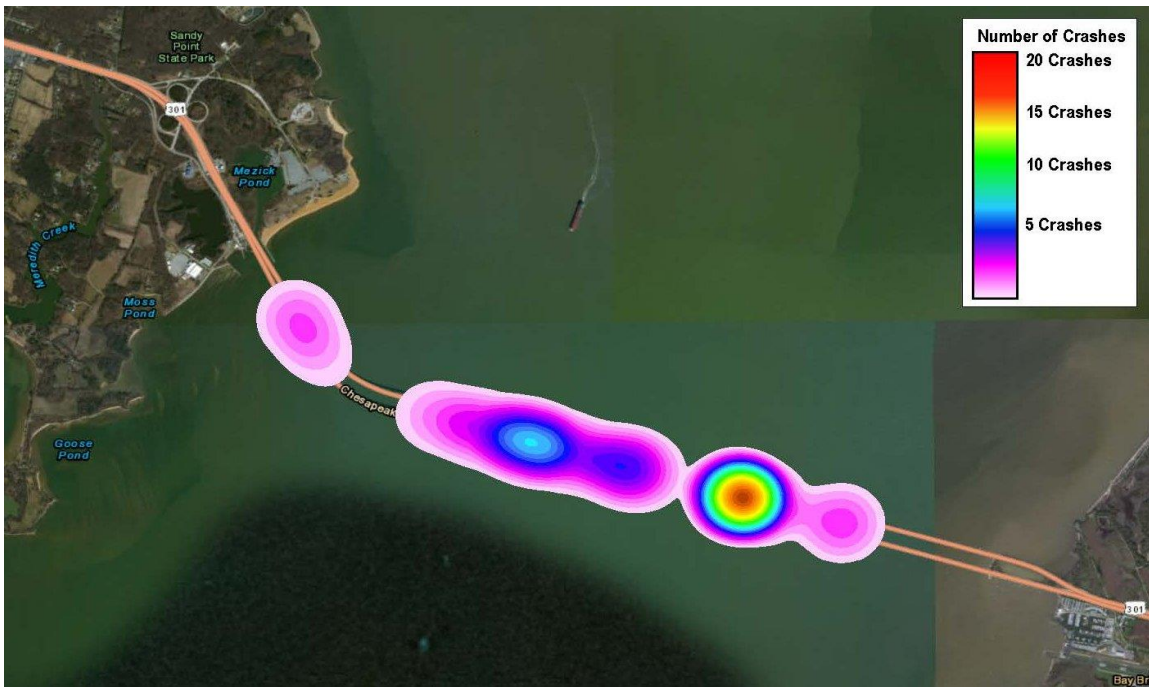
Figure 6. Hotspot map showing location of crashes on westbound span from 2008 through 2010. (Courtesy of Maryland Transportation Authority)
