National Transportation Safety Board  
Washington, D.C. 20594

Highway Accident Brief

**Accident Number:** HWY14MH006  
**Accident Type:** Tire deflation and tread separation, cross-median crash  
**Location:** US Route 90 near milepost 160.2, near Centerville, St. Mary Parish, Louisiana  
**Date and Time:** Saturday, February 15, 2014, about 11:30 a.m.  
**Vehicles:** 2004 Kia Sorento sport utility vehicle  
2005 IC Bus (66-passenger school bus)  
**Fatalities:** 4  
**Injuries:** 2 serious, 30 minor

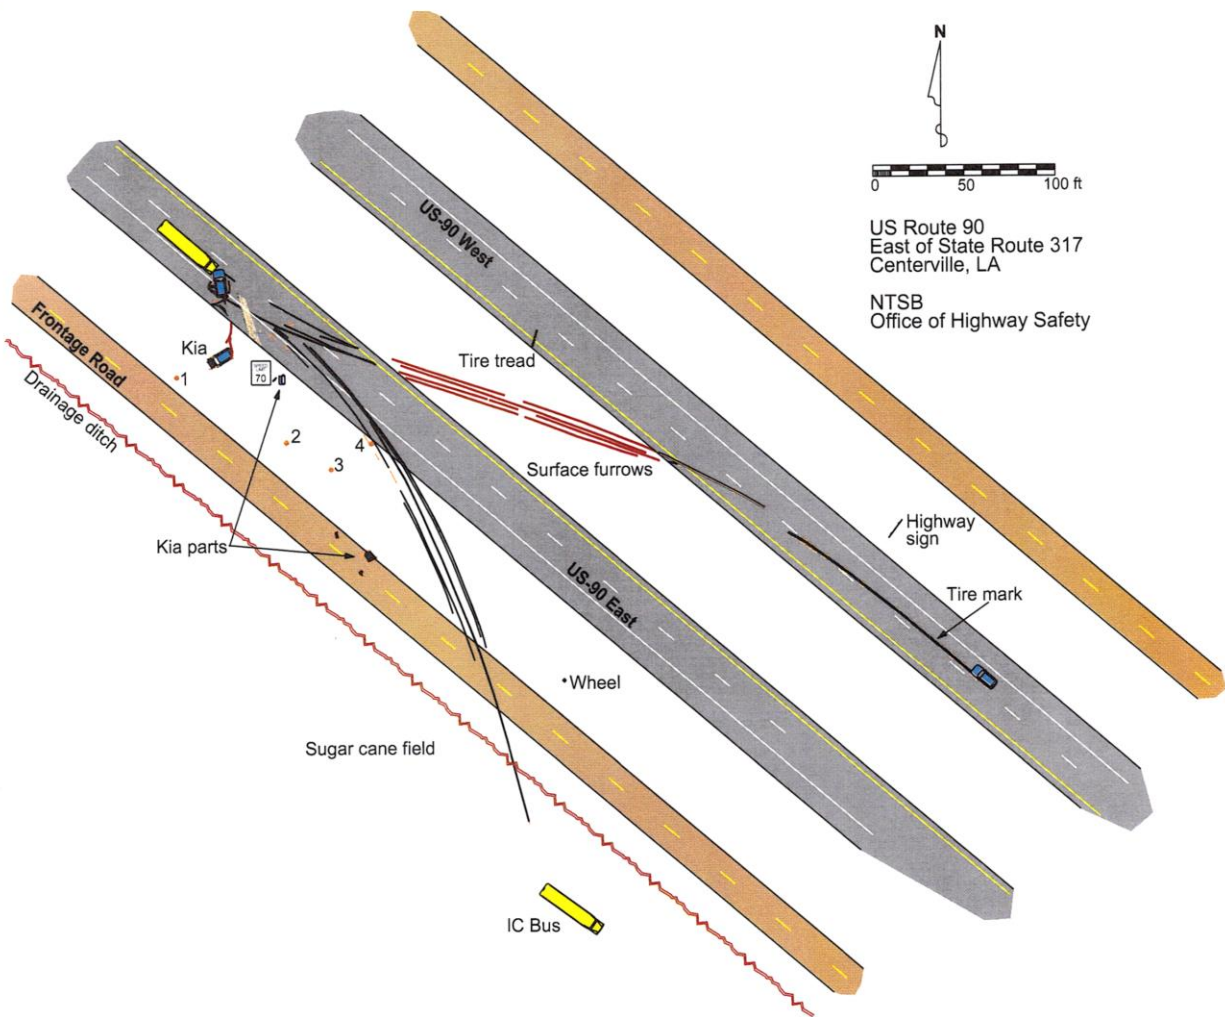
**Figure 1.** Scene drawing showing crash sequence, from Kia loss of control and tire tread separation to final rest positions of both vehicles. Locations of ejected Kia occupants are marked 1–4.

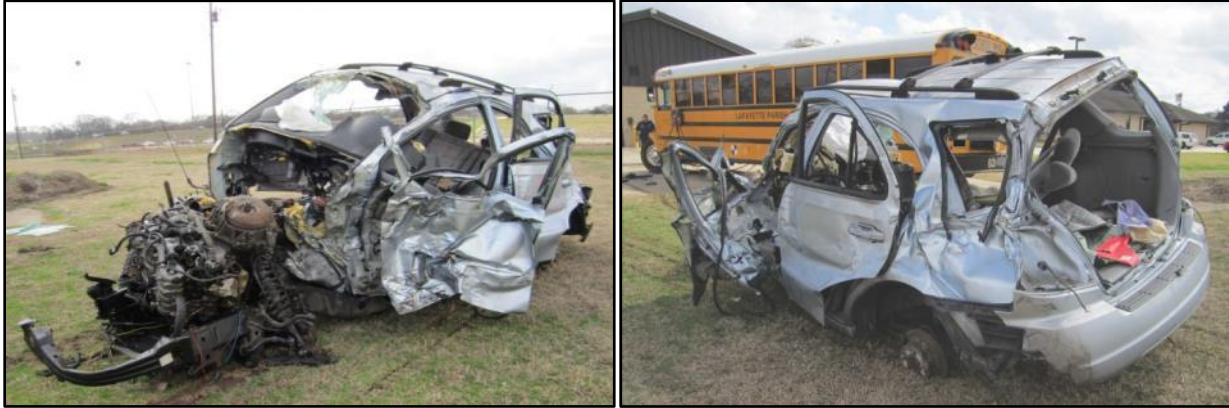
The Kia sustained significant contact damage to the left front axle area and the entire left (driver) side as a result of the initial and subsequent impacts with the school bus (figure 2).<sup>3</sup> The engine block and a portion of the transmission were broken away from their mounts, displaced from the vehicle, and located about 170 feet from the area of impact. The rear hatch was also detached from its mounts and found about 69 feet east of the area of impact.

**Figure 2.** At left, damage to front and driver side of Kia. At right, damage to roof and rear of Kia.

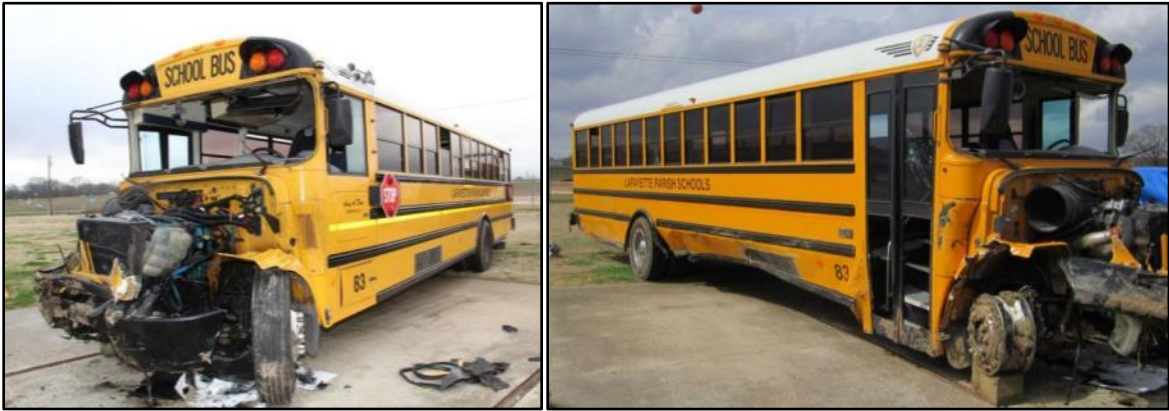
The school bus sustained contact damage primarily to the front end, with additional damage to its right side along the skirt panel below the bus frame (figure 3). The NHTSA databases contained no safety-related recalls or defects for the school bus that would have affected its involvement in this crash.

**Figure 3.** At left, damage to front of school bus. At right, damage to front and right side of school bus.

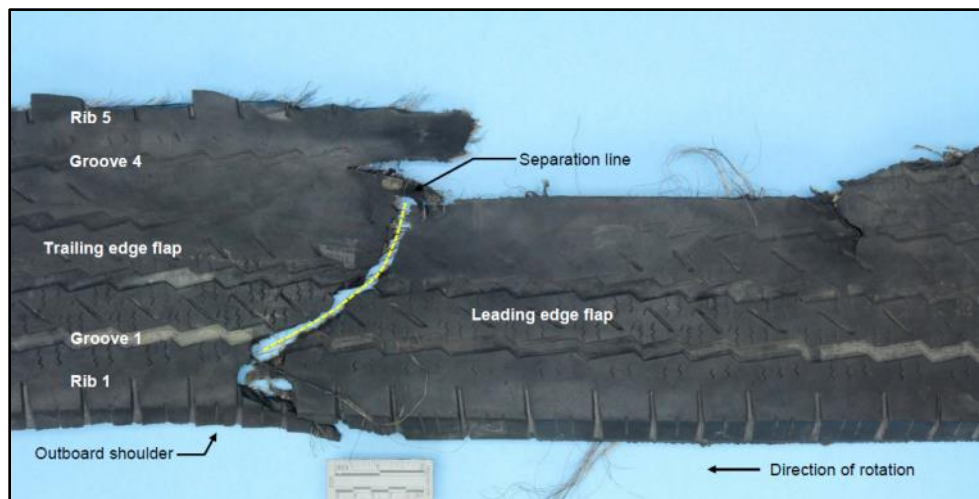
The subject tire was a Michelin Cross Terrain manufactured in late October 2003.<sup>6</sup> The tire tread was composed of five ribs with zigzag grooves between each rib. Tread depth measurements were taken in all four grooves, every 4 inches along what would have been the circumference of the tire (figure 4).

**Figure 4.** Surface side of separated tread, with two flaps in their approximate positions prior to separation.

The average tread depths for grooves 1 through 4 were 4/32, 2/32, 2/32, and 3/32 inch, respectively.<sup>7</sup> The tire had minimum tread depth values of zero at some locations (bald spots), where wear had exceeded the depth of the grooves.<sup>8</sup>

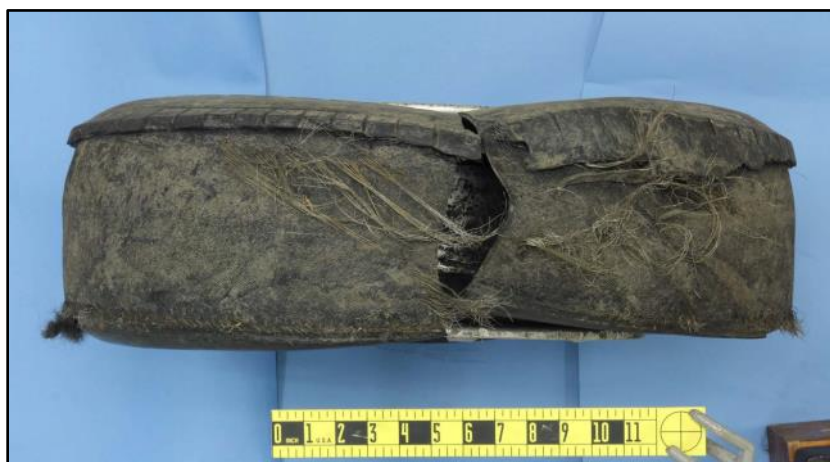
The tread separated from the tire carcass near a bald spot located toward the inboard edge of the tire. The separation started as a delamination between the inner and outer steel belts on the inboard side of the tire. It evolved into a thumbnail-shaped pocket that extended along the shoulder of the tire. The difference in wear between the delaminated region and the remainder of the tread indicates that the pocket was likely present for several hundreds to thousands of miles. Additional delamination formed along the outboard shoulder and progressed toward the inboard shoulder. The tread separated from the tire when the delaminations merged. The tire carcass subsequently split in the radial direction (from the outboard shoulder to the inboard shoulder), and the tire lost pressure (figure 5).

**Figure 5.** View of tire carcass, without separated tread, near split.

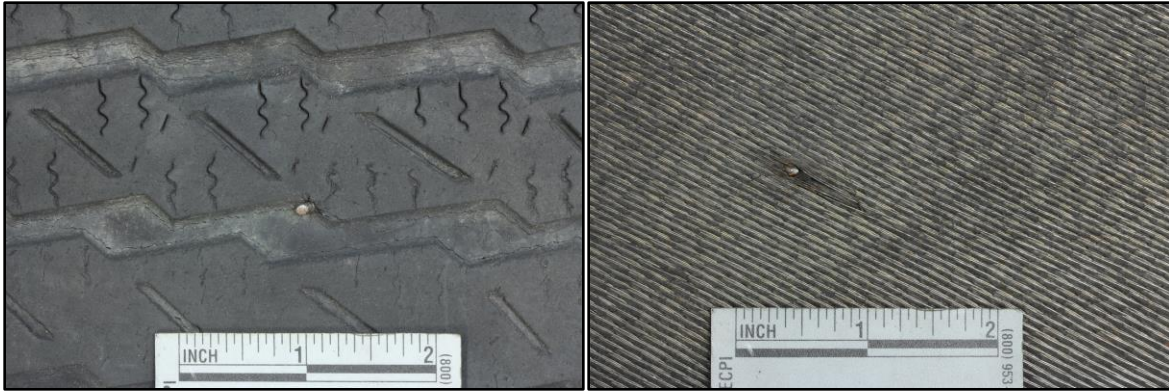
Three foreign objects had penetrated the tread and the outer steel ply. Figure 6 shows one object found approximately 46 inches clockwise from the tip of the leading edge flap.<sup>9</sup> The steel wires in the outer ply were deformed where the objects had penetrated the tread.

**Figure 6.** Tread and separation side images of foreign object that penetrated tread approximately 46 inches from separation.

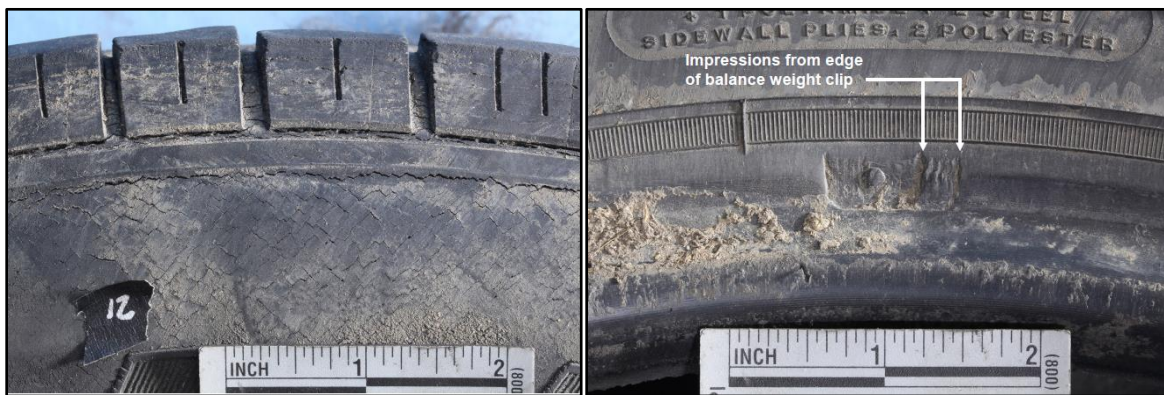
Other physical damage to the subject tire included U-shaped compression set marks on the outboard sidewall and cracking along the sidewall, buttress, and shoulder area (figure 7, left).<sup>10</sup> The wheel weight clip, used to balance the tire, left multiple impression marks near the bead on the inboard side of the tire (figure 7, right), indicating that the tire had likely been operated in an underinflated condition at some point during its lifetime. No precollision damage was found on any of the rims.

**Figure 7.** At left, cracking on inboard sidewall. At right, impressions left by balance weight clip.

<sup>10</sup> Cracking can be associated with overdeflection, foreign materials, ozone deterioration, loss of rubber elasticity over time, and temperature.

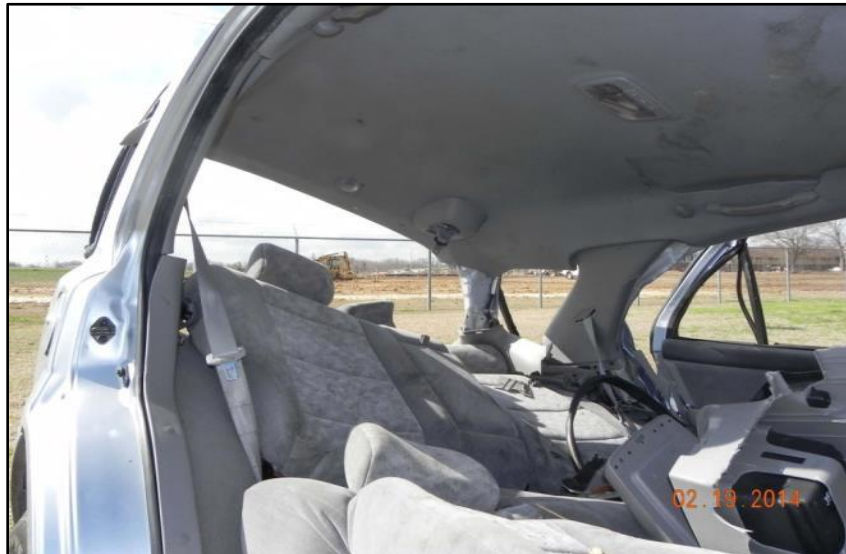
The 37-year-old driver of the Kia and her front seat passenger (a 17-year-old male) were wearing their seat belts at the time of the crash, based on the physical inspection of their lap and shoulder restraints.<sup>11</sup> The driver and front seat passenger frontal airbags deployed. All the seatbacks were broken and displaced rearward as a result of the extreme rotational and rearward forces exerted on the occupants (figure 8).<sup>12</sup> Although the driver was wearing her lap and shoulder restraints, she slipped under the seat belt when the seatback collapsed and was ejected from the vehicle. A 14-year-old male, a 6-year-old female, and a 17-year-old male were seated in the rear. An inspection of all three lap and shoulder restraints in the rear seat showed no evidence of usage at the time of the crash. According to the surviving right front passenger, at the time of the crash, the 6-year-old passenger was not using the booster seat found in the debris inside the vehicle. All three passengers in the rear seat were ejected from the vehicle and fatally injured.

**Figure 8.** Interior view of Kia showing collapsed seatbacks.
