National Transportation Safety Board

Highway Accident Brief

Accident Number: HWY15FH008
Accident Type: 15-passenger van roadway departure
Location: North of the intersection of State Road 78 West with US Highway 27, near Moore Haven, Florida
Date and Time: Monday, March 30, 2015; 12:30 a.m.
Vehicle: 2000 Dodge B3500 Ram 15-passenger van
Owner/Operator: Independent Haitian Assembly of God Church
Fatalities: 8
Injuries: 10 (8 serious, 2 minor)

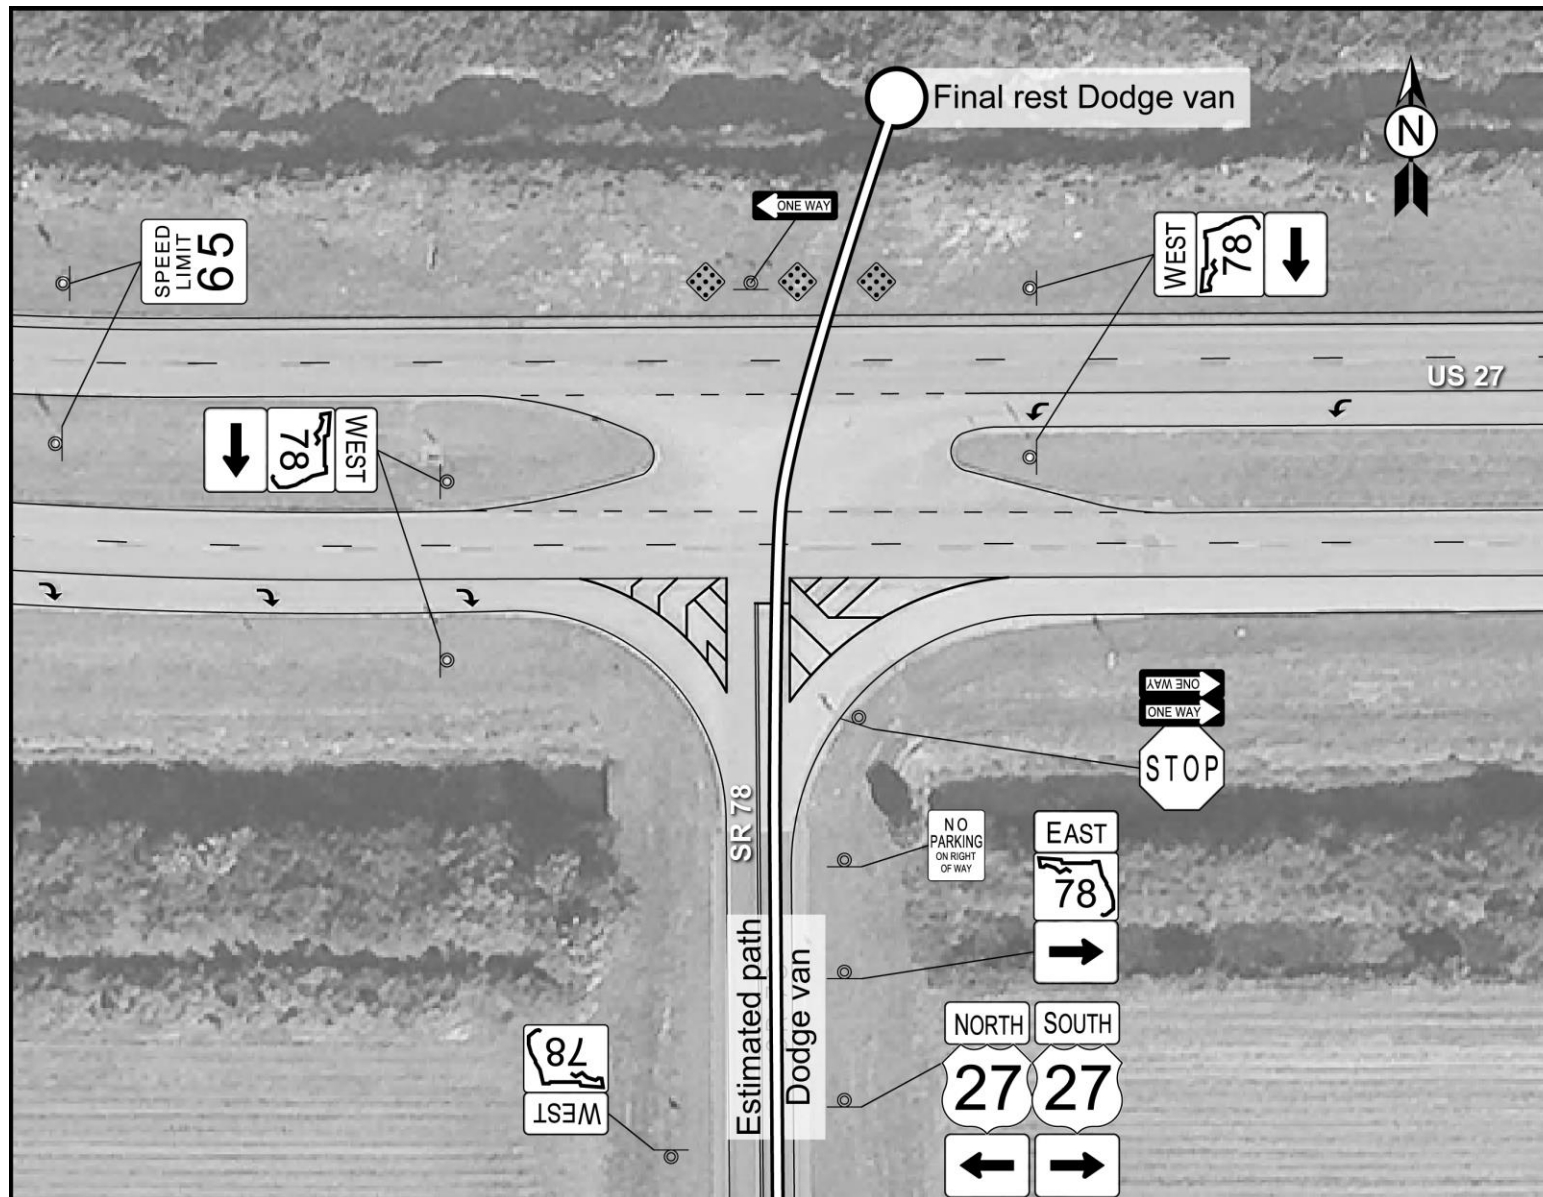
The van failed to stop at the stop sign at the T-intersection with US-27. The van traveled through the intersection, went off the roadway onto the grass shoulder on the north side of US-27, vaulted across a canal, and struck the far side bank, coming to rest 46 feet north of the intersection in the shallow canal, facing northeast. One of the survivors crawled out of the van, walked to the edge of the highway, and waved down help. The collision resulted in eight deaths; the remaining van occupants received injuries ranging from minor to serious and were transported to area hospitals for treatment. Figure 1 shows an overhead satellite view of the intersection of SR-78 West and US-27 with sign locations marked.²

Figure 1. Diagram of the intersection where the crash occurred. (Note: The original image came from the FDOT-funded Intersection Safety Analysis, May 2015; the NTSB has modified that image to accommodate the needs of this report.)

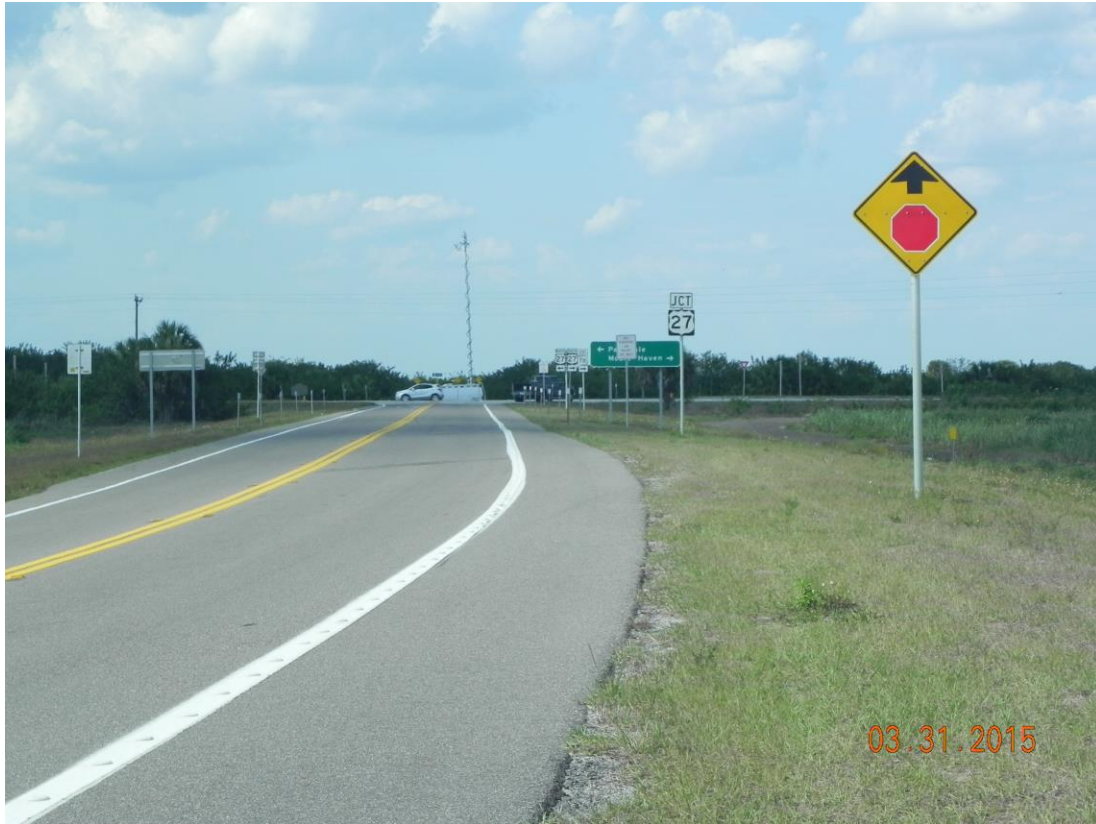
At the time of the crash, a stop sign was posted at the intersection of SR-78 West with US-27. The stop sign measured 36 inches high and 36 inches wide. The bottom of the sign was 8 feet 6 inches above the ground. The sign was located about 64 feet from the edge of the southernmost travel lane on US-27 and about 20 feet from the edge of the easternmost travel lane on SR-78. The 2009 edition of the *Manual on Uniform Traffic Control Devices* (MUTCD) specifies that this size of stop sign is the minimum for conventional road, multi-lane, or expressway applications.³ An advance warning sign, indicating a stop sign ahead, was posted approximately 930 feet prior to the stop sign’s location at the intersection, and four sets of transverse rumble strips were milled into the roadway beginning about 120 feet prior to the advance warning sign. The warning sign and stop sign are shown in figures 2 and 3.

Figure 2. Advance warning sign on the approach to the intersection of SR-78 West and US-27.

In response to these recommendations, the FDOT installed a new “Stop Ahead” sign with a flashing beacon, provided additional rumble strips, replaced the stop sign with an oversized version, and replaced the retro-reflective materials bordering the canal.

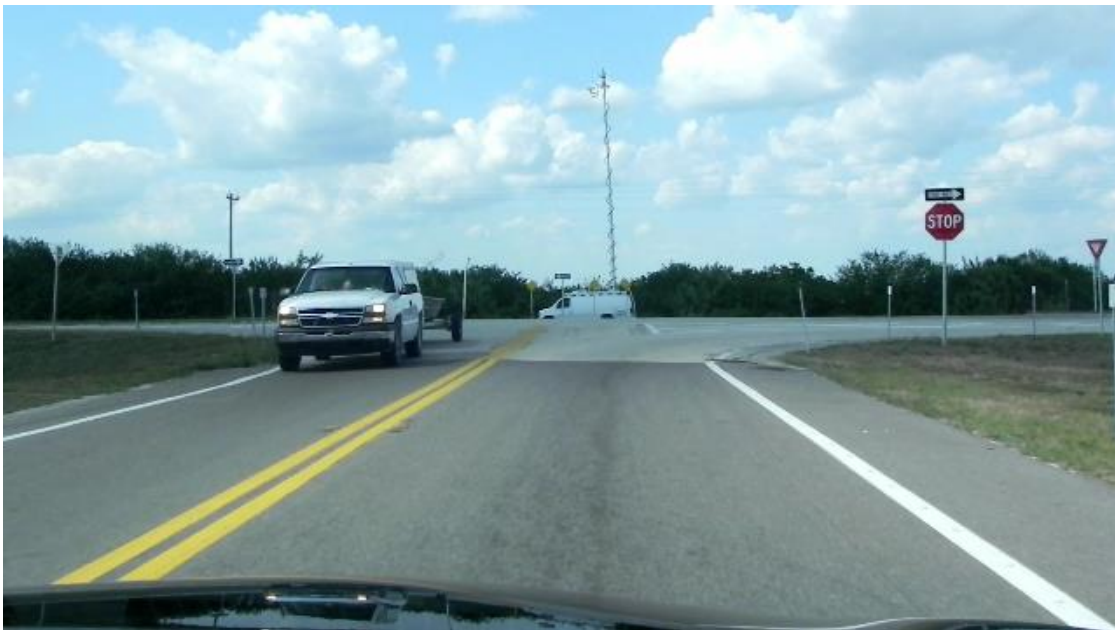
Figure 3. Stop sign at the intersection of SR-78 West and US-27.

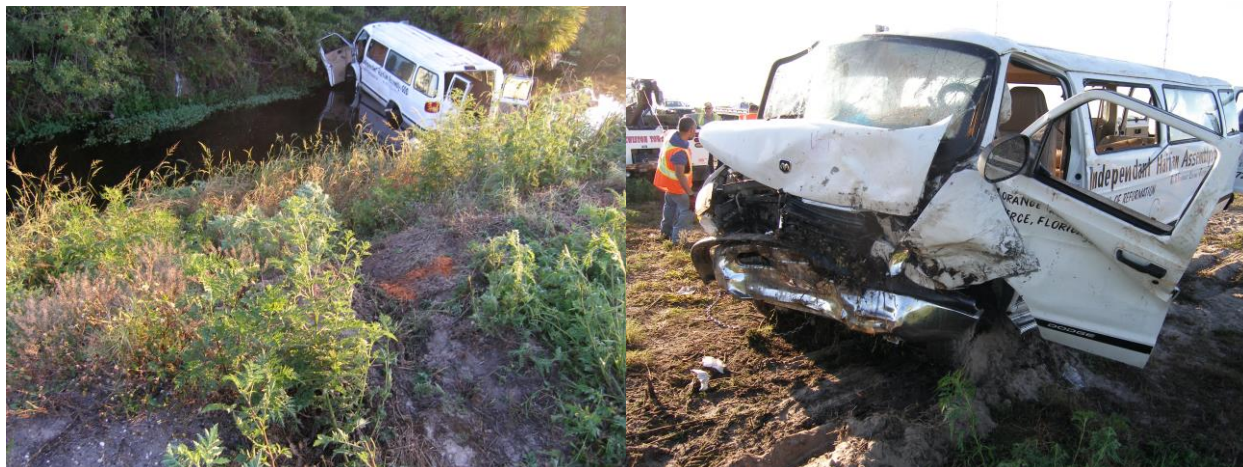
The van had significant contact damage to its entire front end from striking the canal bank before landing in the canal. The hood was buckled back and pushed into the windshield. The roof and windshield header were buckled up and back. The engine was moved rearward, so that it intruded into the area occupied by the dashboard, which was displaced into the passenger cabin. The left front axle was broken. The left bumper corner and left front fender were crushed rearward, restricting the left front tire. The driver door was initially jammed closed but later opened by first responders during the extrication of the driver. First responders found the passenger-side sliding door ajar and removed it to gain access to injured passengers and to remove the deceased. The vehicle's wheelbase was reduced from 127.6 inches to 110 inches on the driver side and to 124 inches on the passenger side. Maximum crush was estimated to be 18 inches at the front bumper. Figure 4 shows a view of the van at final rest and the deformation to its front end.

Figure 4. (a) Left—postcrash view of Dodge 15-passenger van at final rest in canal. NOTE: Orange paint on ground indicates area of vault. (Source: Florida Highway Patrol) (b) Right—postcrash view of front end deformation to Dodge 15-passenger van. (Source: Florida Highway Patrol)

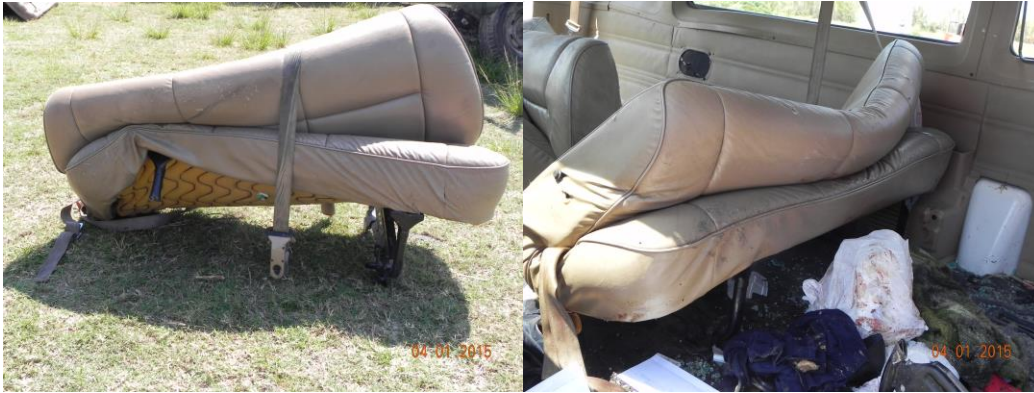
Following the crash, first responders cut and/or removed one or both of the floor attachment points for the bench seats comprising the first and third rows to reach the passengers. The second row bench seat remained attached to the floor. The seatbacks of all three OEM bench seats were almost completely bent forward and flattened against their seat pans. (See figure 5.) First responders stated that, upon opening the van's rear doors, the fourth row non-OEM bench seat was blocking their access to passengers, and they threw it out (into the canal) in the course of the extrication effort. Additionally, after entering the van from the right-side sliding door, first responders found that most of the passengers were piled between and behind the front bucket seats and against the right-side sliding door. Two deceased passengers were found lying on top of a surviving 4-year-old female passenger, who was on the floor under the first row bench seat on the left side. Adjacent to this young girl was a surviving male passenger, who was found partially under the first row bench seat, facing the right-side sliding door.

Figure 5. The bench seats from rows 1 and 2 of the Dodge 15-passenger van.

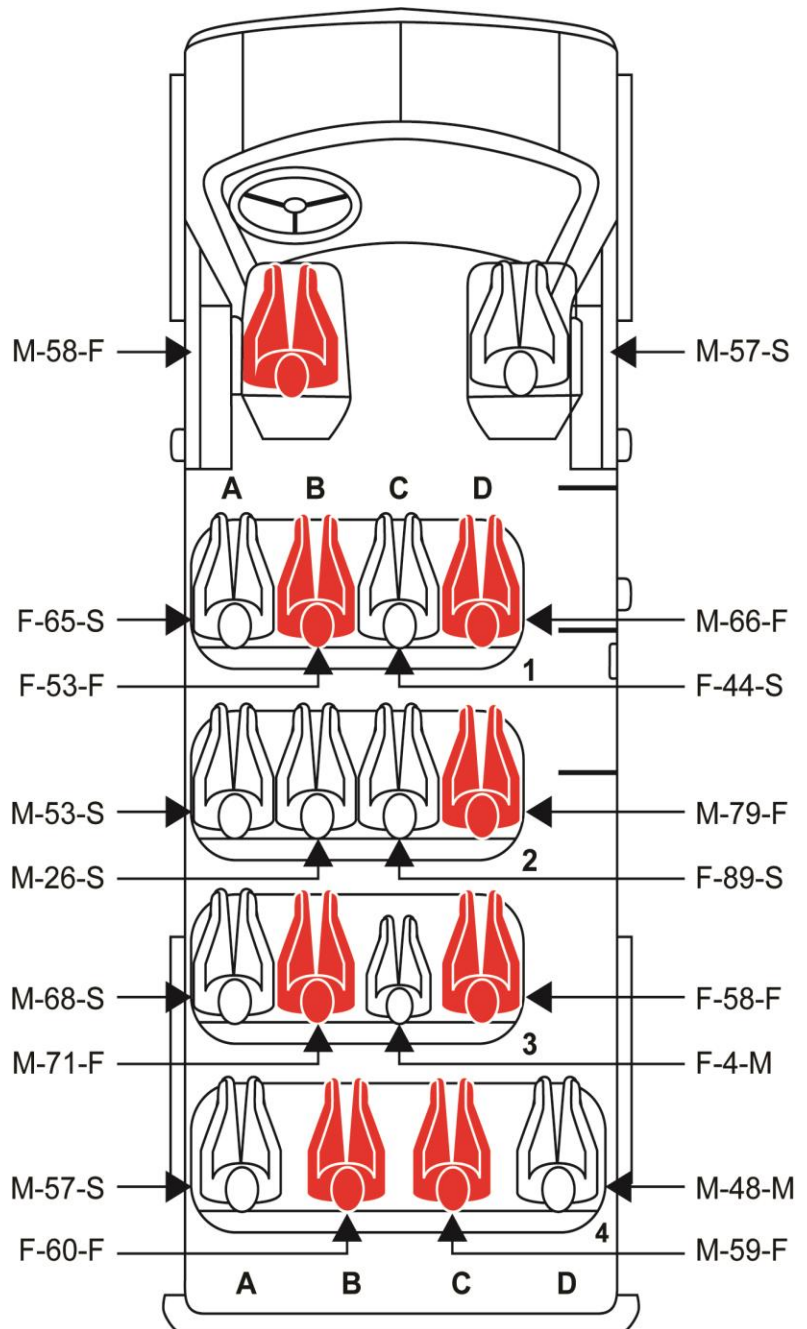
Viewed together, table 1 and figure 6 show the positions, ages, available restraints, restraint use, and injury levels of the van occupants. The table and the seating chart were developed based on information provided in interviews with 3 of the 10 surviving passengers.¹⁷ Interviewees identified and located all but two passengers as to their seating positions. (The unidentified seating positions were the second bench row, seat C, and the third bench row, seat A).¹⁸ (Note that the bench seats in rows 1–3 were designed to hold only three occupants and therefore were equipped with only three restraint systems; however, table 1 and figure 6 show the actual occupancy of the vehicle, which was greater than the vehicle’s design seating capacity.)

Figure 6. Seating positions and individual and survival information for the occupants of the Dodge 15-passenger van. (Occupant images shaded in red indicate a fatality at that location.)
