National Transportation Safety Board

Highway Accident Brief

Rear-End Crash Involving Truck-Tractor Semitrailer and Sport Utility Vehicle, Goodland, Kansas, June 29, 2016

Accident Number:	HWY16FH017
Accident Type:	Rear-end crash
Location:	Milepost 30.1, eastbound Interstate 70, Goodland, Sherman County, Kansas
Date and Time:	June 29, 2016, about 2:15 a.m. mountain daylight time (MDT)
Vehicle 1:	2016 Volvo truck-tractor in combination with a 2007 Great Dane semitrailer
Vehicle 2:	2004 Toyota Sequoia sport utility vehicle (SUV)
Fatalities:	6
Injuries:	5

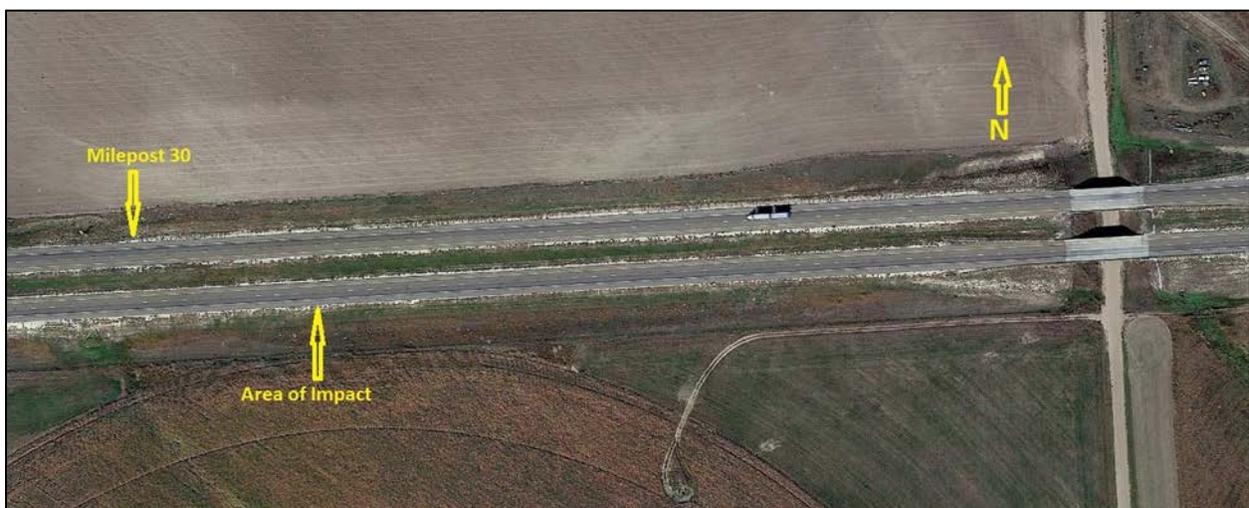
The SUV was traveling at a slower speed than the truck, which overtook the SUV and rear-ended it. The truck driver told investigators that, to avoid an imminent collision with the SUV, he took evasive action by applying the brakes and steering to the left. Roadway mark evidence supports that he did take such action when he was about 100 feet away from the SUV. According to data from the truck's engine control module (ECM), the truck was traveling about 75 mph when it struck and overrode the rear of the SUV. (See figures 1 and 2 for location and crash site information.)

Figure 2. Aerial view of crash location near milepost 30 eastbound on US-70, indicating area of impact. (Source: Google Earth modified)

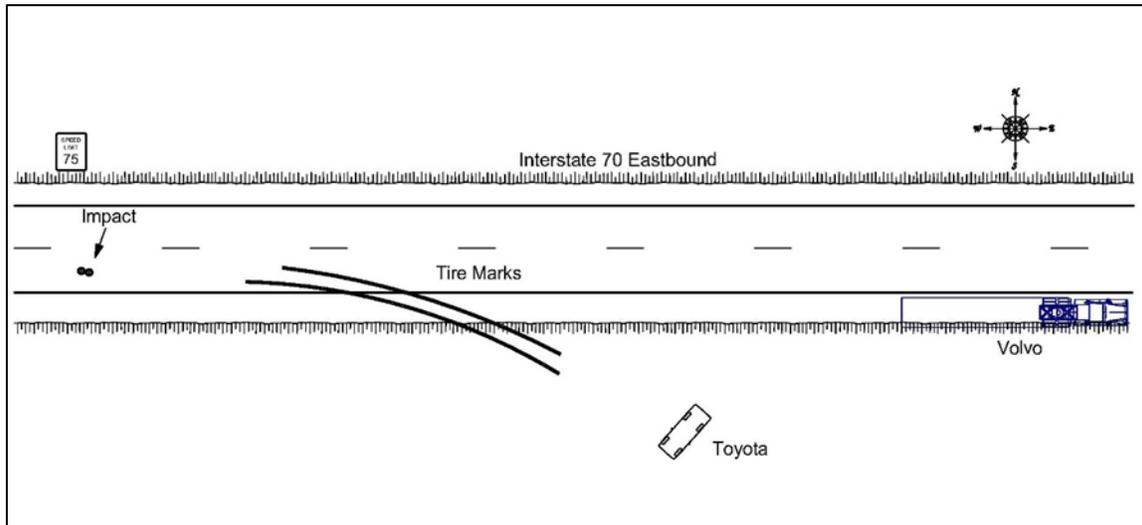
After being struck by the truck, the SUV traveled off the south edge of the pavement, rotated clockwise, and overturned, coming to rest on its roof, facing southwest.² The truck continued for a short distance on I-70 before coming to a controlled stop on the south shoulder of the eastbound lanes. (See figure 3 for the area of impact and the vehicles' final rest positions.)

Figure 3. Diagram of collision area showing location of impact, tire marks, and final rest positions of the SUV and the truck.

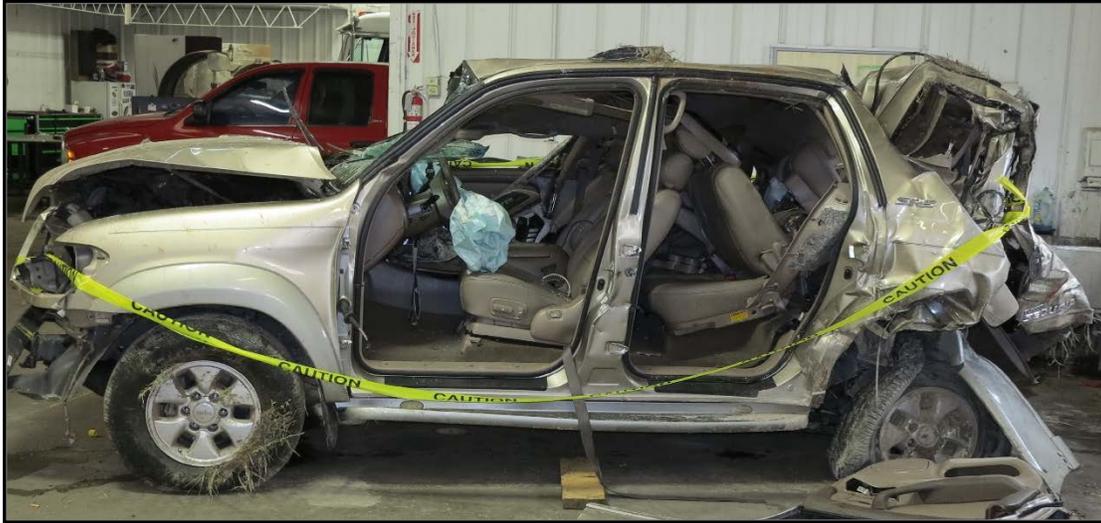
The SUV was extensively damaged. It had contact damage that went across its entire rear and reduced the interior rear occupant space. The rear frame rail was deformed and pushed down and forward, almost to the rear axle. First responders removed both left side doors during extrication efforts at the crash scene. The entire front of the SUV also had contact damage resulting from the overturn sequence. (See figure 4 for a photograph of the SUV postcrash.)

Figure 4. Damaged SUV; photograph taken facing the left side of the vehicle.

The second row of seats was deformed, pushed forward and downward from the rear. The third row of seats had also been displaced forward and, because of floorboard deformation, the tops of the seats were near the headliner.³

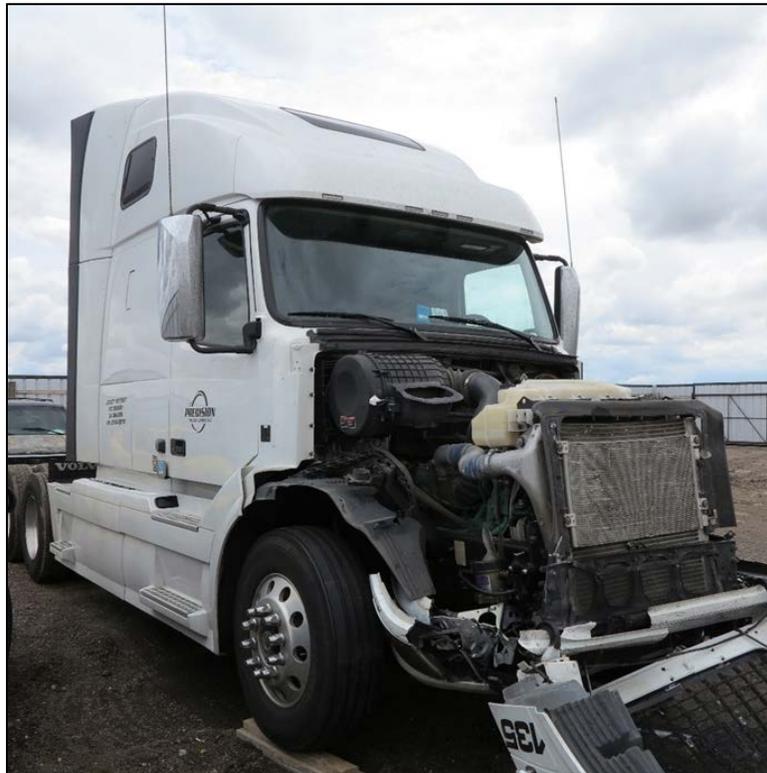
The entire front end of the truck-tractor sustained contact damage. No damage or intrusion affected the truck's passenger compartment. All driver controls were intact and undamaged. The semitrailer was not damaged in the collision. (See figure 5 for a postcrash photograph of the truck-tractor.)

Figure 5. Damage to the right front of the truck-tractor.
