National Transportation Safety Board

Highway Accident Brief

Fatal Pedestrian Collision with Sport Utility Vehicle Alexandria, Virginia, August 30, 2016

Accident Number:	HWY16SH025
Accident Type:	Fatal pedestrian collision with sport utility vehicle
Location:	Richmond Highway (US Route 1) at Gregory Drive, near Alexandria, Virginia
Date and Time:	August 30, 2016, about 6:17 a.m. eastern daylight time
Vehicle:	2008 GMC Yukon
Driver:	69-year-old female
Pedestrian:	56-year-old male
Fatalities:	1

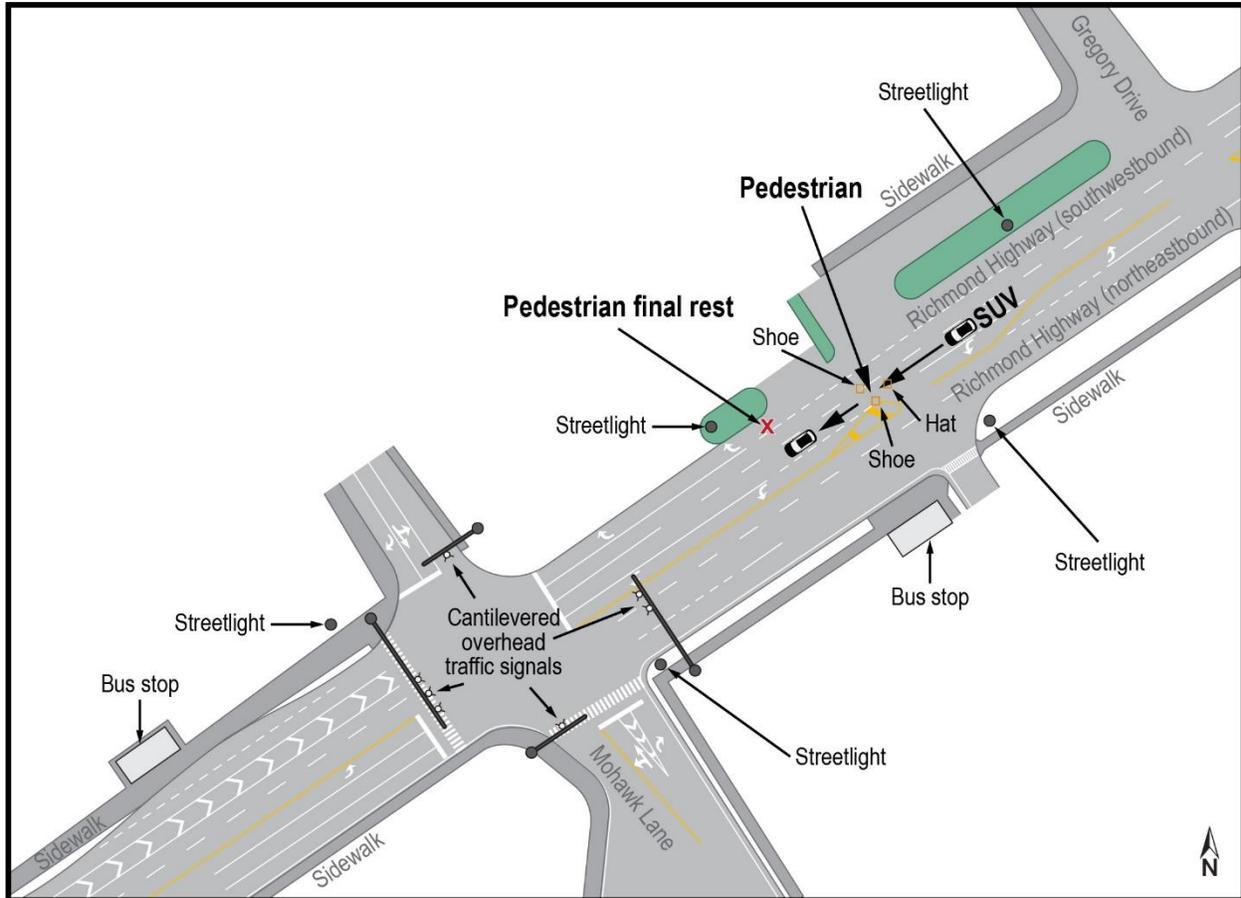
About 6:17 a.m. on Tuesday, August 30, 2016, a 2008 GMC Yukon sport utility vehicle (SUV), driven by a 69-year-old female, was traveling south in the left southwestbound lane of Richmond Highway (US Route 1) about 9 miles southwest of Alexandria, Virginia.¹ A 56-year-old male pedestrian had walked into the southwestbound lanes from the northwest side of the highway. The pedestrian continued to walk south in the left lane for a short distance until the right front of the SUV struck him, causing fatal injuries. The driver told responding police officers that she did not see the pedestrian until it was too late. Investigators found no evidence of preimpact braking and no postimpact skid marks. The area of impact was 100 feet southwest of the intersection of Richmond Highway and Gregory Drive (figure 1).

After the collision, the SUV driver stopped in the left southwestbound lane of travel, about 11 feet from the pedestrian. The driver stayed on the scene until the police arrived. The pedestrian came to rest on the roadway in the right-turn lane of southwestbound Richmond Highway near the curb, about 112 feet from the point of impact. The Fairfax County Police Department documented a debris field near the impact point between the pedestrian and the SUV.

Figure 1. Diagram showing path of SUV on Richmond Highway, point of impact, pedestrian final rest, roadway debris, and surrounding features such as streetlights and bus stops.

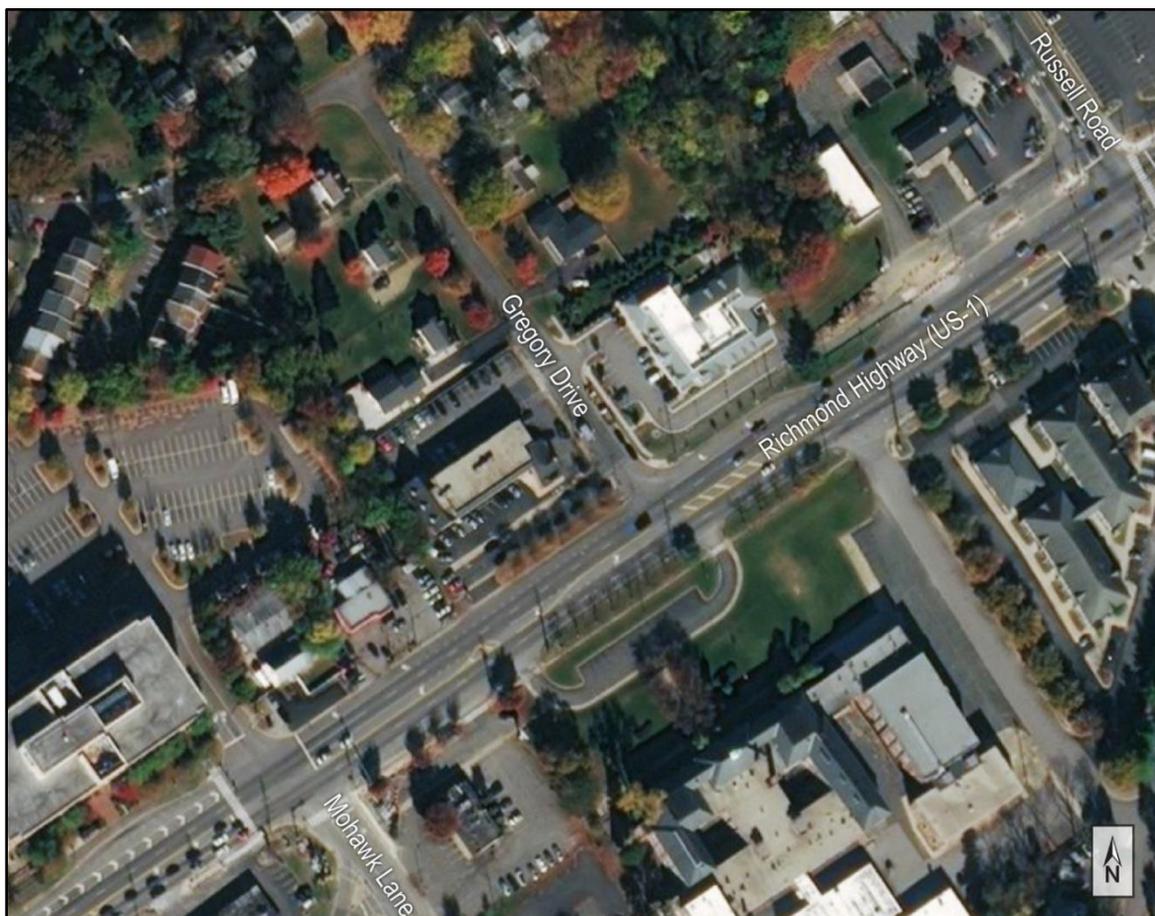
Figure 2. Aerial view of crash location showing nearest intersection to crash site (Gregory Drive), nearest pedestrian crosswalks (at Russell Road and Mohawk Lane), surrounding buildings and parking lots, and nearby residential neighborhood. (Base photo by DigitalGlobe)

The block on the northwest side of Richmond Highway where the crash occurred has no sidewalks next to the highway. Near the crash site, a raised grassy strip planted with trees separates Richmond Highway from a short service road paralleling the highway (refer to figure 1). People have worn a foot trail in the grassy strip. Vehicles are allowed to parallel-park on the service road, which contains entrances to parking lots for local businesses. A sidewalk on the northwest side of the service road runs the length of the road and dead-ends where the road reconnects with Richmond Highway.

The closest crosswalk on Richmond Highway is 350 feet southwest of the area of impact, at the intersection of Richmond Highway and Mohawk Lane. The closest crosswalk to the northeast, at the intersection of Richmond Highway and Russell Road, is 850 feet from the crash site. Pedestrian walk phases are incorporated into the timing sequence of the traffic lights at both intersections.

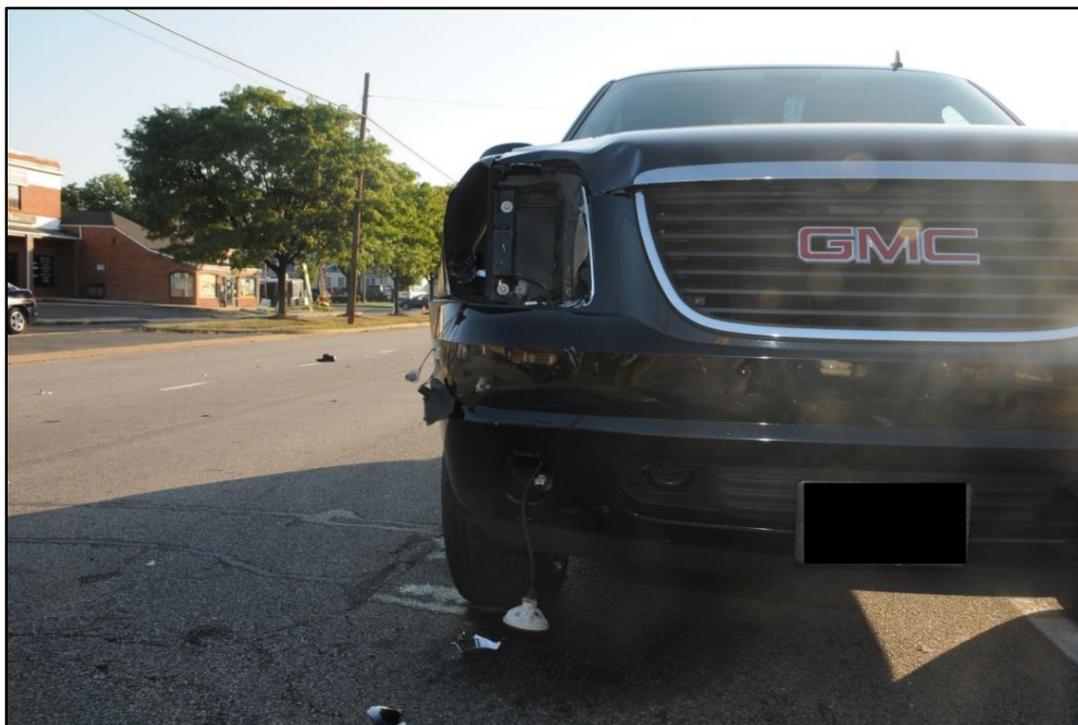
front of the vehicle (figure 3). The headlight lens and most of the assembly on that side were missing. The headlight bulb was still attached to part of the reflector and was hanging from the connector wire. The right side of the hood showed contact damage from the top of the headlight cavity to the base of the windshield. The right front fender also showed contact damage near the headlight. The right front headlight bulb, in the area of impact, displayed hot shock on the filament, indicating that the headlight was illuminated at the time of impact. The vehicle's headlight controls were in the automatic position. The SUV's front air bags did not deploy in the crash.

Figure 3. Photograph of crash SUV showing damage on right side to headlight, hood, and fender.
