National Transportation Safety Board

Highway Accident Brief

Collision Between Passenger Train and Refuse Truck at Active Grade Crossing, Crozet, Virginia, January 31, 2018

Accident Number:	HWY18MH005
Accident Type:	Train and refuse truck collision at active grade crossing
Location:	Lanetown Road at Buckingham Branch Railroad, milepost 195.85, near Crozet, Albemarle County, Virginia
Date and Time:	January 31, 2018, about 11:16 a.m. eastern standard time
Vehicle 1:	2018 Freightliner refuse truck
Operator 1:	Time Disposal, LLC
Vehicle 2:	Amtrak train P923-31 (Congressional Special Train)
Operator 2 (railroad):	Buckingham Branch Railroad
Operator 2 (train):	Amtrak
Fatalities:	1
Injuries:	9

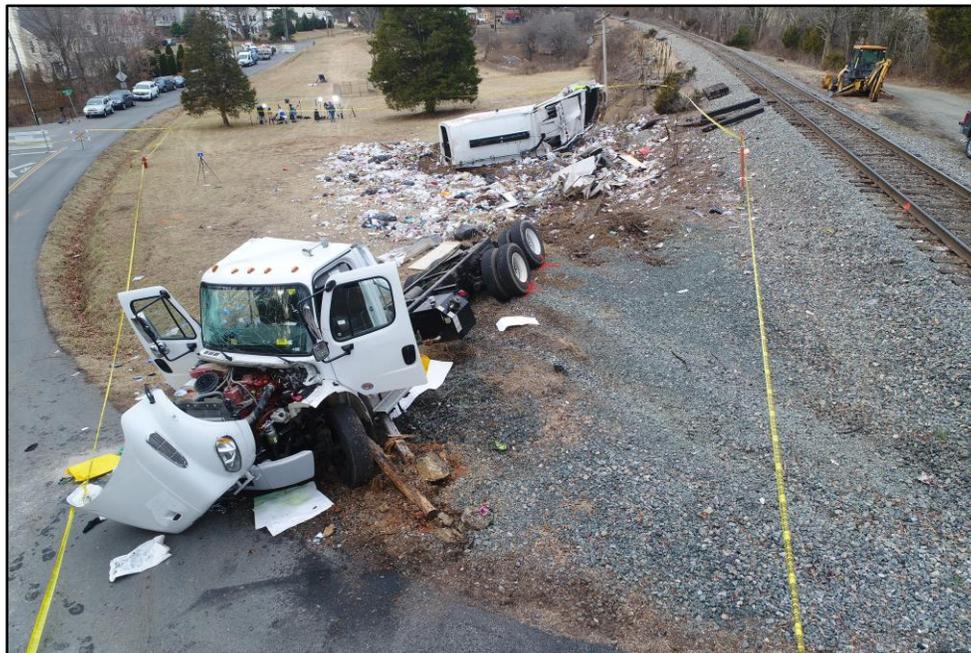
Figure 2. Truck at rest position postcrash, with partial view of displaced hopper.

The truck sustained severe damage to the body and major mechanical systems. The refuse hopper separated from the chassis at impact. The left rear of the hopper had contact damage from the locomotive, indicating that the truck was positioned at a slight angle on impact. The top of the truck's hood was displaced, and the bottom was partly disconnected from the front bumper. The windshield was shattered but still in place. The entire length of the truck's frame was twisted, and both frame rails were bent to the right at an angle of about 45 degrees. The rear of the cab was separated from the frame and displaced up and to the left.

The floor of the cab below the driver's seat was buckled and deformed upward, while the seat had rotated right and to the rear so that it protruded from the cab's rear window. The midsection of the passenger bench was displaced forward to within 3 inches of the console. The structural integrity of the roof was compromised in several places, with a maximum intrusion into the cab of 19 inches. Despite the intrusions, the cab had sufficient survivable space.

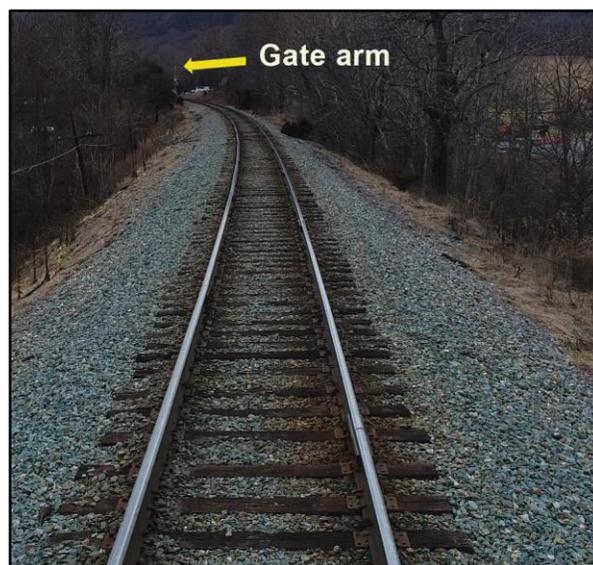
On February 2, 2018, NTSB investigators conducted distance observations at the crash site, using an exemplar train and an exemplar refuse truck, to determine at what point on the track the train's crew could have first seen the truck. One member of the crew on the exemplar train was the road foreman of engines, who had filled that role on the crash-involved train. When the exemplar train was about 896 feet east of the crossing, the road foreman of engines said that was where he first saw the crash-involved refuse truck drive around the north gate before stopping on the tracks. A high-definition image captured by an NTSB small unmanned aircraft system (UAS) shows that the north gate of the Lanetown Road grade crossing becomes visible about that far from the crossing (figure 4).²²

Figure 4. Location of exemplar locomotive at point where road foreman of engines recalled seeing refuse truck at north gate during postcrash distance observations. (Image captured by UAS)

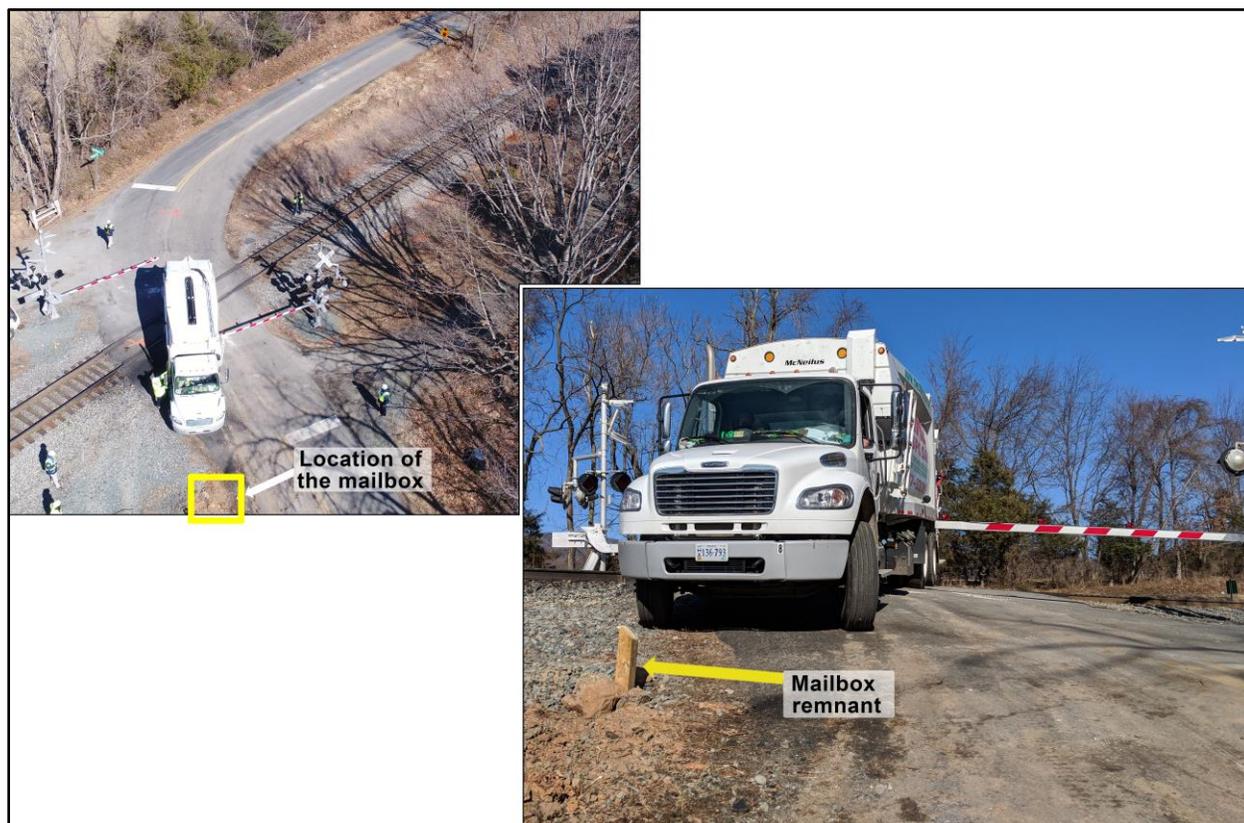
The driver of the exemplar truck maneuvered around the north gate, but he could not drive around the south gate and clear the tracks (figure 5). He stated that he could not safely exit the crossing. The position where the exemplar driver stopped appeared to be nearly the same as the crash truck's position at impact, based on the video from the forward-facing camera on the lead locomotive. The mailbox, which was south of the tracks and west of Lanetown Road, as shown in figure 5, would have prevented the crash driver from clearing the crossing without damaging the south gate arm, the mailbox post, or the side of the truck. The configuration of the grade crossing and the position of the mailbox structure indicate that maneuvering a refuse truck around the lowered gate arms could not have been the crash driver's routine practice at this grade crossing.

The left image in figure 5 indicates that there might have been sufficient space for the crash truck to reverse (although another vehicle approached the grade crossing before the crash), but it is unknown whether the truck driver—who refused interview requests by NTSB investigators—had the option of backing up before the impact. Although the approach to the grade crossing

included LGCGC warning signs, the observations using the exemplar truck showed that the underside of the crash truck would not have become lodged on the crossing.

Figure 5. Overhead (top) and front (bottom) views of exemplar truck at position similar to that of crash truck at time of impact; also shown are locations of mailbox and remnant of mailbox post.
